APPENDIX A
OTHER REPORTS AND INVESTIGATIONS

Subject: **INFORMATION**: Geotechnical Memorandum No. GM06-03; **Geotechnical Site Reconnaissance of Shelter Cove Road System [Addendum to Geotechnical Memorandum GM28-99, "AK PFH 39, Shelter Cove Road: PIR Preliminary Geotechnical Information" (2/18/00)]**

Subject: **Geotechnical Memorandum GM06-03: Geotechnical Site
Reconnaissance of Shelter Cove Road System
[Addendum to Geotechnical Memorandum GM28-99,
“AK PFH 39, Shelter Cove Road: PIR Preliminary
Geotechnical Information” (2/18/00)]**

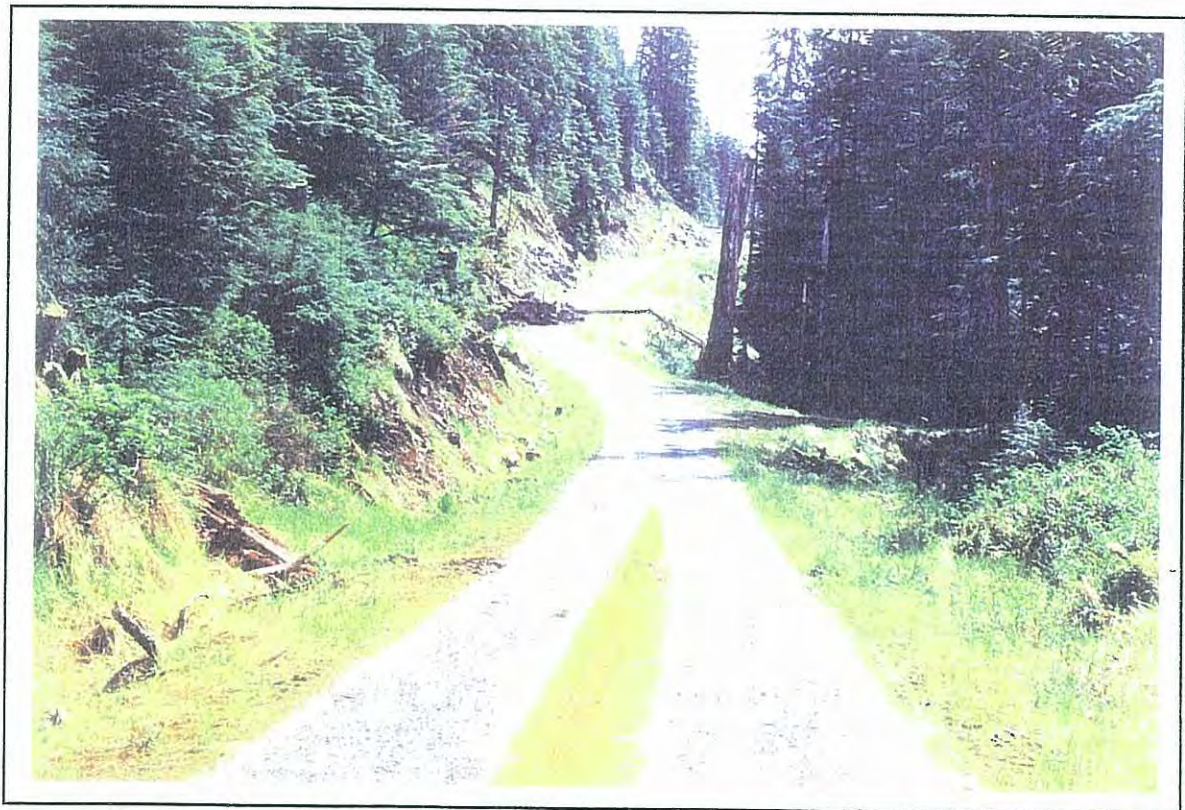
Photo 2 : Typical roadway section showing steep cut slopes in mixed soil and rock common material. Note irregular roadway alignment.

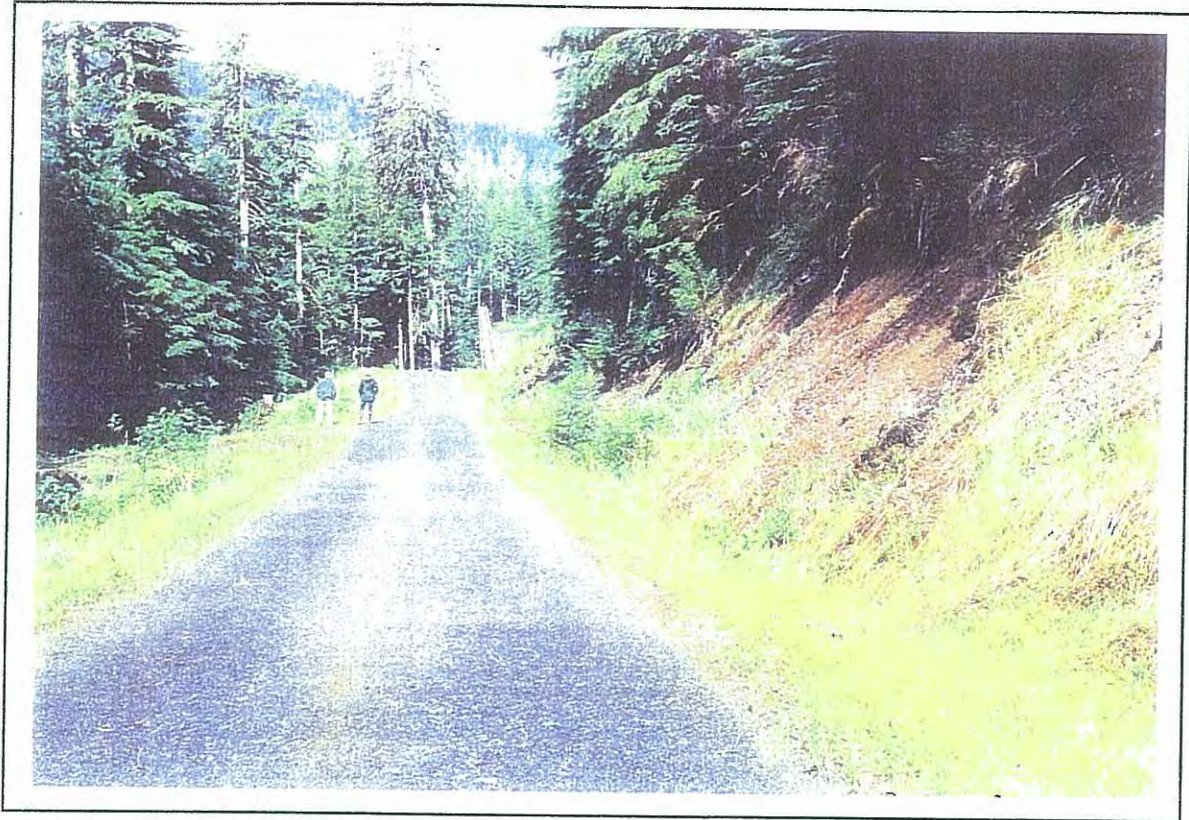
Cut sections in bedrock were separated by sections of common material consisting primarily of fine sandy organic silt with varying amounts of broken rock. The common materials had been excavated at slope ratios of 1V:1.33H to 1:1. (Bob Emley stated that the cut slopes for timber sale roads aren't "designed". Instead, the contractor typically excavates "blast" rock about 1V:2H to 1V:1.33H, rippable rock about 1V:1.33, and common material 1:1 or flatter.

Contractors do not get paid for excavation flatter than 1:1 but they excavate flatter cuts when they need additional material elsewhere on the job. It appeared that common materials on the Shelter Cove road had been excavated in the range of 1:1 to 1V:1.25H.) The common cuts appeared to be generally stable, but I did see a section of 4 to 5 m (13.1 to 16.4 ft.) high cuts in moist silty soil in which several failures had occurred. The failures had been stabilized with Class 4 or Class 5 riprap stacked steeply against the slope like a shallow inlay, which seemed to be working pretty well.

Photo 3 : Close-up of typical steep cut construction in common material. Note steep brow at top of cut.

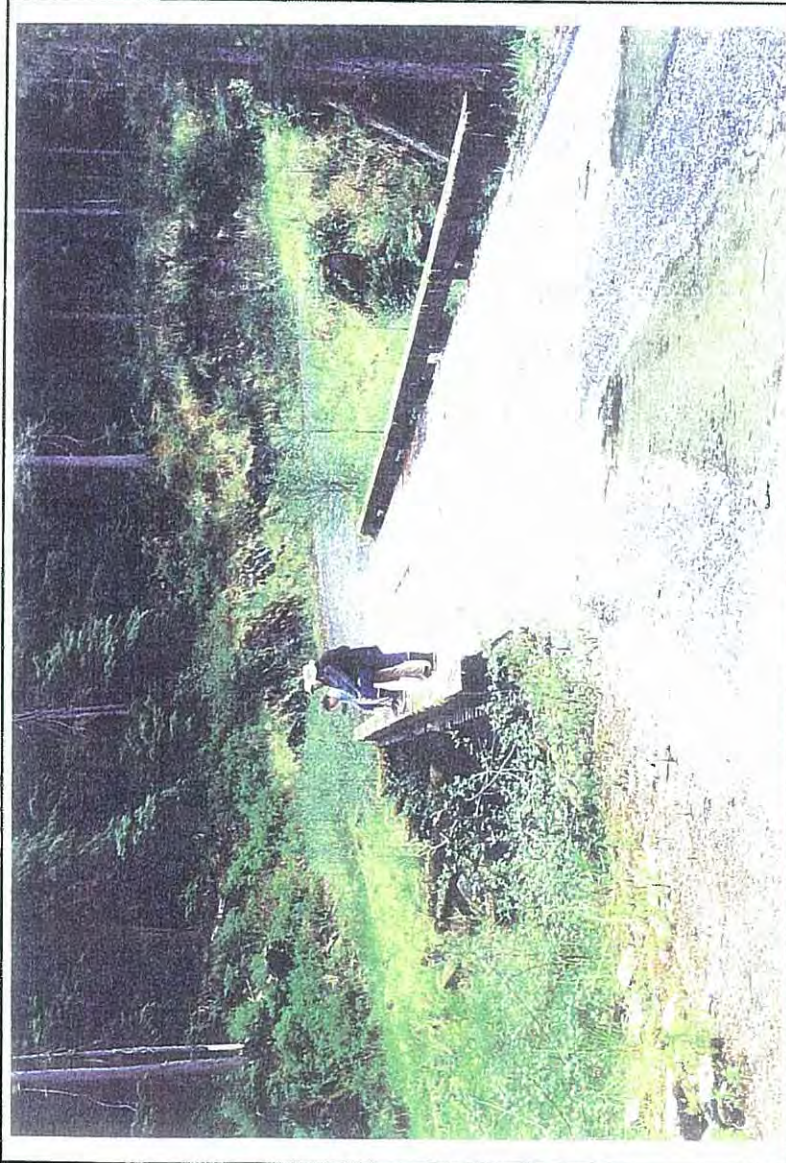
Photo 7 : Another view of bridge at MP 7.5. Proposed project would realign road with new bridge.

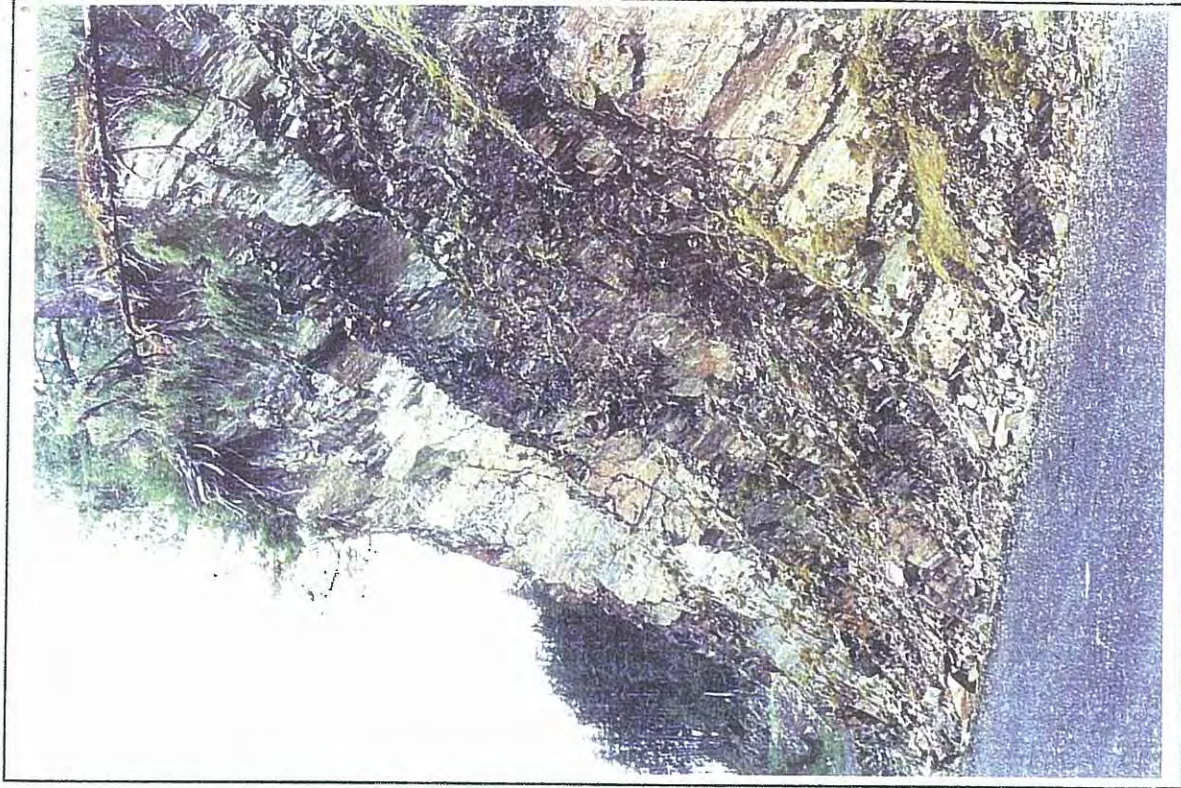
The cut slope materials on this road system consist primarily of bedrock overlain by about 0 to 6 m of colluvium consisting of mixed sandy silty soil and angular rock fragments. The bedrock is primarily phyllite which is a highly jointed, fractured, and thinly laminated metamorphic rock of lower metamorphic grade than schist and generally not as micaceous. The phyllite on the Shelter Cove road system forms prominent outcrops along the roadway in which the rock varies from relatively massive, unfractured and unjointed rock to highly fractured and jointed and from slightly weathered to deeply weathered. Existing road cuts in harder rock appeared to have been excavated at slope ratios of about 1V:2H to 1V:1.33H (1/2 to 1 to 3/4 to 1) and in softer rock at about 1V:1H. Rock cut heights varied from about 3 m to 20 m (10 to 65 ft.).

Photo 8 : Highly fractured, jointed, and thinly laminated phyllite bedrock typical at Shelter Cove road system.

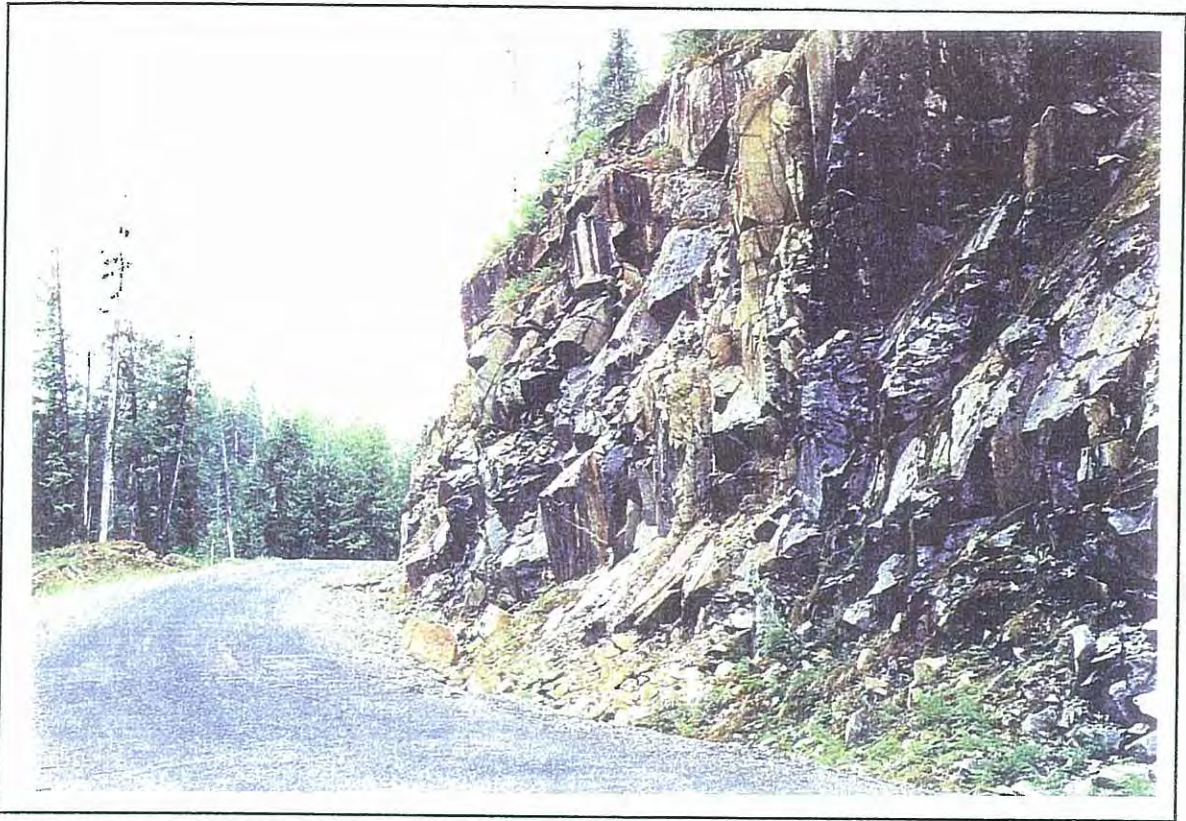
The phyllite bedrock on this project is foliated, fractured, and moderately to highly jointed. Well-developed planar joints were observed at some locations. It is possible that rock stabilization measures such as rock bolting or doweling would be required in some places to stabilize adversely oriented blocks or masses of rock exposed by new cuts.

Photo 9 : Another outcrop of extremely fractured phyllite with planar joints inclined toward roadway (right side of photo).
