**Deadhorse Airport Improvements
Draft Environmental Assessment**

Water Resources Impacts – Floodplains

Appendix H Water Resources Impacts – Floodplains

Project Number: NFAPT00549

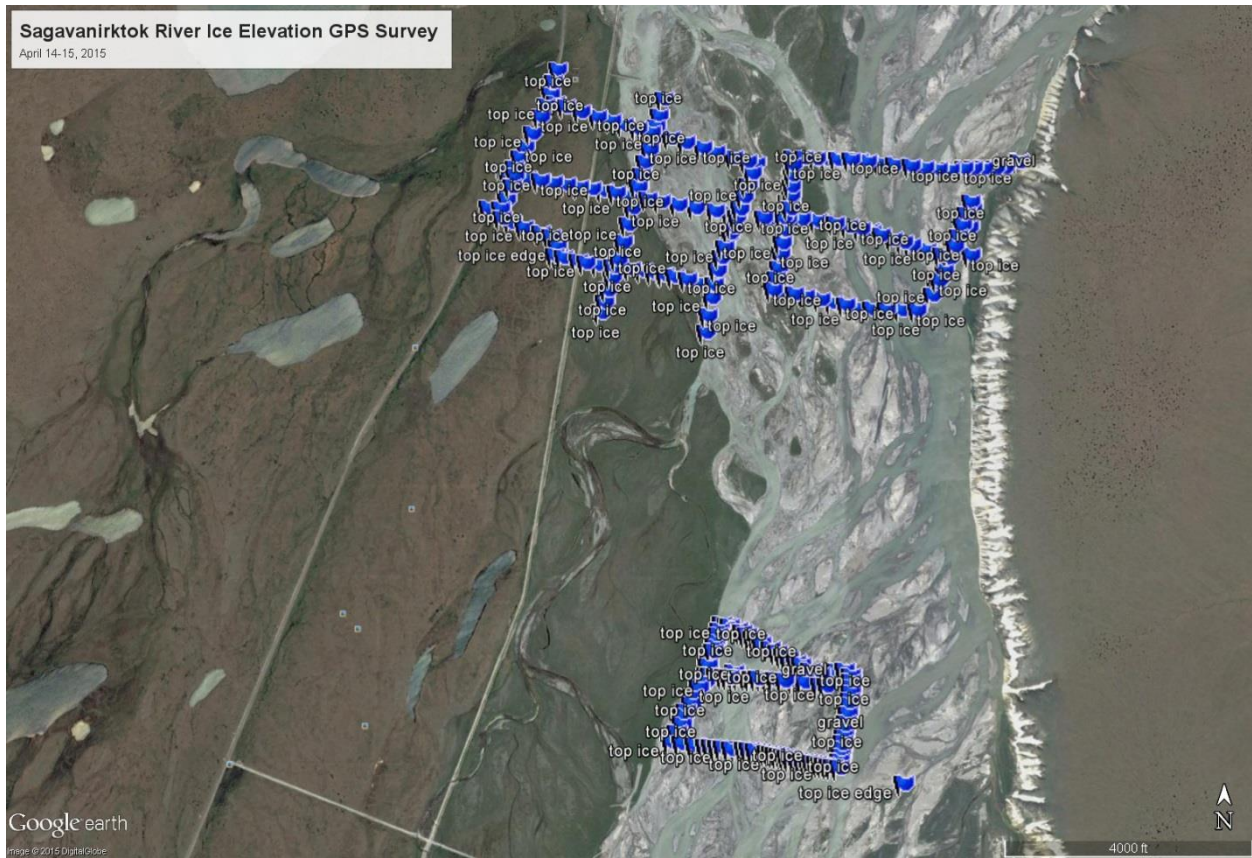
Figure 12. Locations of points surveyed with a GPS to map ice elevation near Franklin Bluffs.

Unfortunately, it was soon discovered that the rover range was severely limited due to radio malfunction at the base station. A second problem occurred when, due to cold temperatures, the base station battery died before 4 hours of static observations were collected. Battery failure was viewed as a lesser problem, since 2 hours is the minimum collection period for standard static observation, and well beyond 2 hours had been reached, just not the goal of 4 hours. Because of impaired base station radio telemetry and limited time, concentration was directed at the cross-sectioning effort farther north at the separation of the river channels and the beginning of aufeis encroachment on the highway.

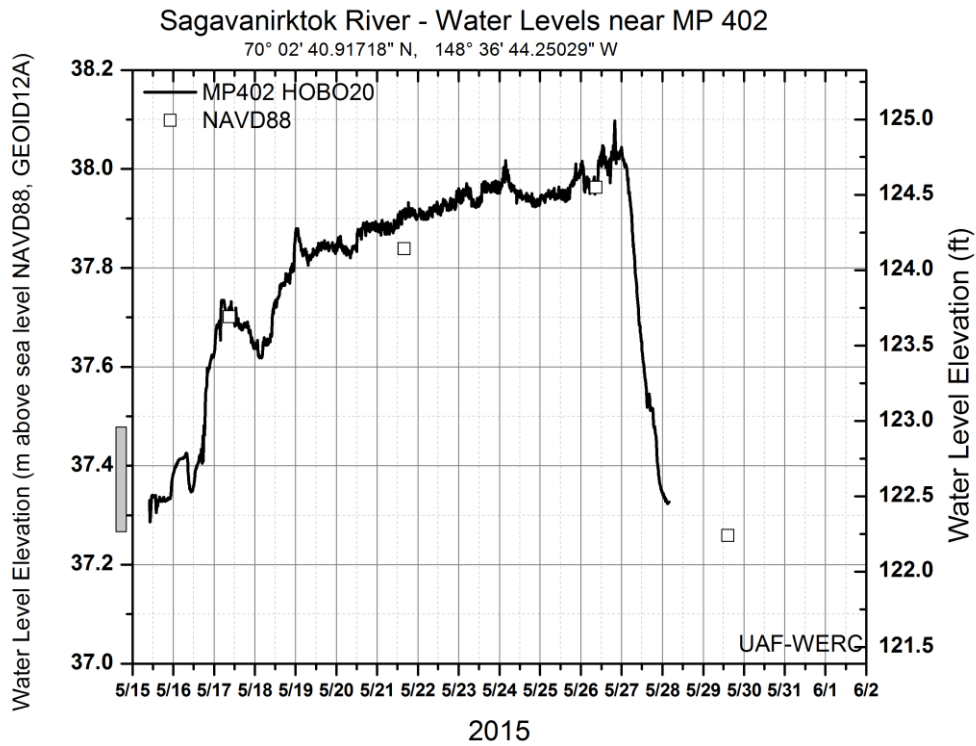
Figure 24. Water levels on the Dalton Highway near MP402.

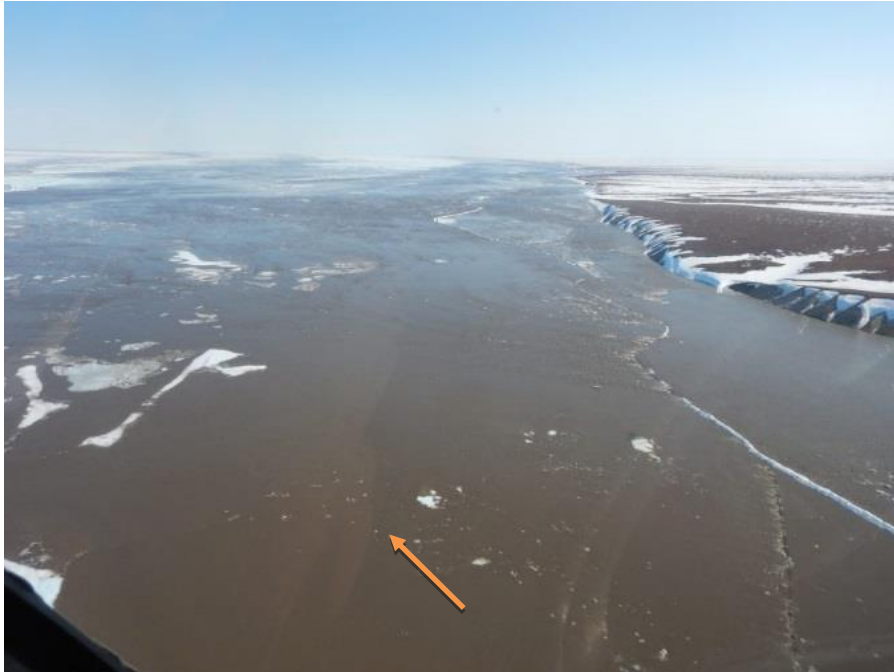
Figure 26. Measurement reach looking north on May 18, 2015. The Franklin Bluffs are on the right. Most of the flow is on the east (right) side of the channel, partially contained by a failing snow dike. Water is flowing over ice to the left (west) of the snow dike.

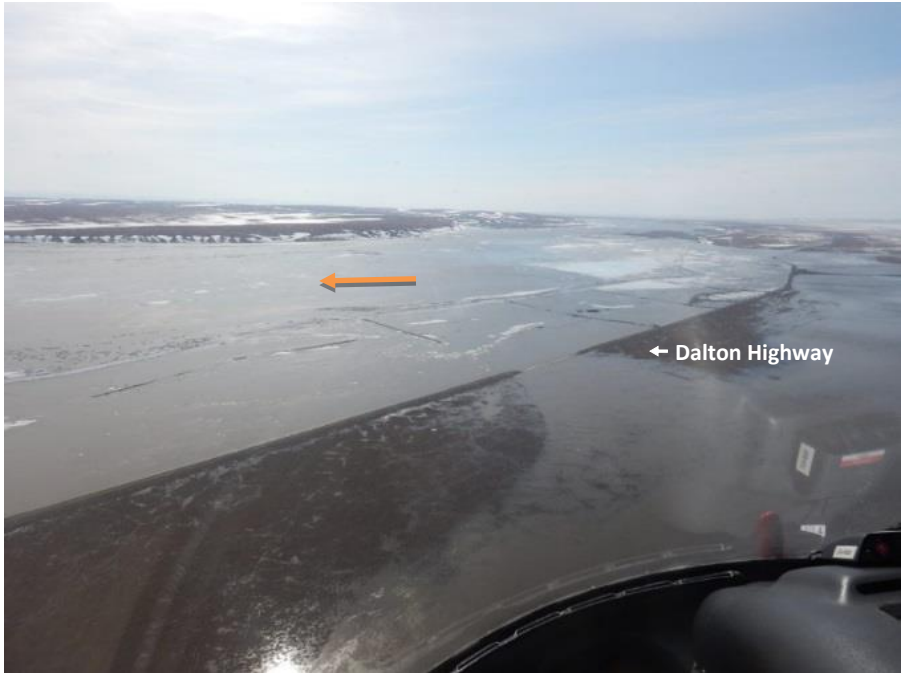
Figure 27. Measurement reach on May 20, 2015, facing southwest, with Franklin Bluffs in the distance. The photograph shows water flowing over the Dalton Highway near the spur dikes. Water levels are very high, and water continues to flow over the ice on the western side of the river.

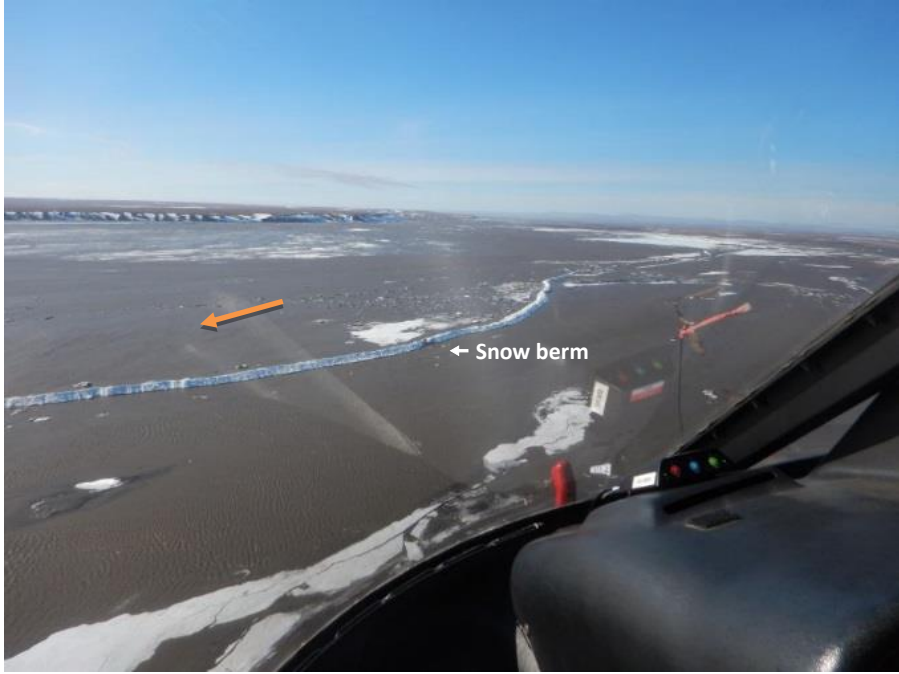
Figure 29. Measurement reach on May 23, 2015, facing south. Franklin Bluffs are visible at the top left of the photograph.

Pictures were taken at the measurement reach each day (Figure 26 through Figure 34). Additional photographs can be found in Appendix B. Around May 20, 2015, the peak flow for spring breakup was over 1600 cms (56,500 cfs). Flows decreased through the next week, until a rainfall event on May 29 caused flows to increase for a brief period.

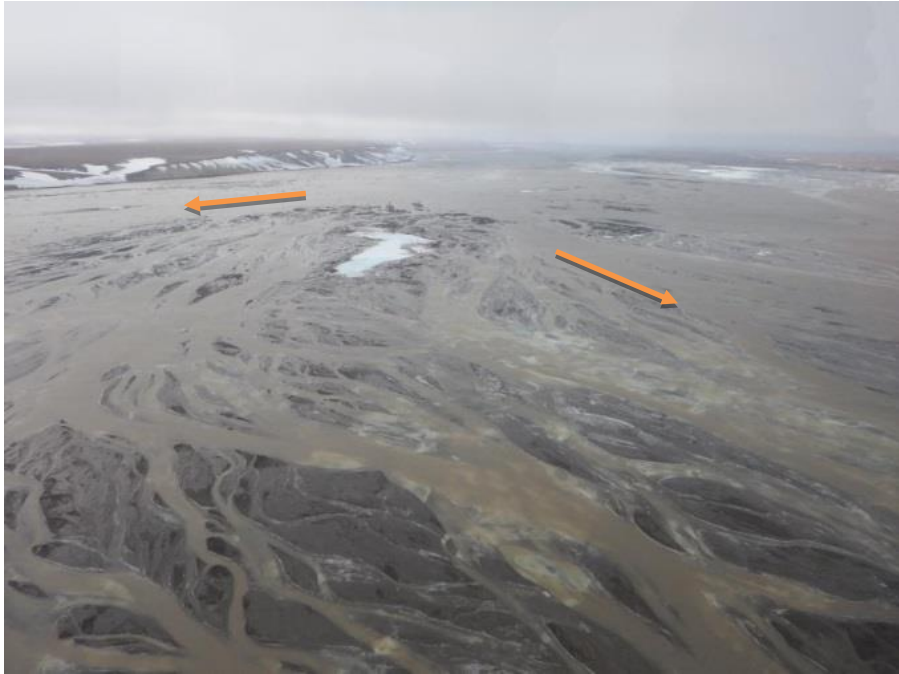
Figure 30. Measurement reach on May 24, 2015. Photograph is taken facing south, and Franklin Bluffs are visible at the top left. Water levels have declined, and gravel bars are becoming visible, defining the bifurcation.

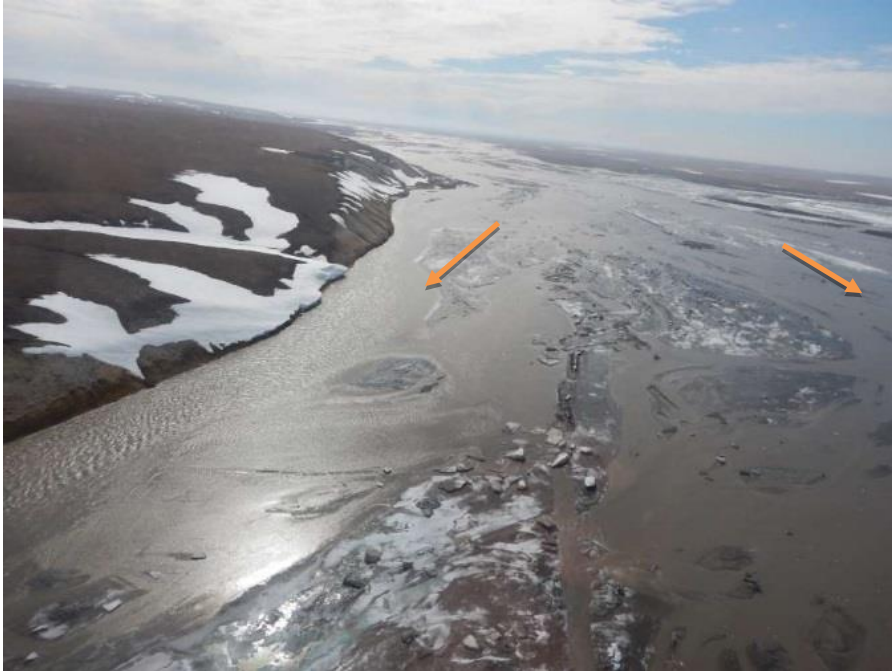
Figure 31. Measurement reach on May 27, 2015, facing south. Franklin Bluffs are at the left. Water levels have receded, and stranded ice is observed on gravel bars.

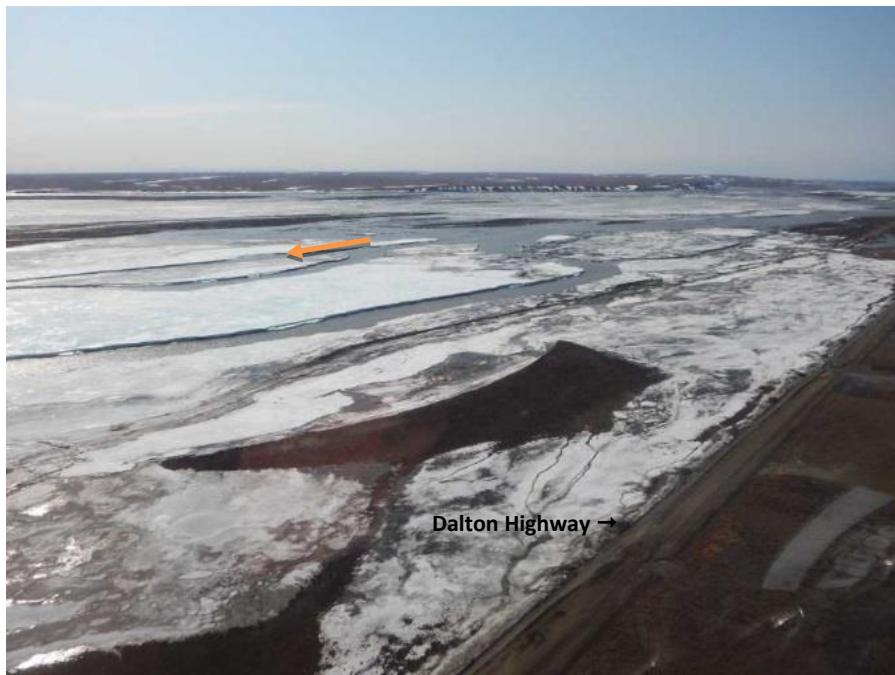
Figure 32. Measurement reach on May 28, 2015, near the west channel facing south. Franklin Bluffs are visible toward the top center of the photograph. Extensive ice remains in the west channel.

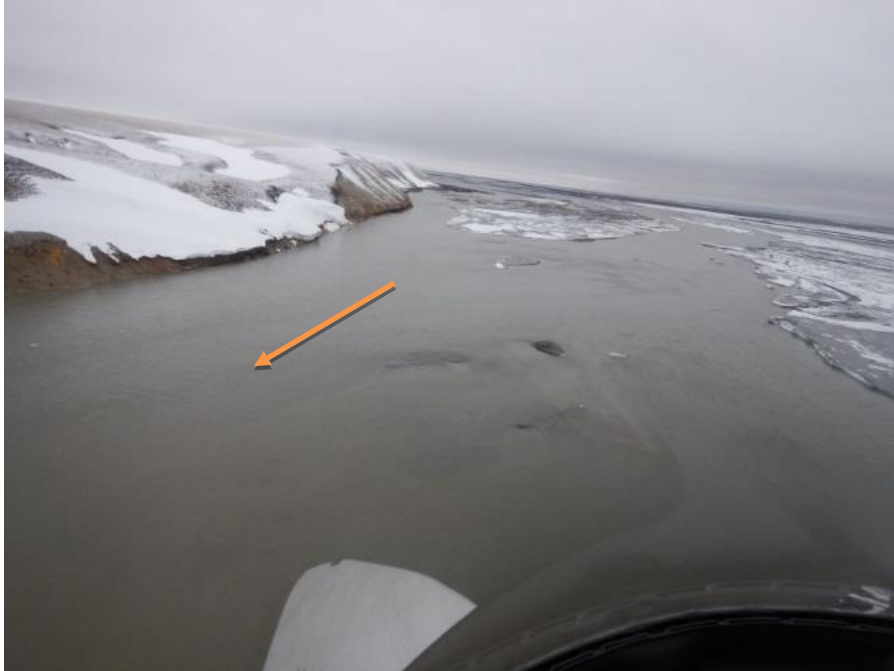
Figure 33. Measurement reach on May 29, 2015, facing south (upstream). Franklin Bluffs are visible at the left. Water levels have increased in response to rain. This channel is the East Fork.

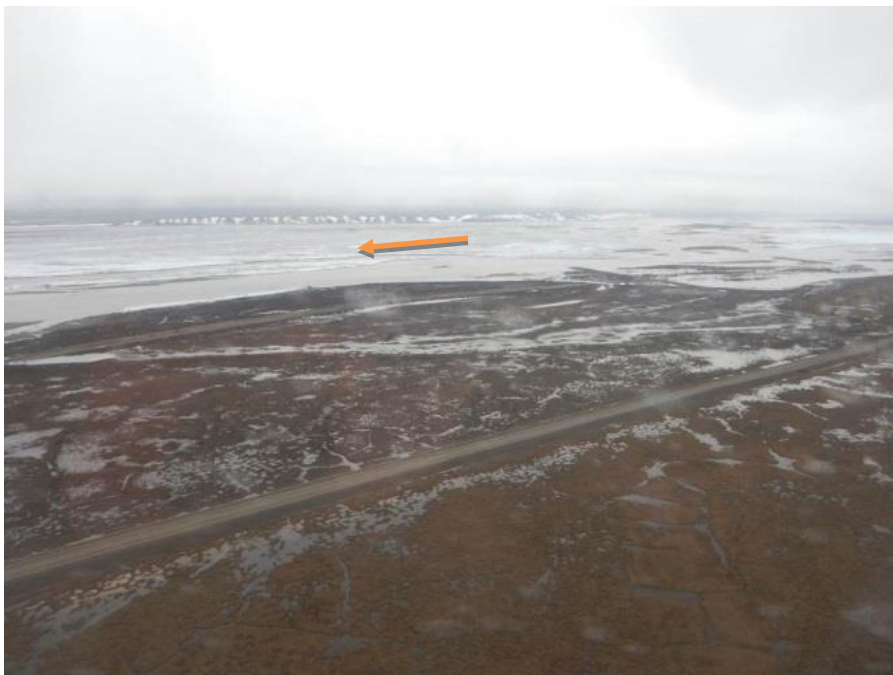
Figure 34. Measurement reach on May 30, 2015, facing southwest. Franklin Bluffs are in the distance. Water levels and flows increased in response to rainfall.

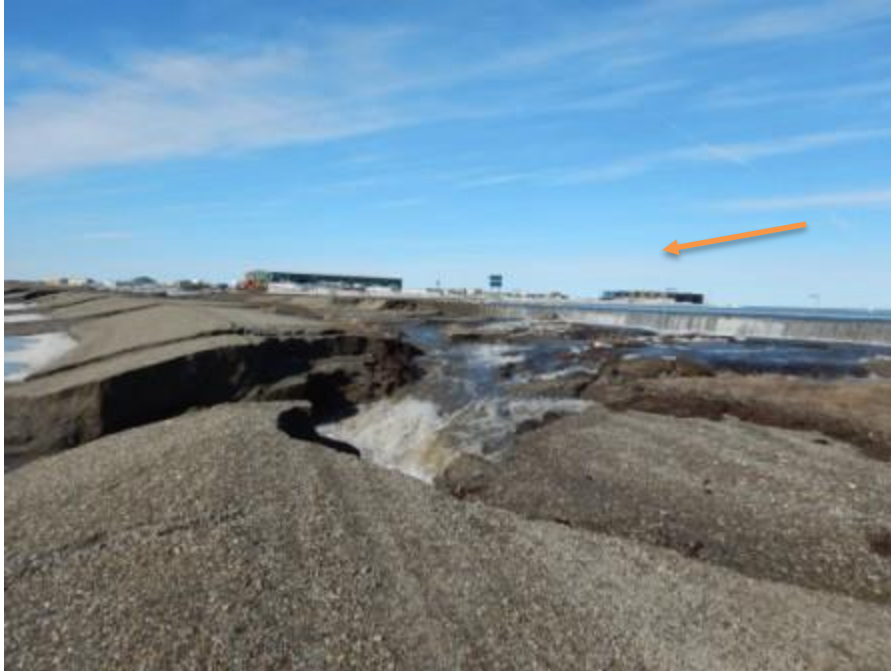
Figure B.1. Photo taken May 19, 2015, near Dalton Highway MP414. View is south and shows accumulated floodwater west of the Dalton over-topping the road surface at right, flowing across tundra in mid-ground, and cutting through a protective gravel berm as the water returns to an active channel of the Sagavanirktok River at the far left of photo.

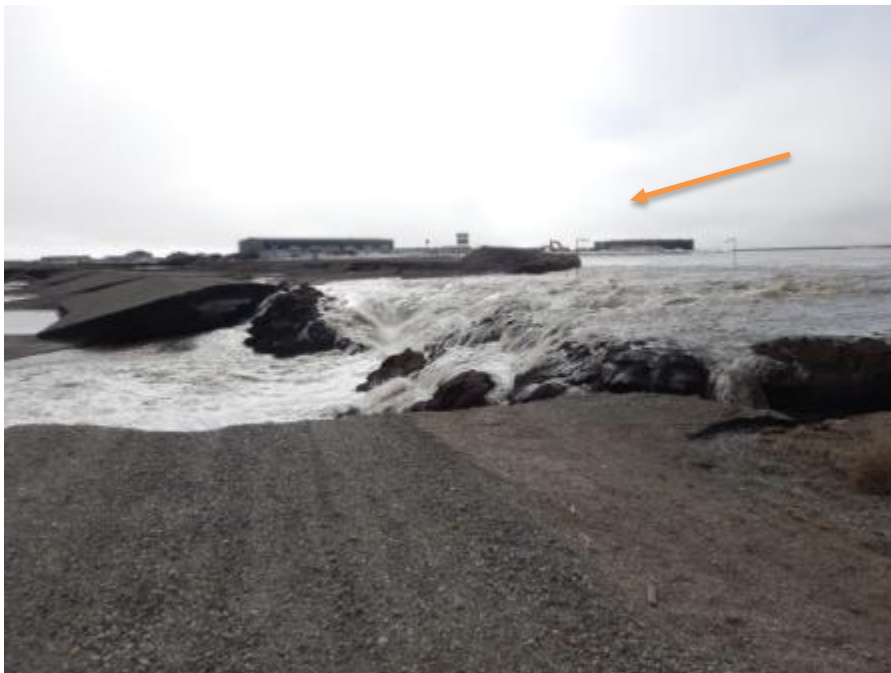
Figure B.2. Photo taken May 20, 2015, near Dalton Highway MP414, view south. Dark material is permafrost.

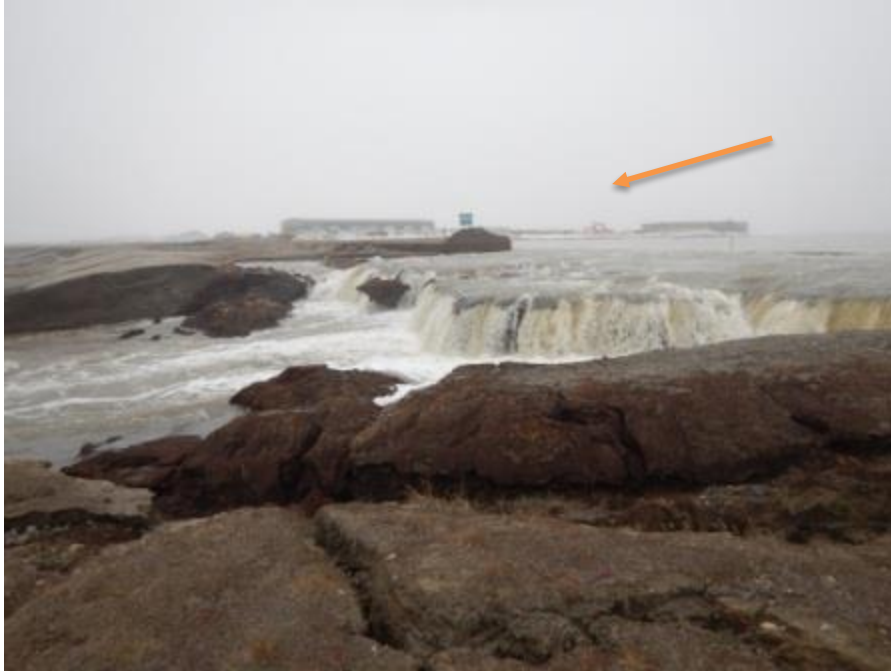
Figure B.3. Photo taken May 22, 2015, near Dalton Highway MP414, view south. This photo was taken several feet to the right of Figure B.2. Note the extensive removal of permafrost in center of photo and continued erosion at the waterfall face. The difference in elevation from tundra surface to the active river channel is approximately 9–12 ft (3–4 m) in this area.

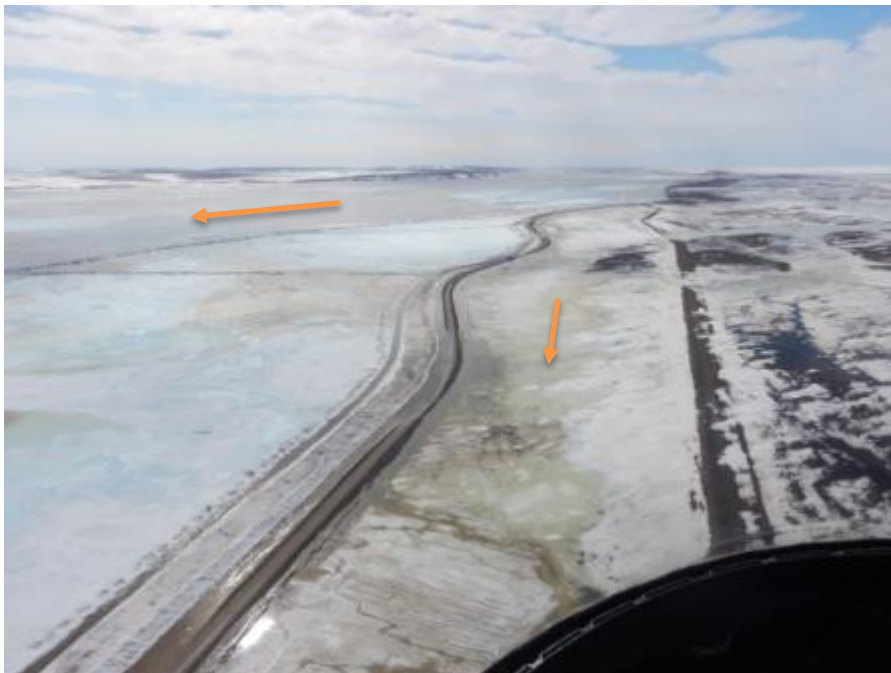
Figure B.4. Photo taken May 17, 2015, near Dalton Highway MP400. View is south and shows the highway on the left and the buried pipeline on the right, converging to intersection. Aufeis is extensive, including area between road and pipeline. Some water is flowing on the ice, and the road is beginning to flood. A Sagavanirktok River channel is at far left, and Franklin Bluffs are seen in the distance, on the horizon.

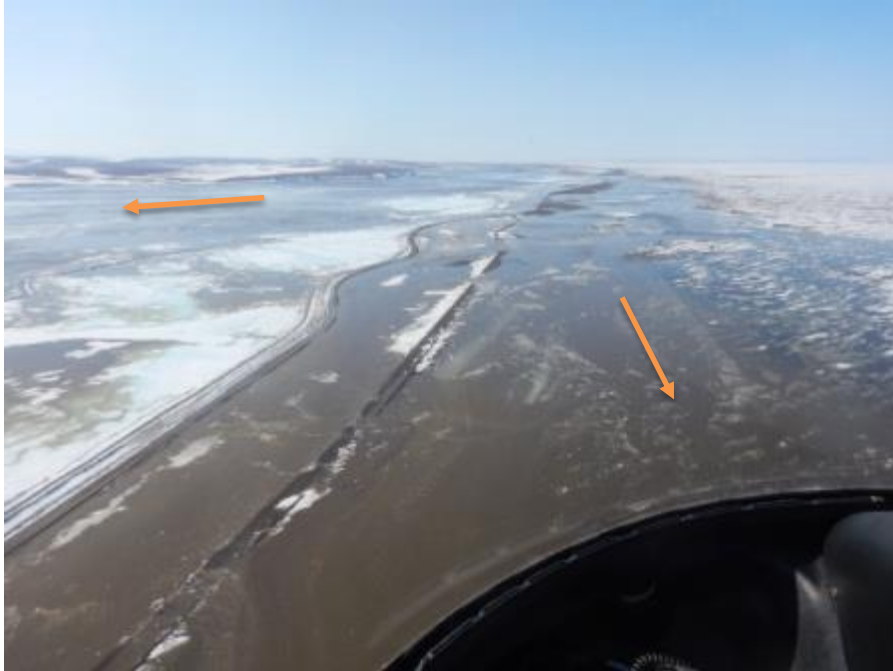
Figure B.5. Photo taken May 18, 2015, near Dalton Highway MP400, view south. Photo shows water levels rising and inundation of tundra west (right) of the pipeline. A Sagavanirktok River channel is at far left, and Franklin Bluffs are seen in the distance, upper left of center.

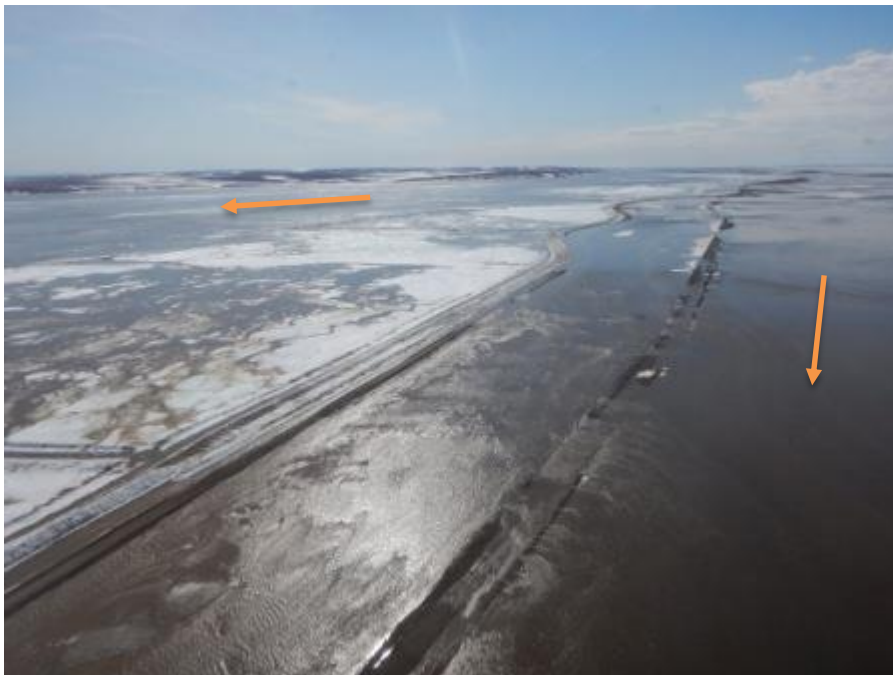
Figure B.6. Photo taken May 19, 2015, near Dalton Highway MP400, view south. Continued high water west (right) of the road and pipeline. A Sagavanirktok River channel is at far left, and Franklin Bluffs appear near the horizon, upper center of photo.

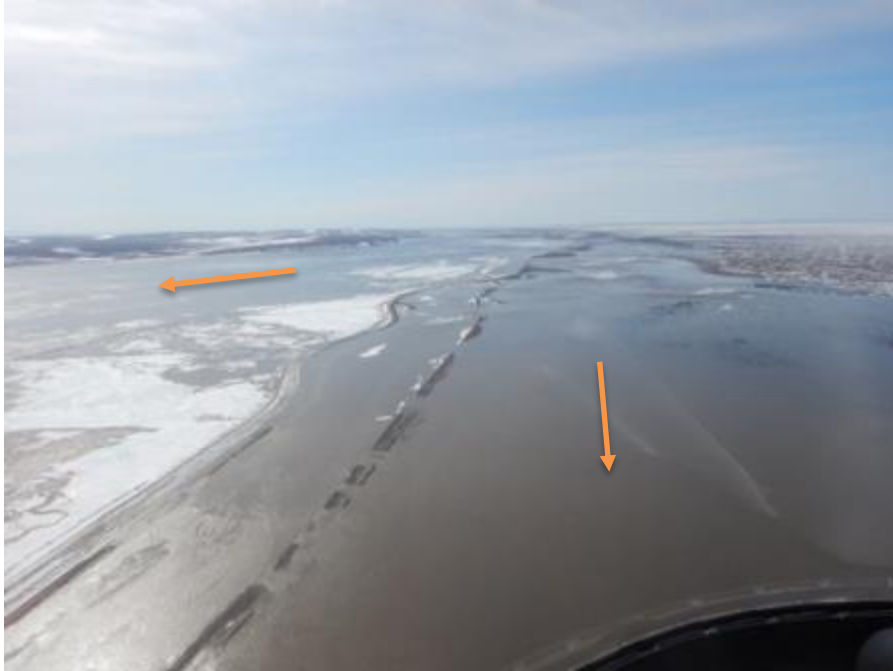
Figure B.7. Photo taken May 20, 2015, near Dalton Highway MP400, view south. Continued high water west (right) of the road and pipeline. Note completely submerged sections of road in this area. A Sagavanirktok River channel is at far left, and Franklin Bluffs are seen in the distance, upper left of center.

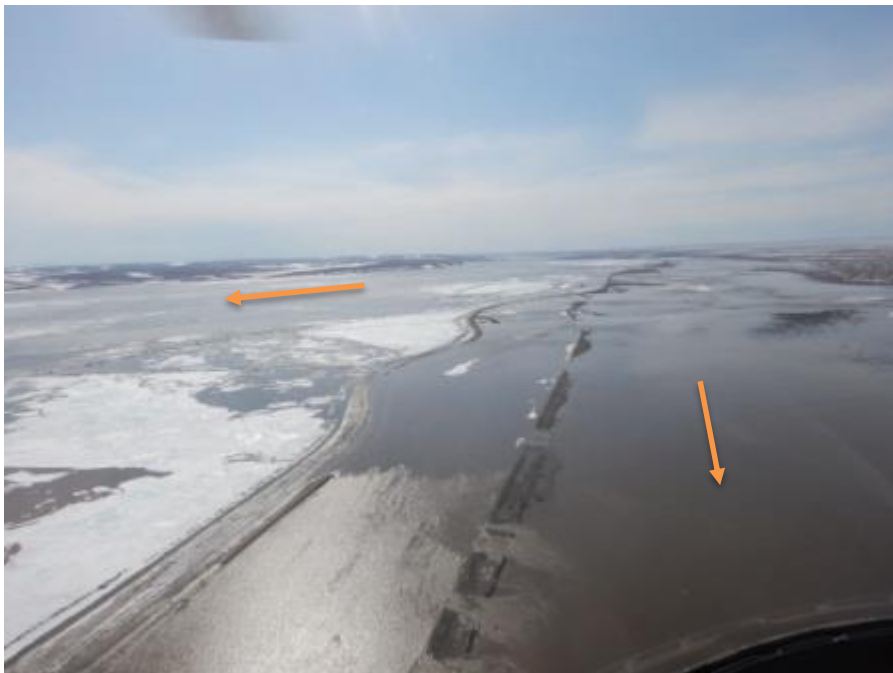
Figure B.8. Photo taken May 21, 2015, near Dalton Highway MP400, view south. Water levels are falling, but extensive areas remain submerged. A Sagavanirktok River channel is at far left, and Franklin Bluffs are seen in the distance, upper left of center.

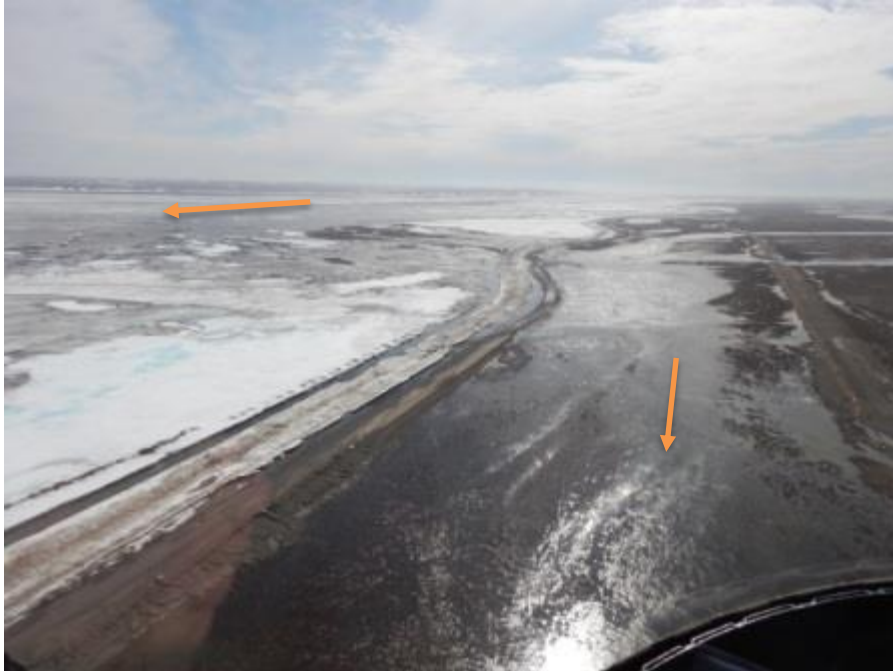
Figure B.9. Photo taken May 27, 2015, near Dalton Highway MP400, view south. Water levels have dropped appreciably, and tundra west of the pipeline (far right) is no longer flooded. Road damage is easily discernable in this photo. A Sagavanirktok River channel is at far left, and Franklin Bluffs are seen on the horizon, upper center.

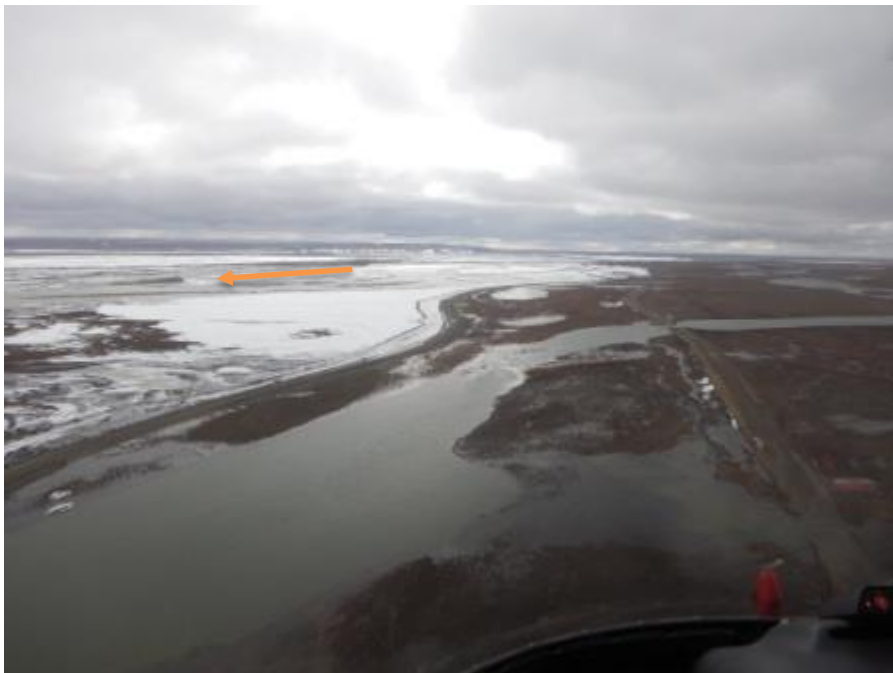
Figure B.10. Photo taken May 31, 2015, near Dalton Highway MP400, view south. Tundra between road and pipeline is emerging as water levels continue to fall. The aufeis between the road and pipeline is completely gone, but much remains east (left) of the road. Road repair work has begun. A Sagavanirktok River channel is at far left, and Franklin Bluffs are seen on the horizon, upper left of center.

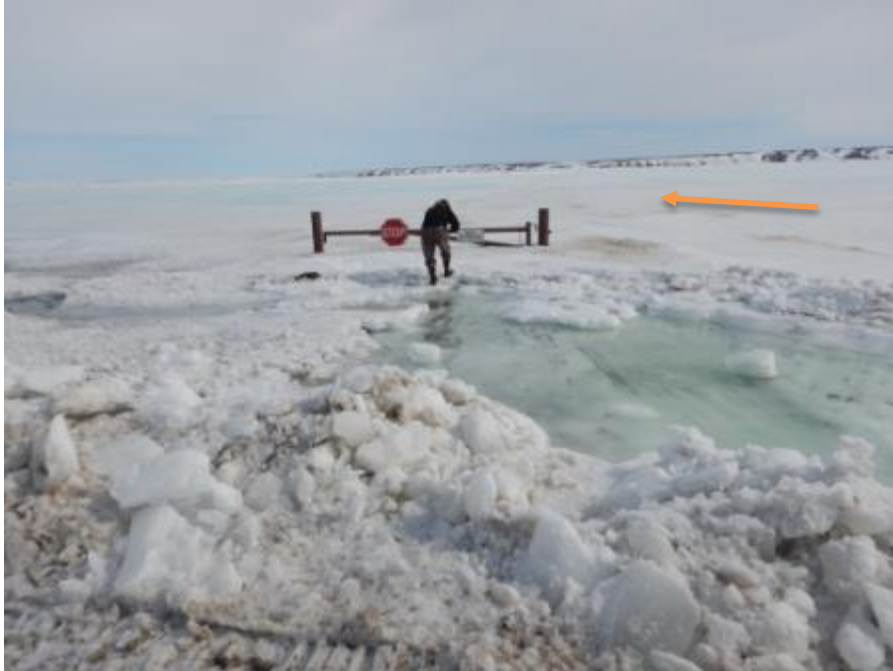
Figure B.11. Photo taken May 15, 2015 at Dalton Highway MP395.5. View is northeast and shows the extensive buildup of aufeis—several feet thick at this location—evidenced by the partially buried Alyeska access gate. Franklin Bluffs can be seen in the background.

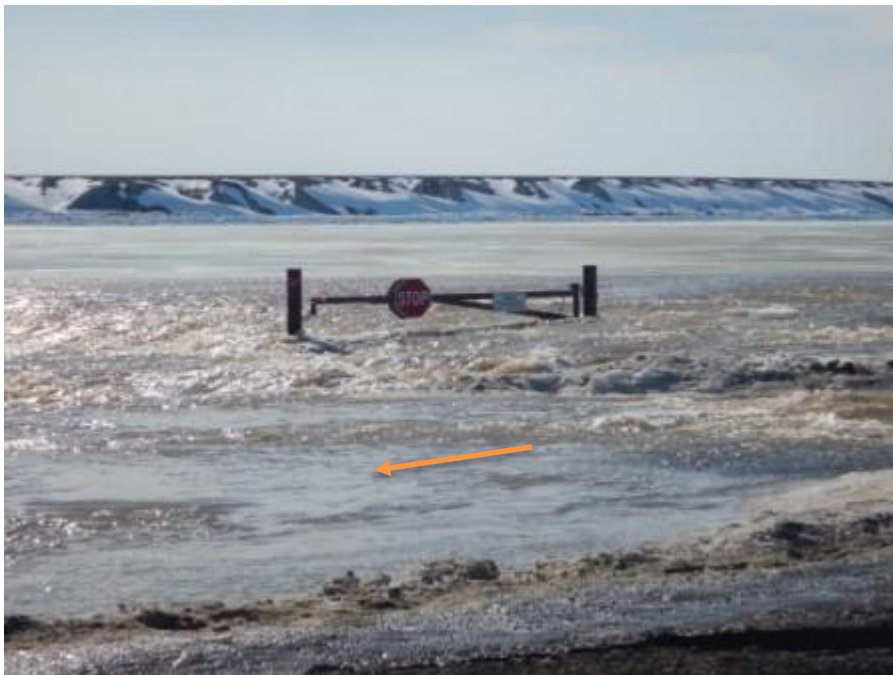
Figure B.12. Photo taken May 17, 2015 at Dalton Highway MP395.5, view east. Water is flowing on top of aufeis. One of the diversionary snow dikes in the river channel can be discerned along the far edge of the ice flat and the base of the Franklin Bluffs.

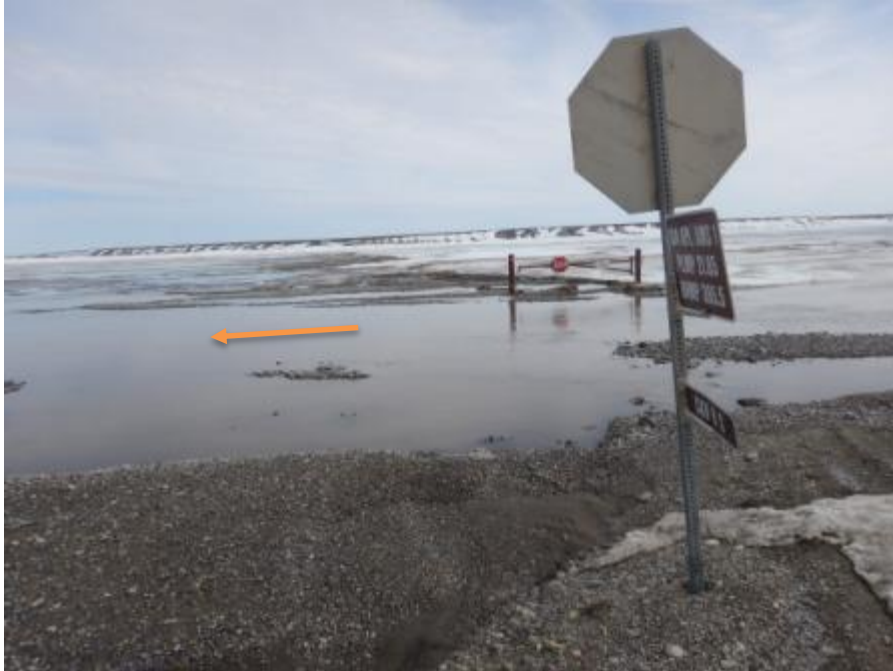
Figure B.13. Photo taken May 21, 2015 at Dalton Highway MP395.5, view east. Photo shows access road rendered impassable until repair. Water levels are falling, and although most of the ice has melted in the foreground, a considerable amount remains in the area beyond the gate.

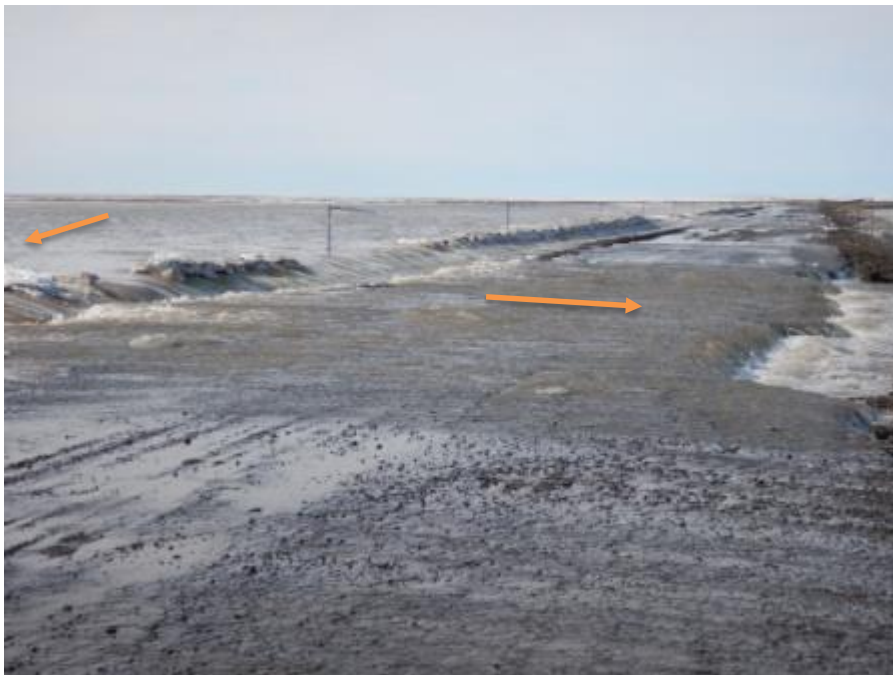
Figure B.14. Photo taken May 17, 2015, near Dalton Highway MP395. View is south and photo shows water at left flowing over afeis accumulation 1–2 ft higher than the road surface. Water continues across road and begins erosion of the west (right) shoulder. Road material is still frozen at this time. This location is the southernmost occurrence of flooding across the road.

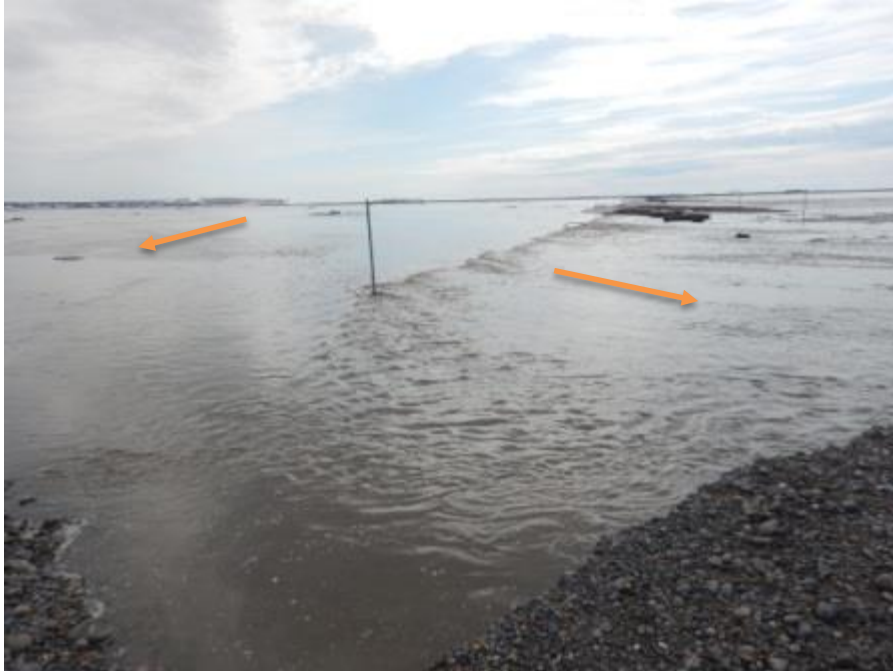
Figure B.15. Photo taken May 21, 2015, near Dalton Highway MP395, view south. While some ice remains under the water on the left, the road has been eroded down to the underlying tundra. Note the bent delineator, above and right of photo center; this is the left-most delineator in Figure B.14. This delineator was hit by large mobile ice transported in the current by sliding on top of the aufeis.

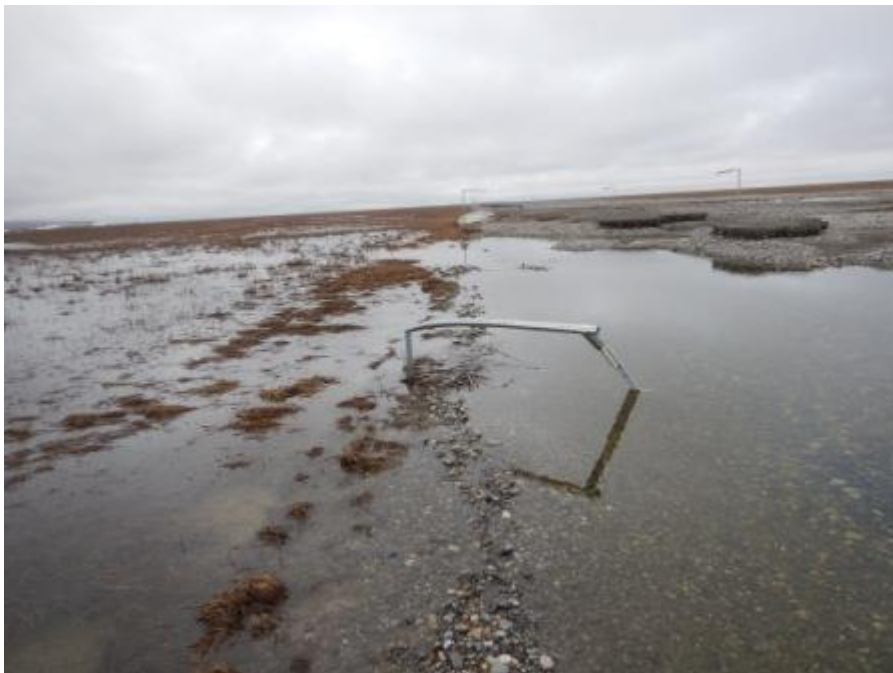
Figure B.16. Photo taken May 26, 2015, near Dalton Highway MP395, view south. Water has stilled and cleared, revealing the depth of damage to the road. Bent delineator noted in Figure B.15 was the location of a water-measuring instrument that broke free during ice collision and was subsequently buried in deposited gravel west of the road. Unfortunately, the instrument was not recoverable.

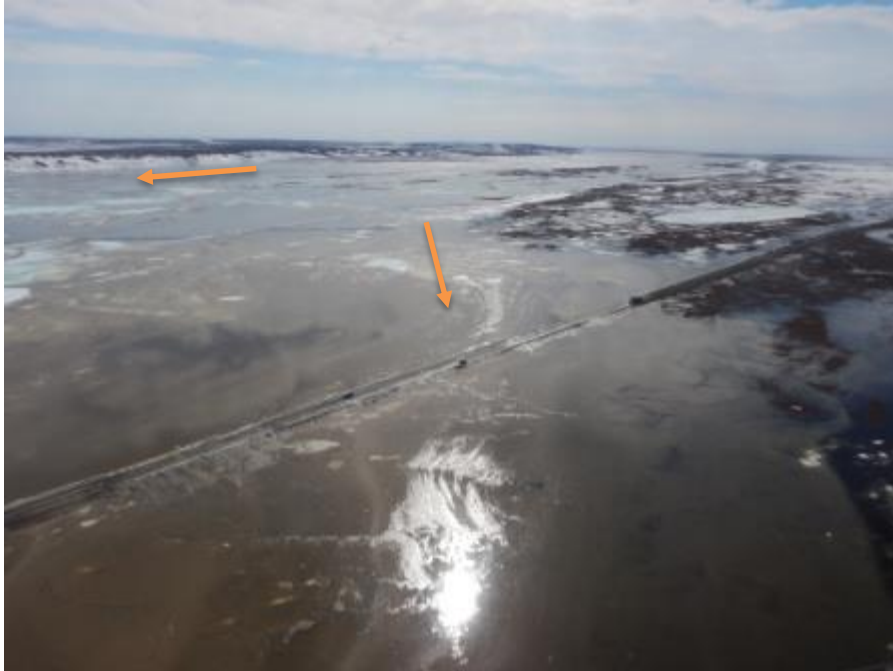
Figure B.17. Photo taken May 17, 2015, near Dalton Highway MP395. View is southeast and shows the initial flooding of the road in this area. This location is the southernmost incidence of flooding during this event. Compare with Figure B.14, which shows a ground view as seen from the road surface at left edge of this photo. Note vehicles still using road. Franklin Bluffs are in the distance.

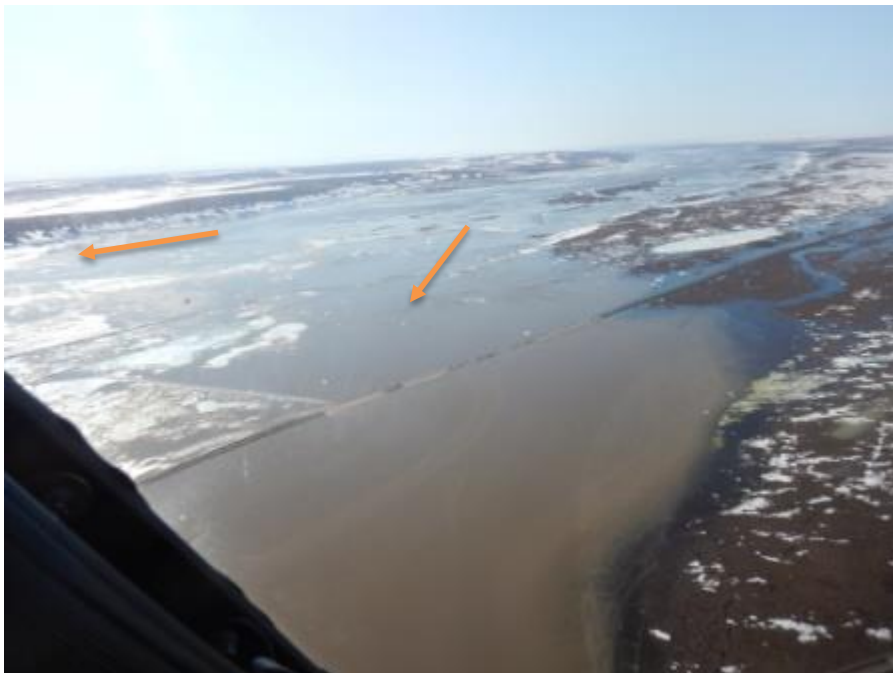
Figure B.18. Photo taken May 18, 2015, near Dalton Highway MP395, view southeast. Water is nearing peak, submerging aufeis at left of photo. Franklin Bluffs appear at upper left.

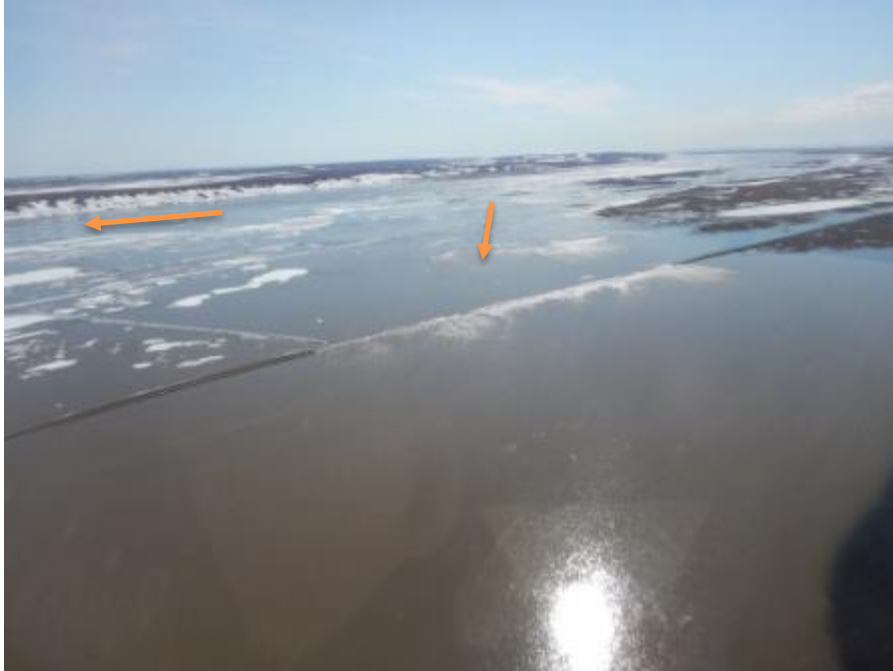
Figure B.19. Photo taken May 19, 2015, near Dalton Highway MP395, view southeast. Aufeis at left is mostly covered. Franklin Bluffs seen in distance at left.

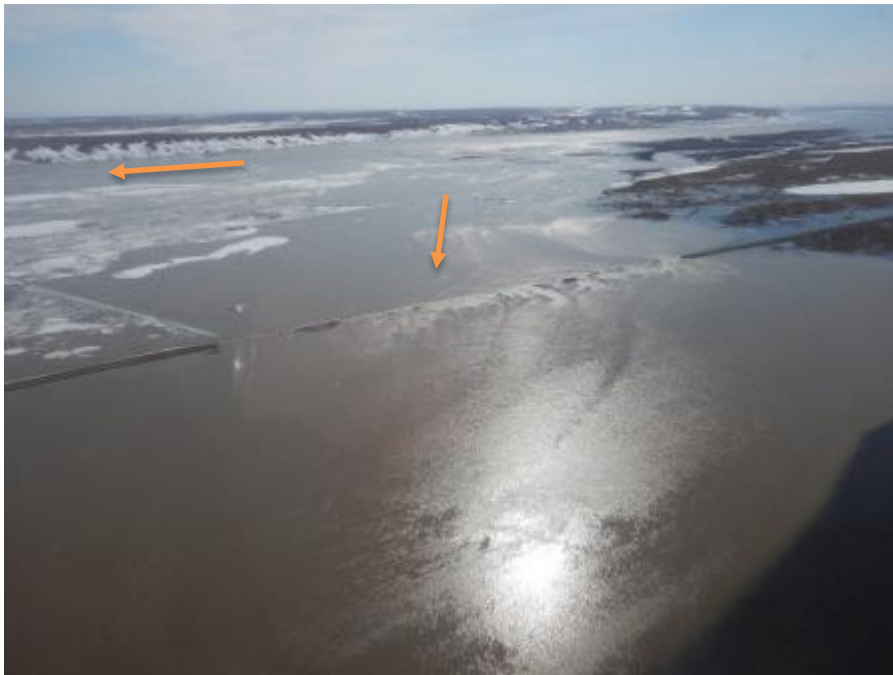
Figure B.20. Photo taken May 20, 2015, near Dalton Highway MP395, view southeast. Even though water levels are high, the aufeis is still visible at left. Franklin Bluffs seen in the distance.

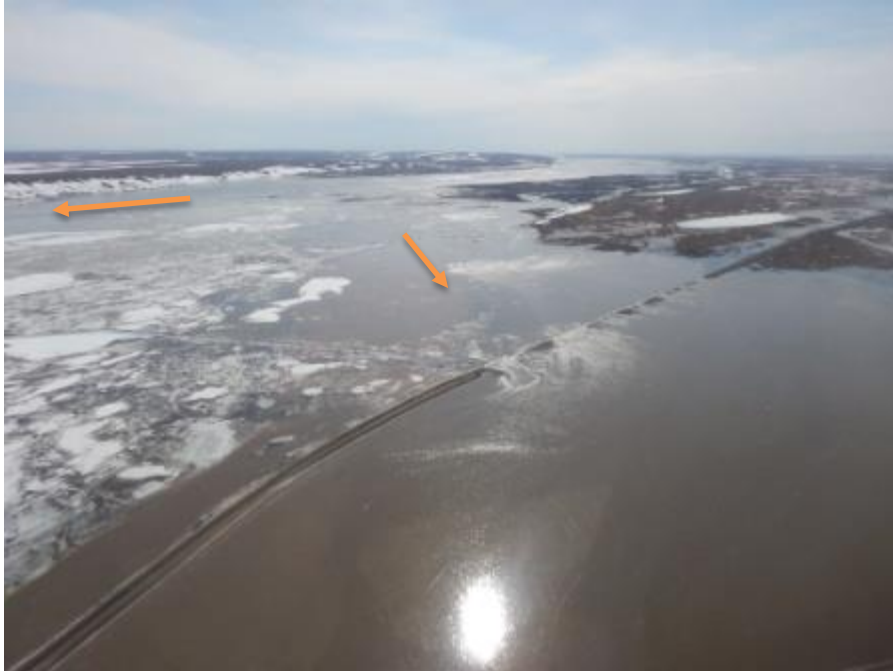
Figure B.21. Photo taken May 21, 2015, near Dalton Highway MP395, view southeast. Much aufeis at left is exposed, and water levels are falling. Eroded channels across road are clearly visible. Franklin Bluffs seen in upper left.

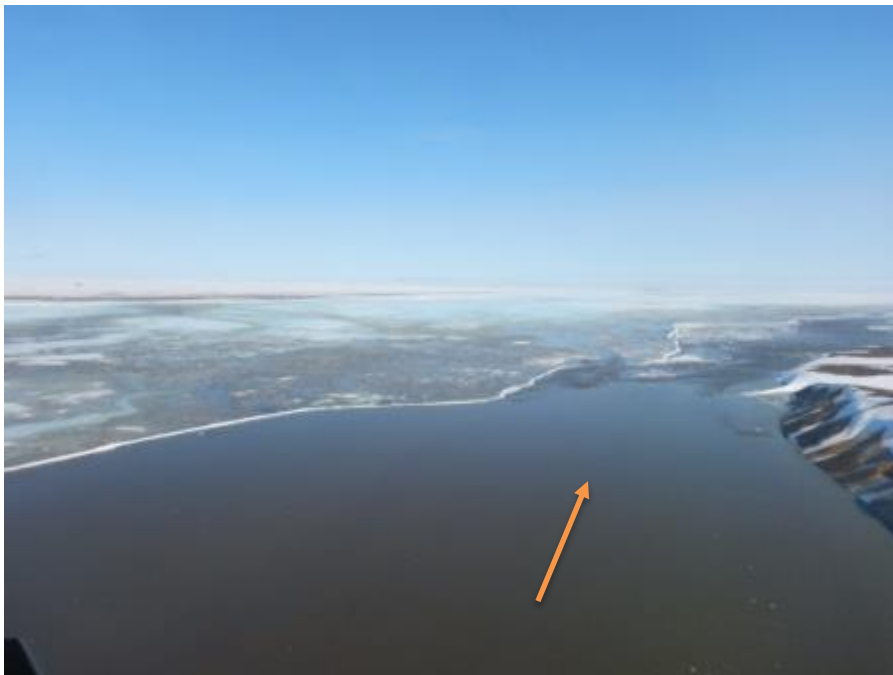
Figure B.22. Photo taken May 16, 2015, near bifurcation of the Sagavanirktok River. View is north. Photo shows a large amount of water being directed to the East Fork by a diversionary snow dike with extensive aufeis beyond. Dark linear streak near horizon is Dalton Highway. Franklin Bluffs are east (far right).

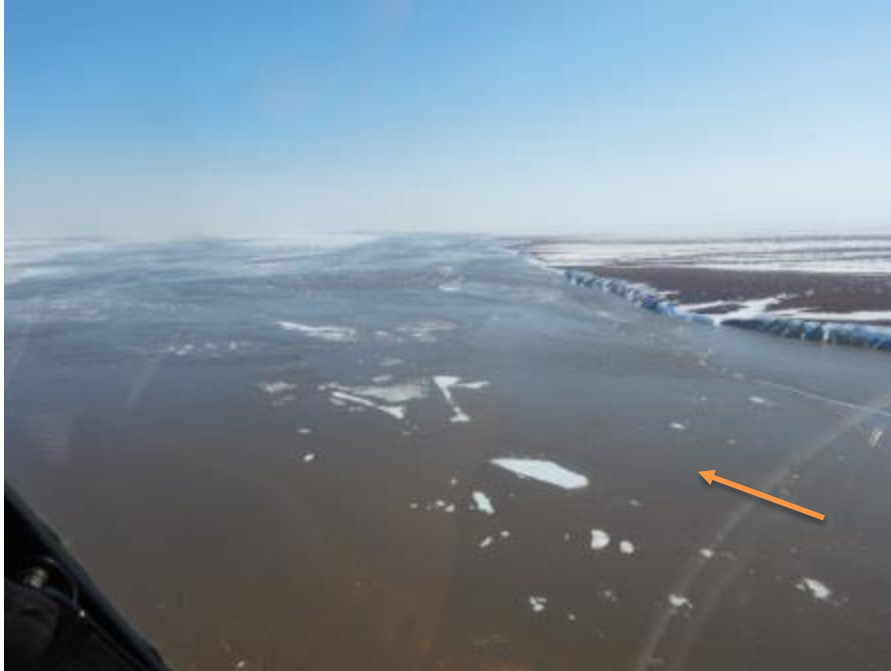
Figure B.23. Photo taken May 18, 2015, near bifurcation of the Sagavanirktok River, View is north. Franklin Bluffs and the diversionary snow dike noted in Figure B.22 can be seen at right. The snow dike is failing, and water covers much of the aufeis seen in Figure B.22.
