**Deadhorse Airport Improvements
Draft Environmental Assessment**

Water Resources Impacts – Floodplains

Appendix H Water Resources Impacts – Floodplains

Project Number: NFAPT00549

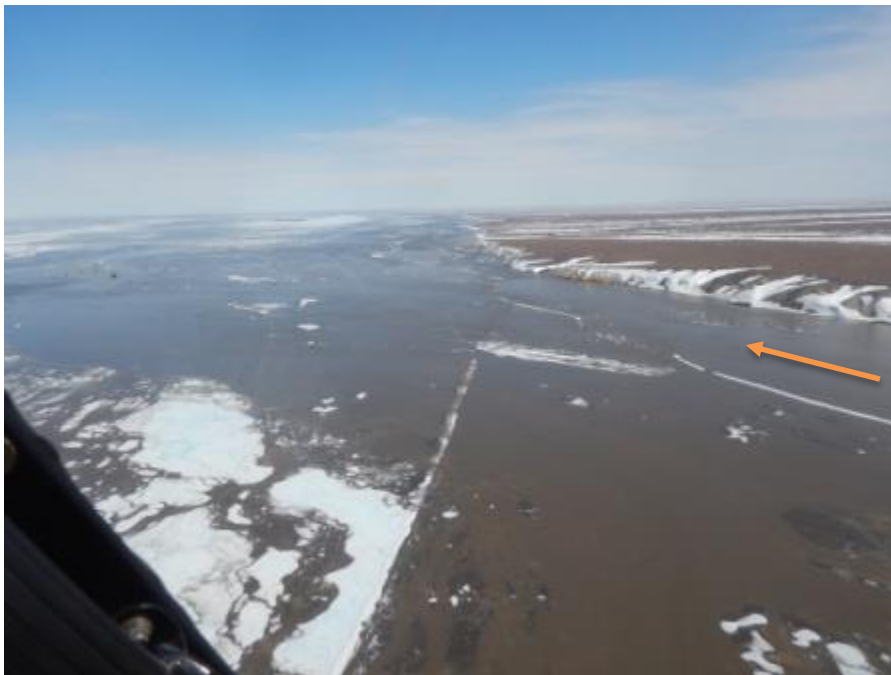
Figure B.24. Photo taken May 21, 2015, near bifurcation of the Sagavanirktok River. View is north. Though failing, snow dikes continue to divert water to the East Fork. Water levels have dropped from peak, and stranded ice can be seen between the right-most snow dike and Franklin Bluffs at right (near arrowhead). This stranded ice was adjacent to the gauging station installed by UAF during this event.

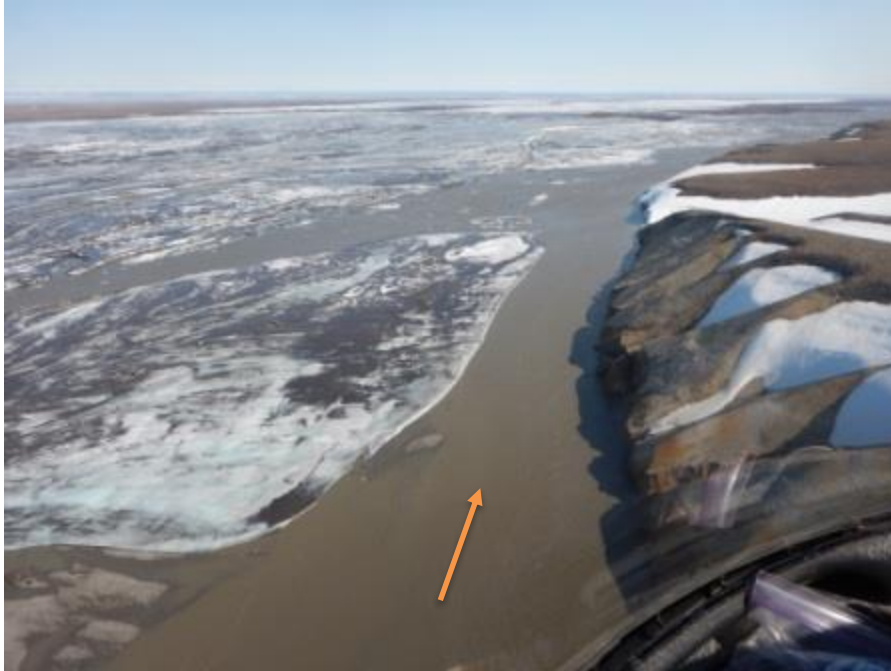
Figure B.25. Photo taken May 21, 2015, near bifurcation of the Sagavanirktok River. View is north. Franklin Bluffs are at right, and definite channels are appearing. Aufeis remains on many gravel bars. This is the main channel of the East Fork.

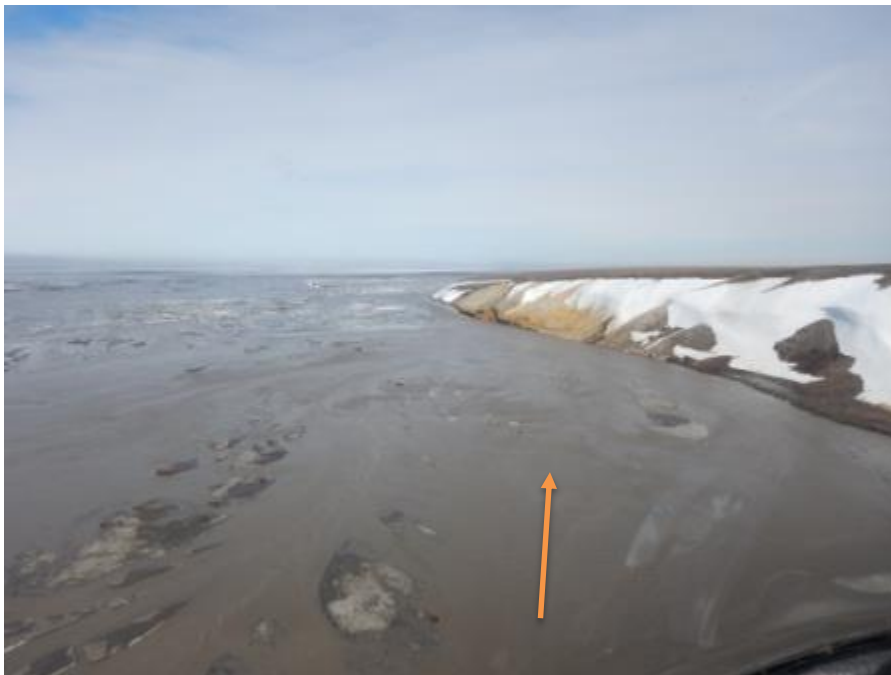
Figure B.26. Photo taken May 27, 2015, near bifurcation of the Sagavanirktok River. View is north. This photo, taken closer to Franklin Bluffs, seen at right, shows water levels receding and gravel bars appearing. Snow dikes are all but gone, and some aufeis remains in the middle distance.
