STATE OF ALASKA
Department of Transportation and Public Facilities
2301 Peger Road Fairbanks, AK 99709

Date: 7/18/2022

Nenana - Totchaket Road

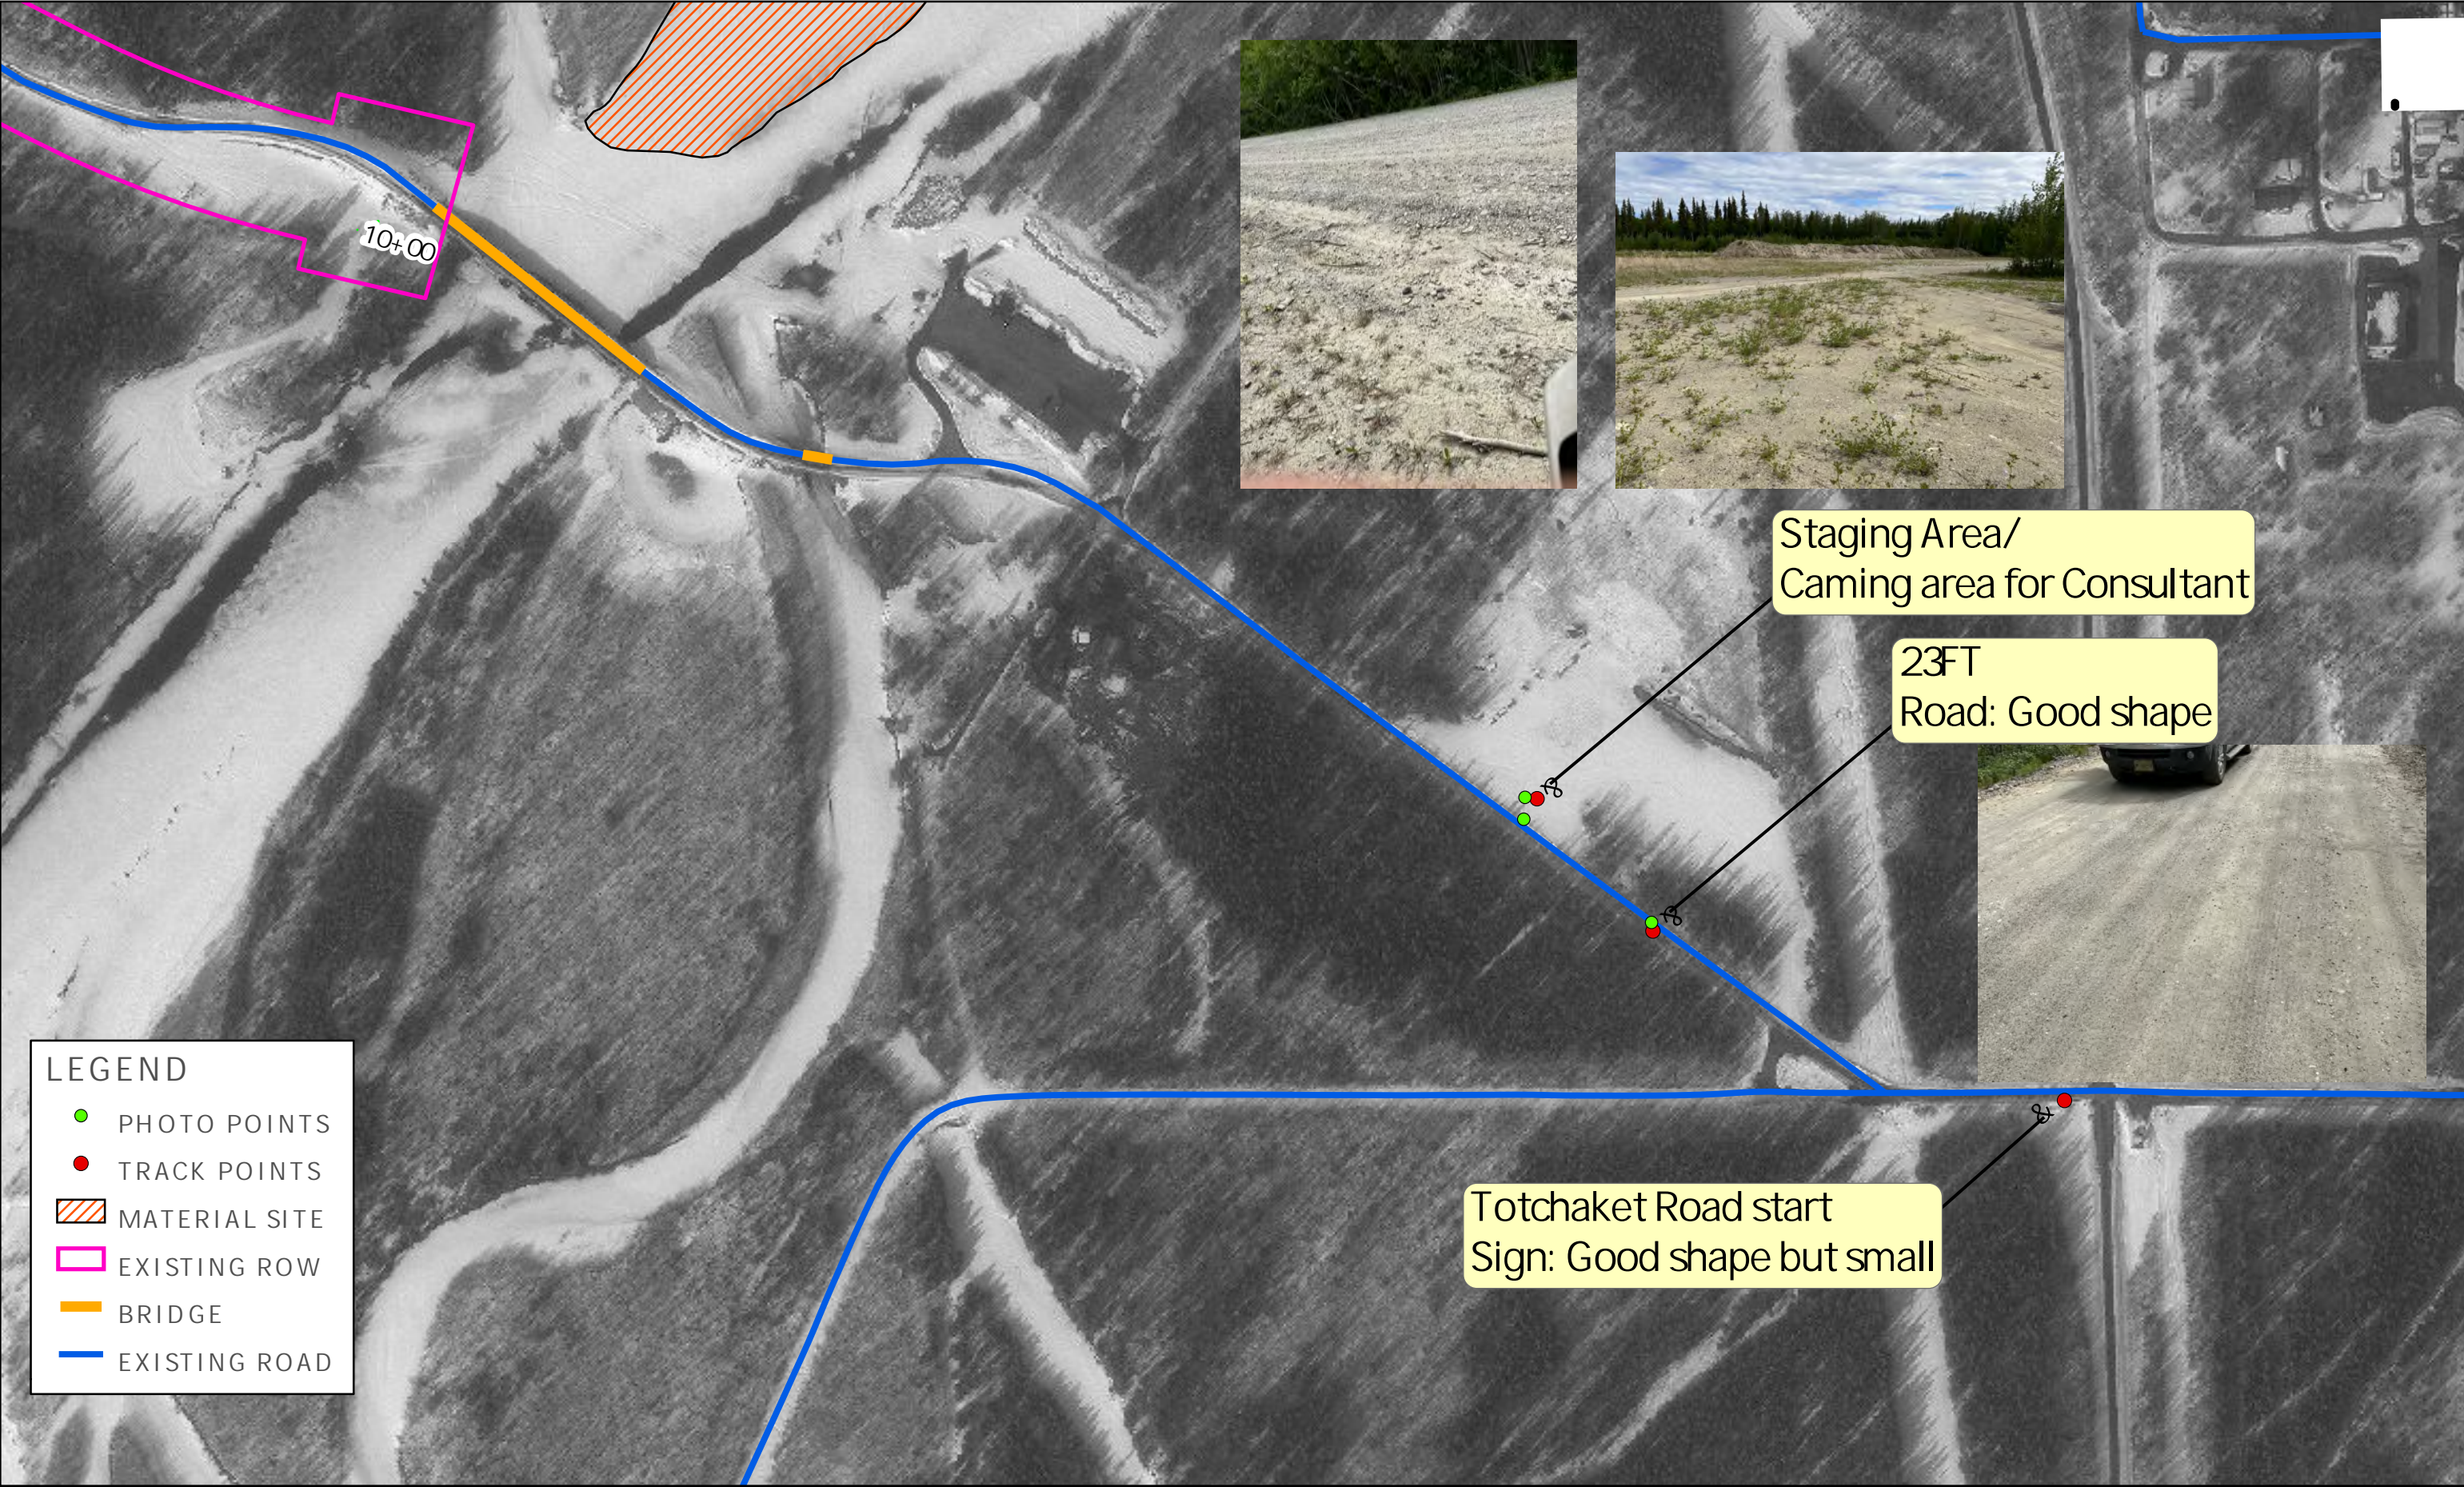
Figure 1

23FT
Road: Good shape

Totchaket Road start
Sign: Good shape but small

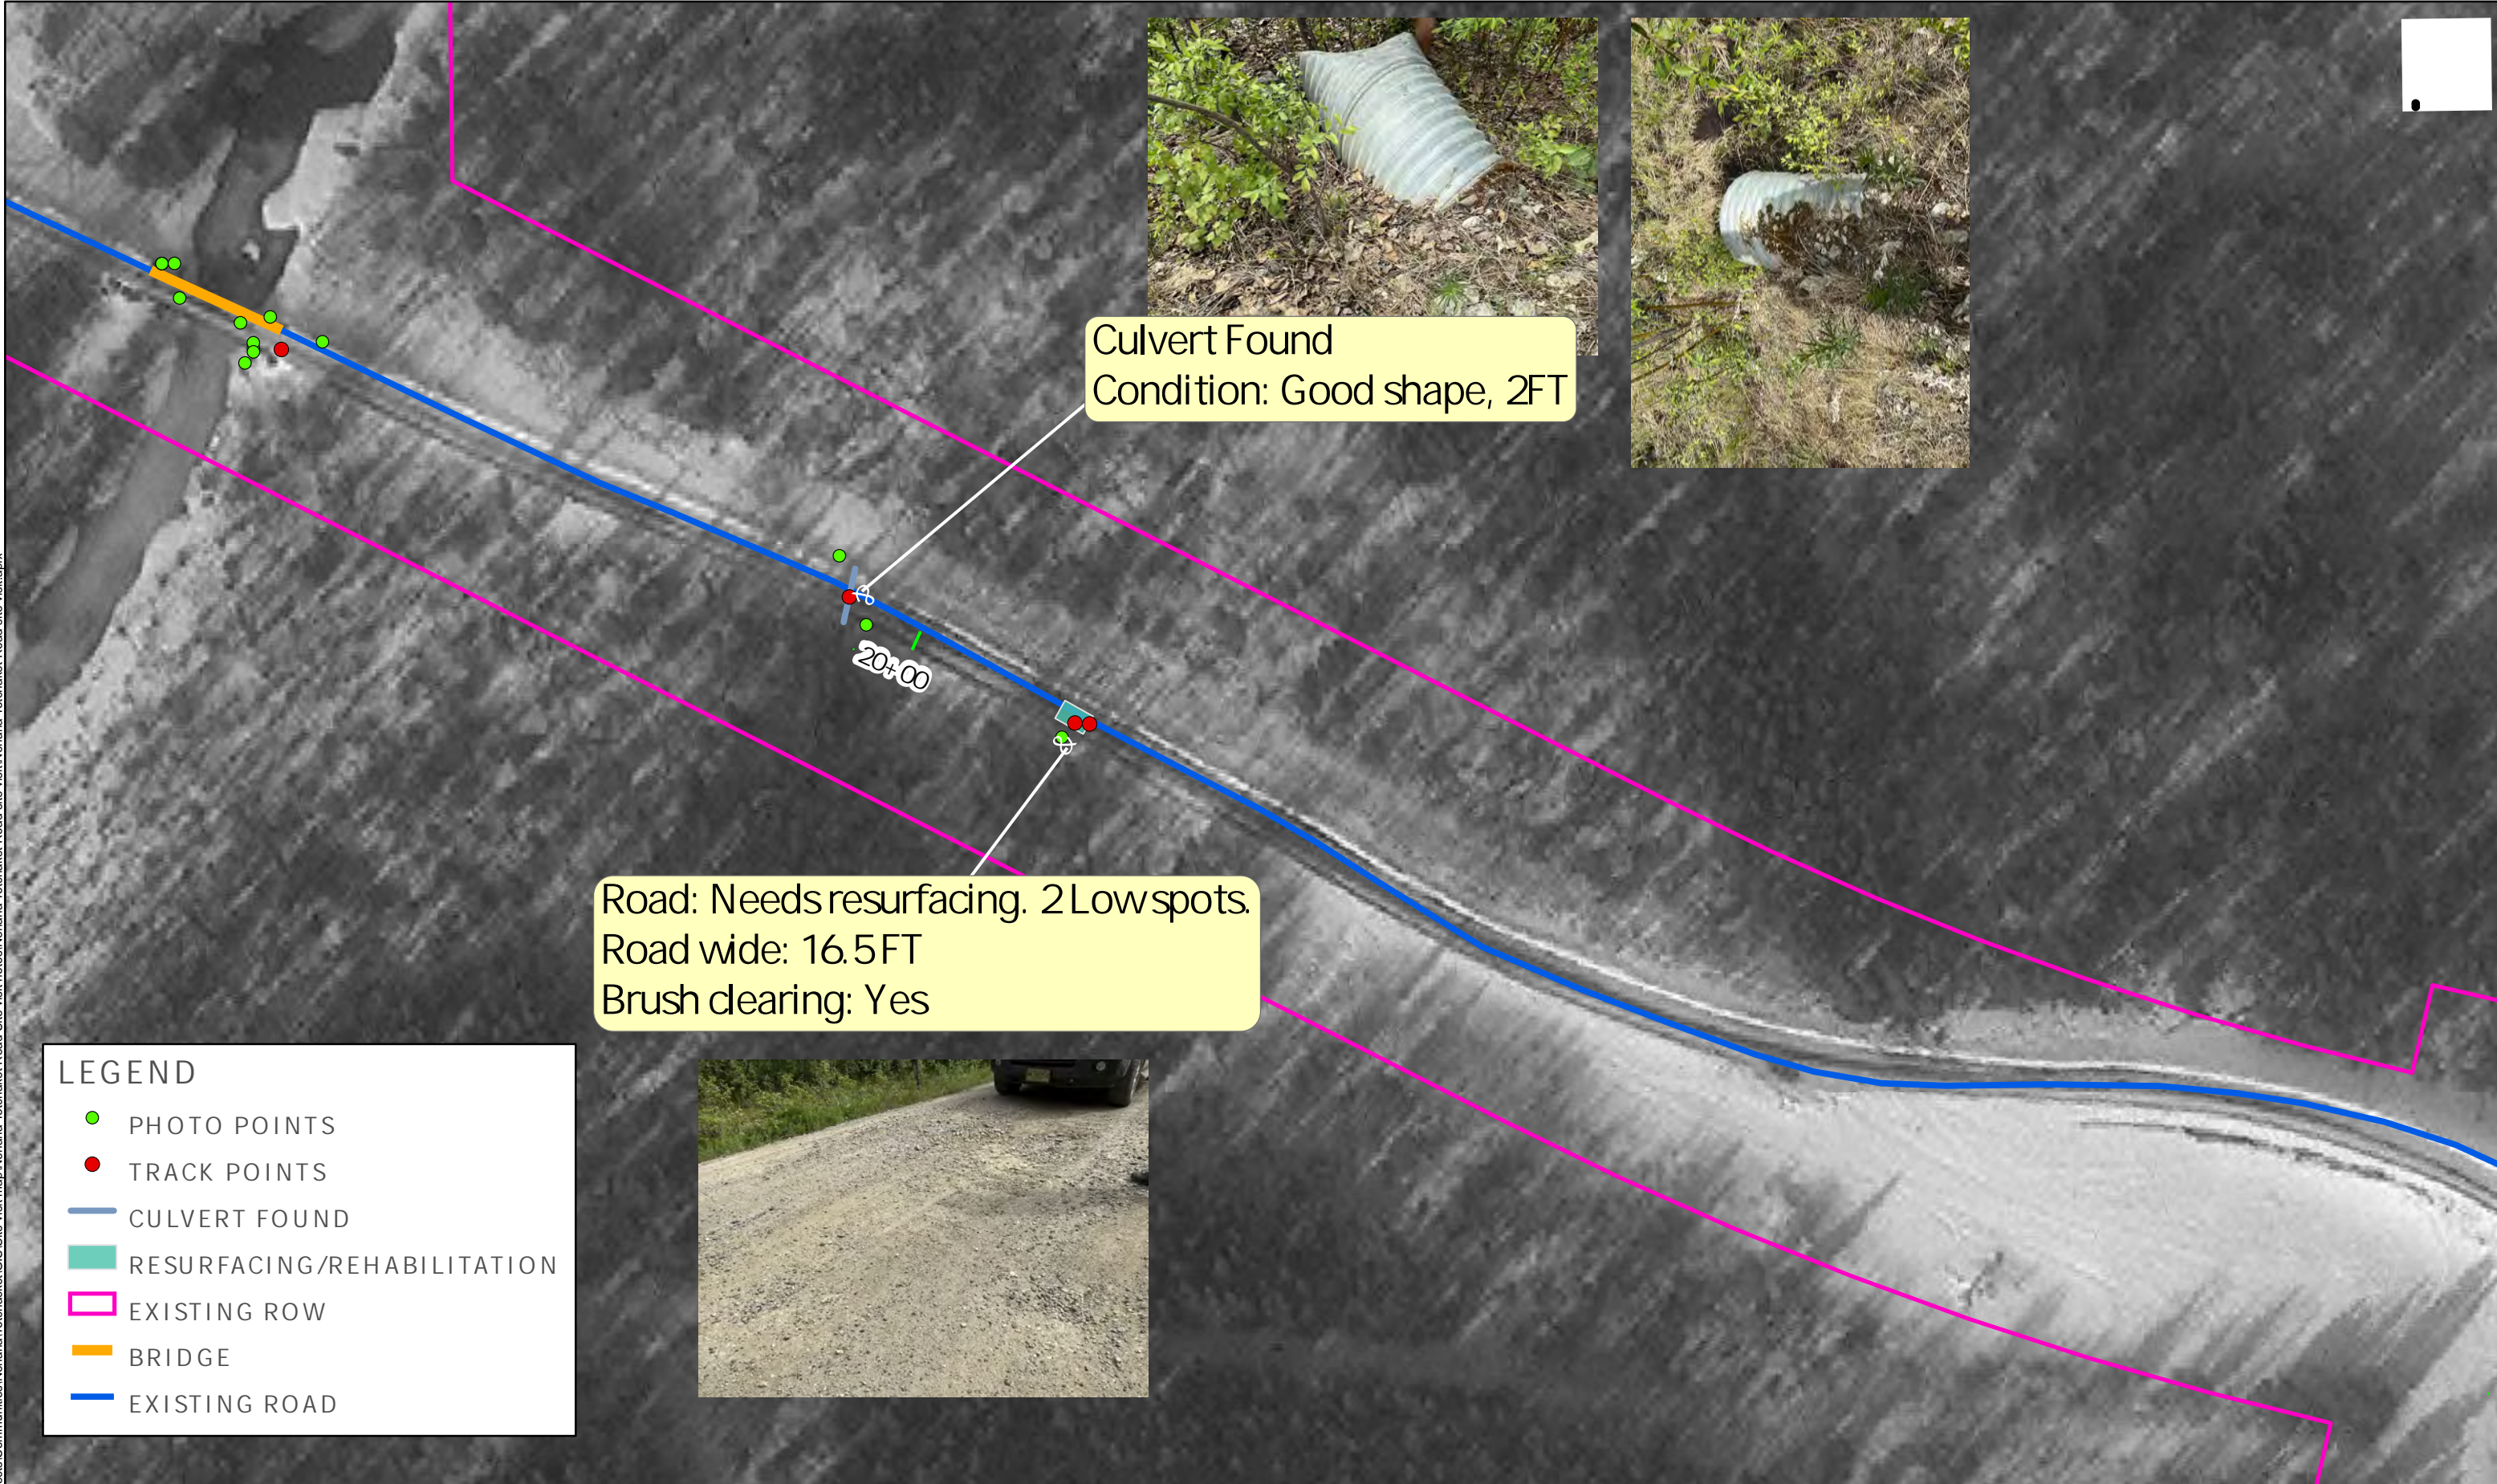
Figure 2

Road: Needs resurfacing. 2 Low spots.
Road wide: 16.5FT
Brush clearing: Yes

Culvert Found
Condition: Good shape, 2FT

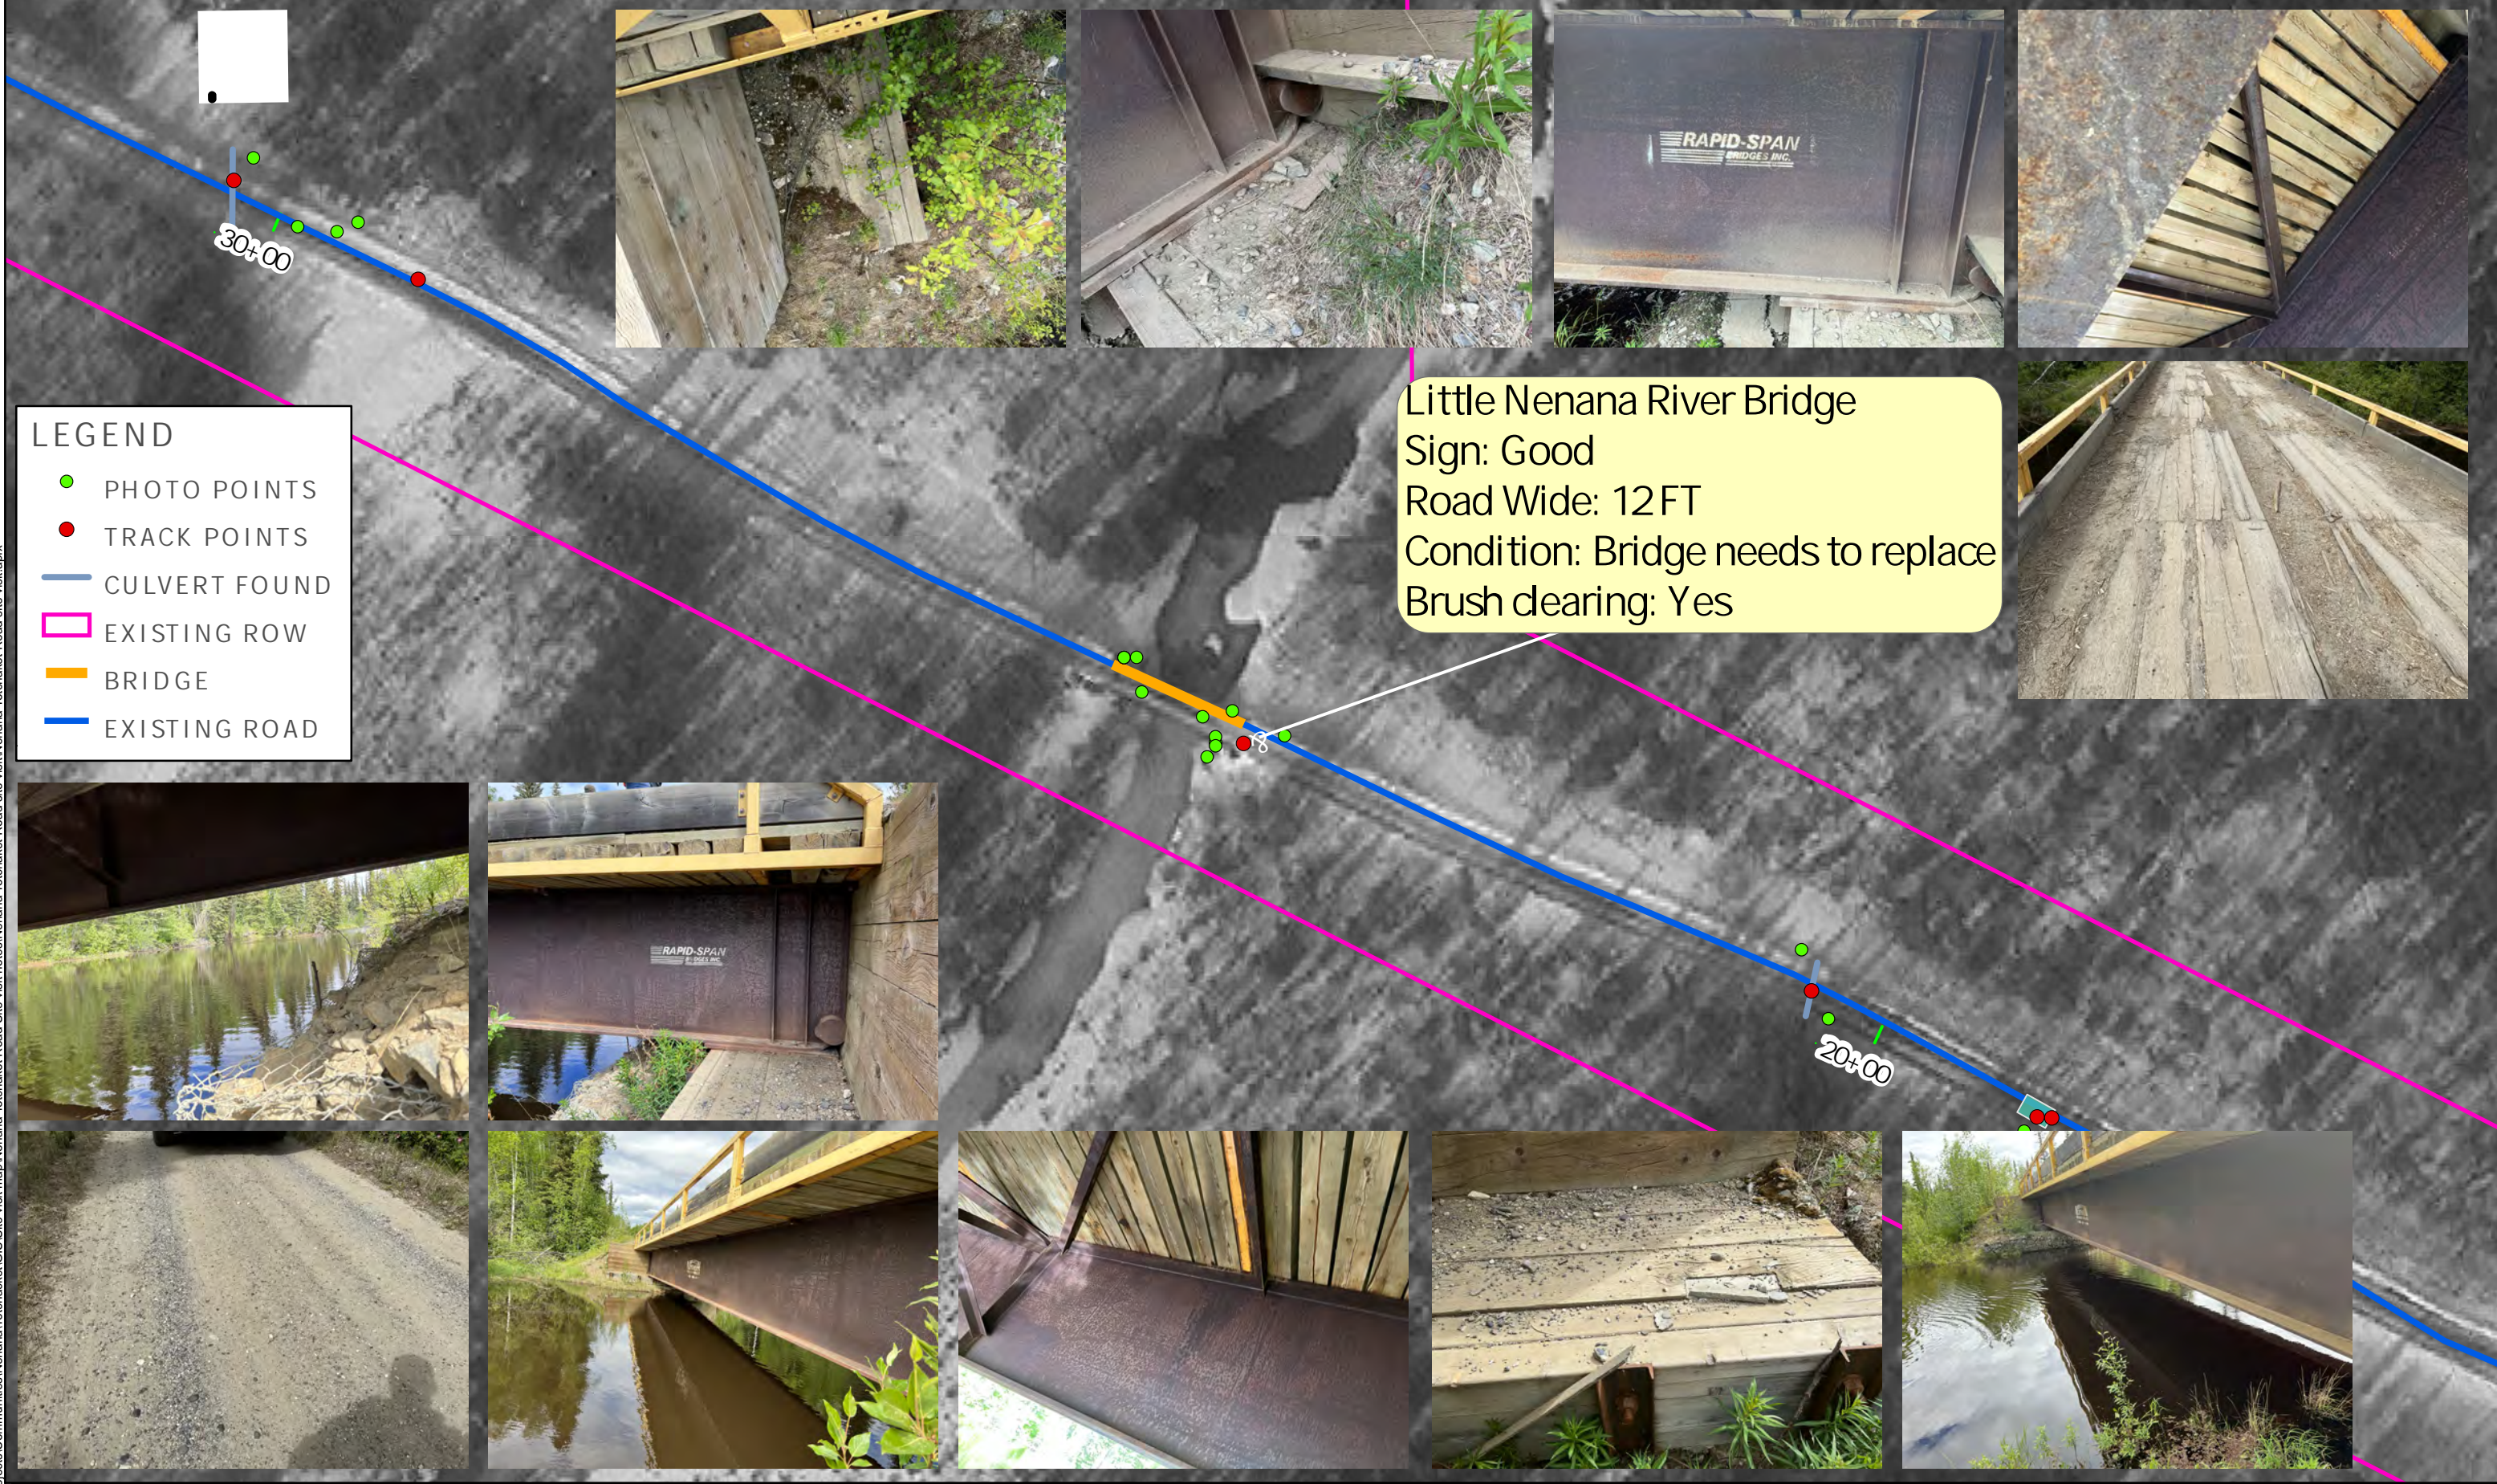
Figure 3

Little Nenana River Bridge
 Sign: Good
 Road Wide: 12 FT
 Condition: Bridge needs to replace
 Brush clearing: Yes

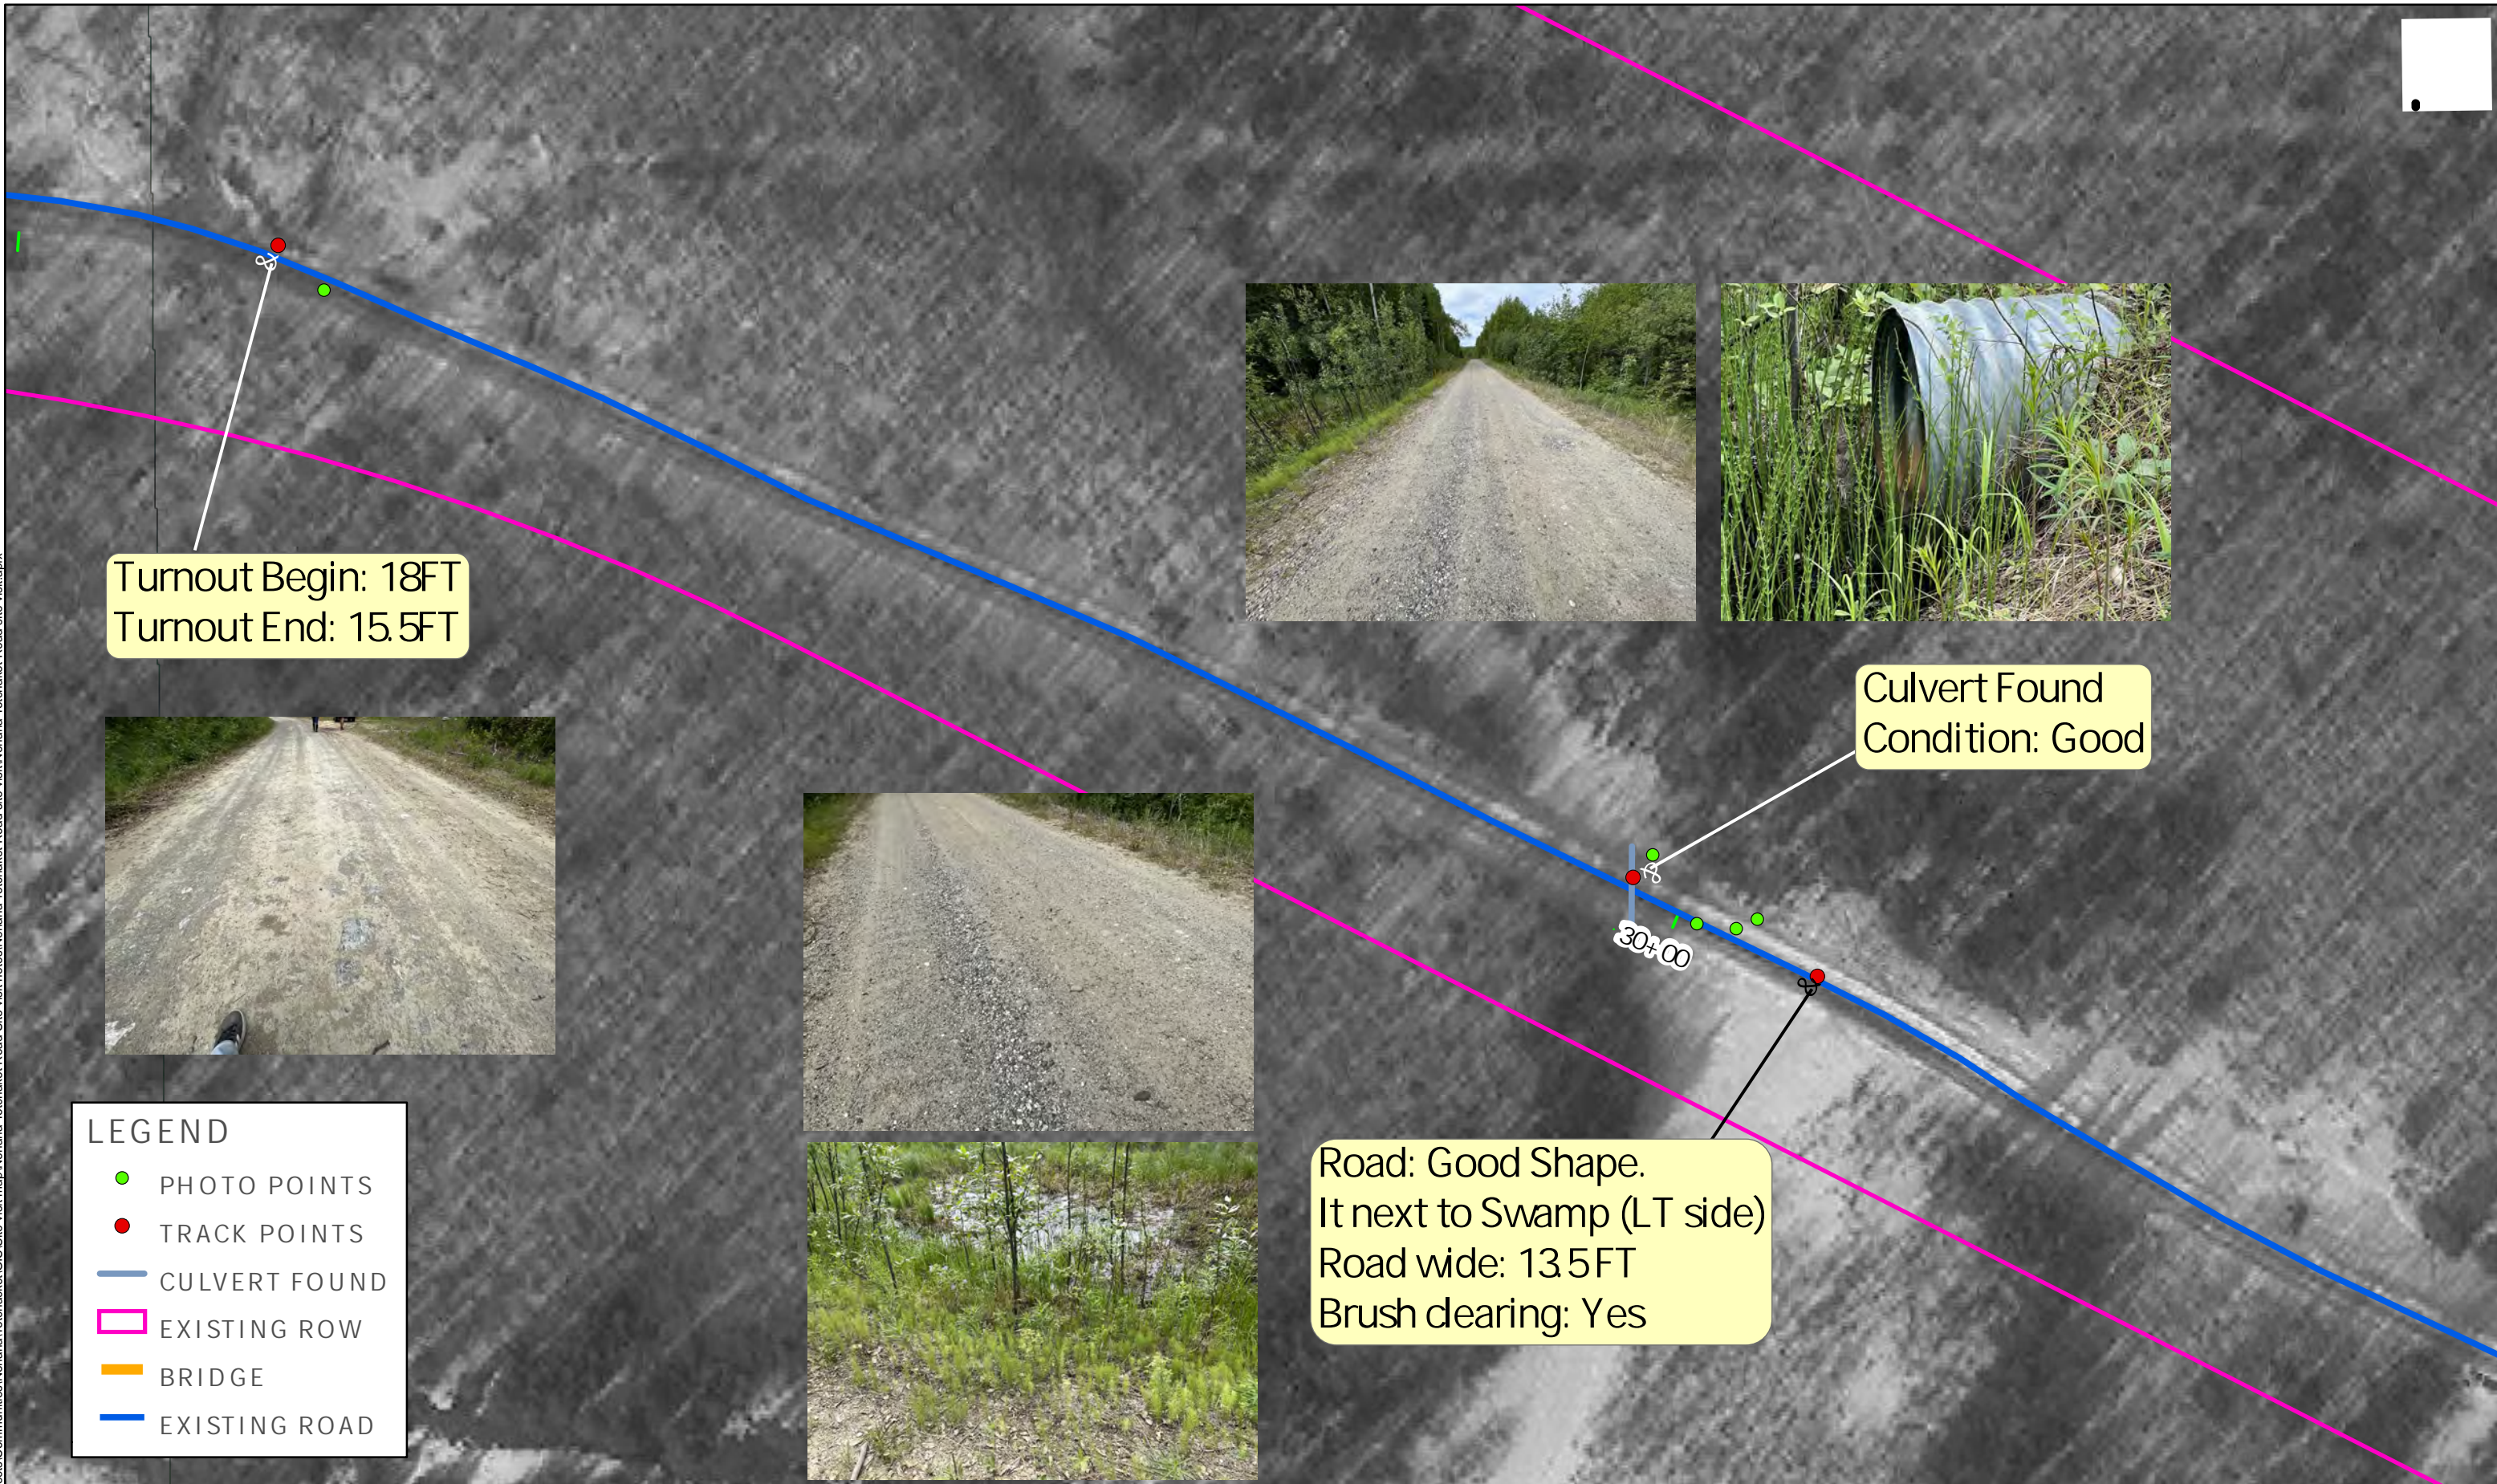
Figure 4

Turnout Begin: 18FT
Turnout End: 15.5FT

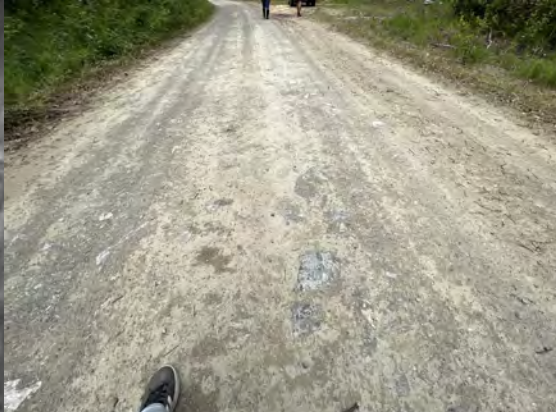
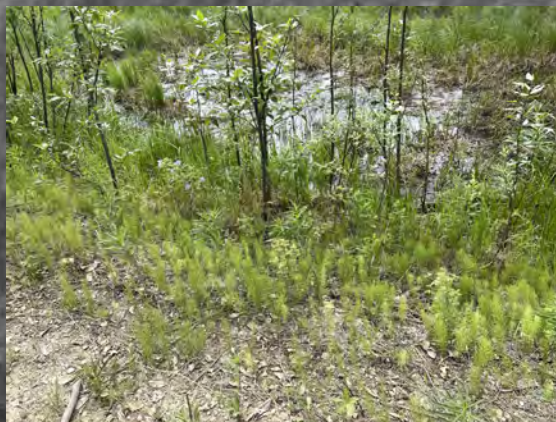
Culvert Found
Condition: Good

Road: Good Shape.
It next to Swamp (LT side)
Road wide: 13.5FT
Brush clearing: Yes

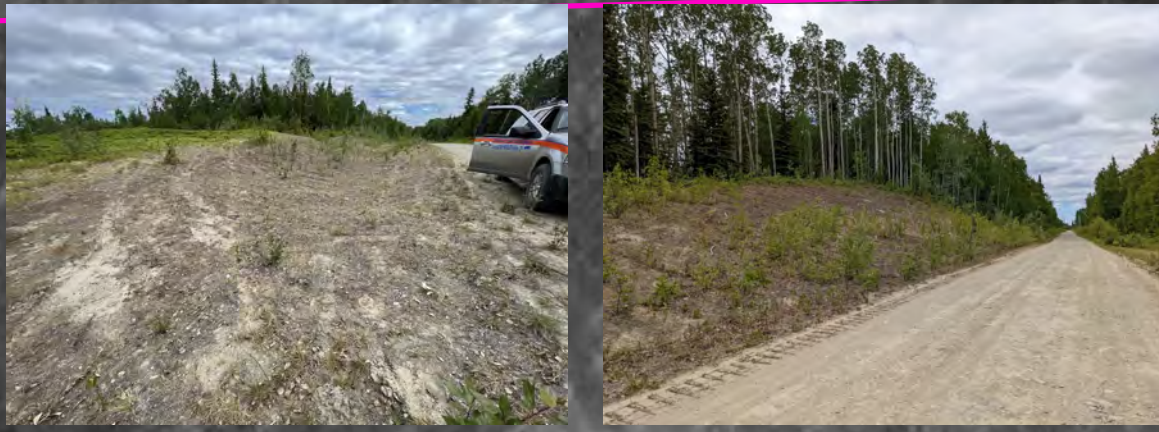
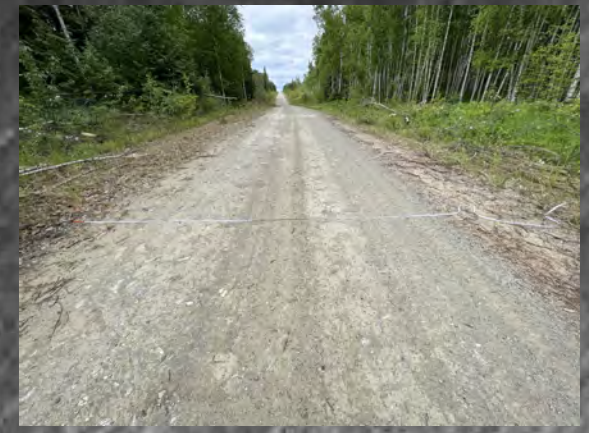
Figure 5

Stageing Area/
Turnout (RT side)

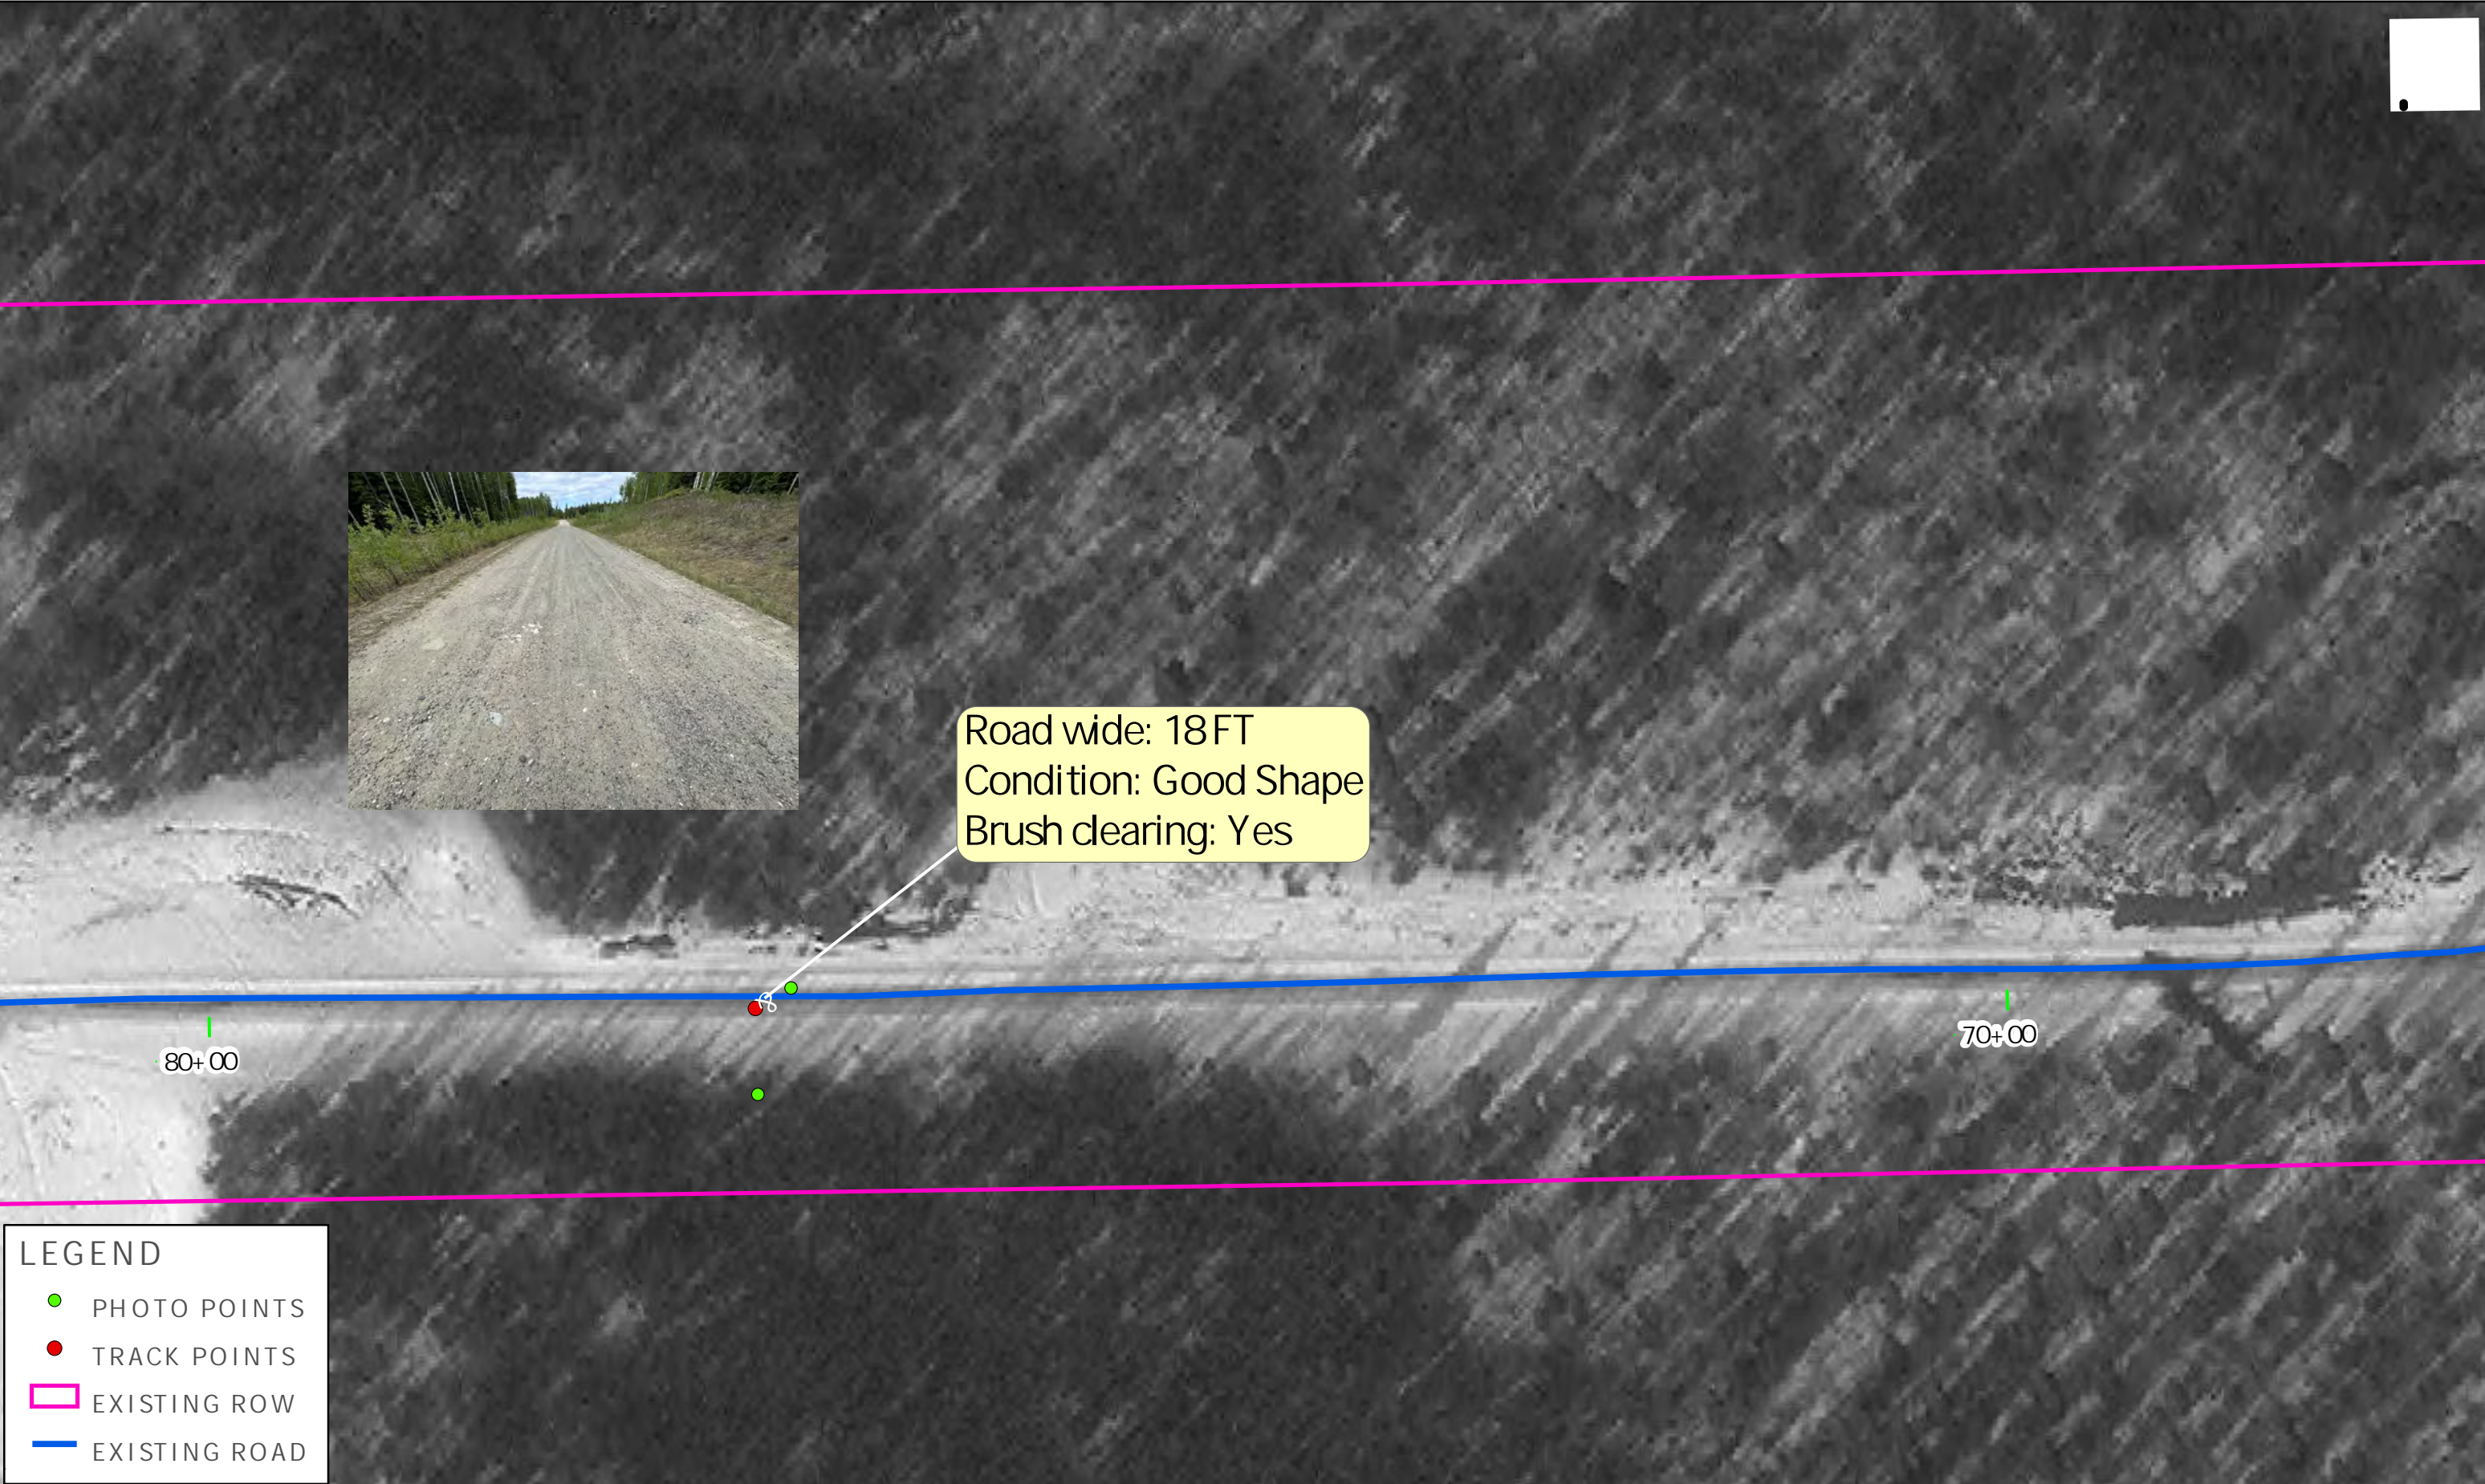
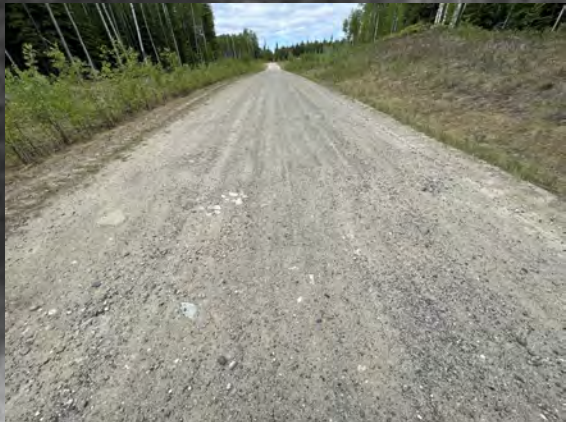
Road wide: 18FT
Condition: Good Shape
Brush clearing: Yes

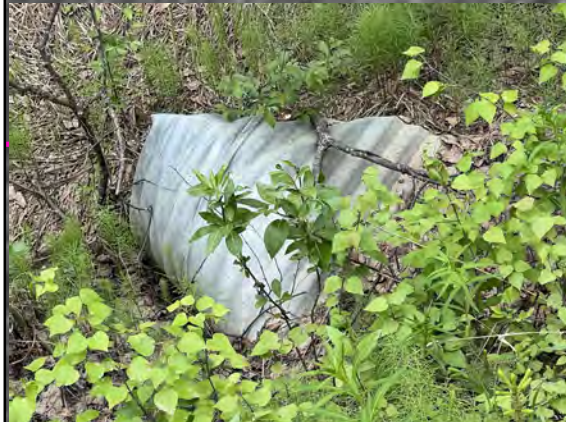
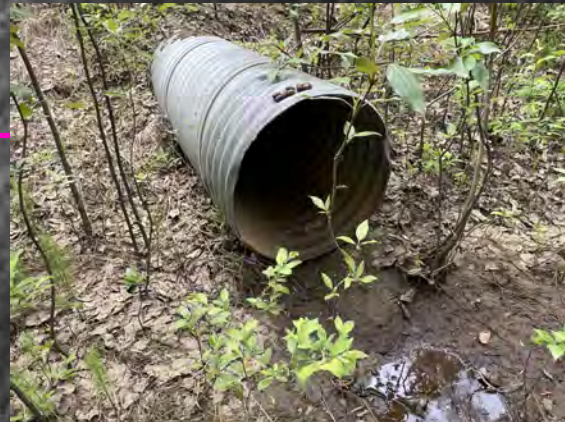
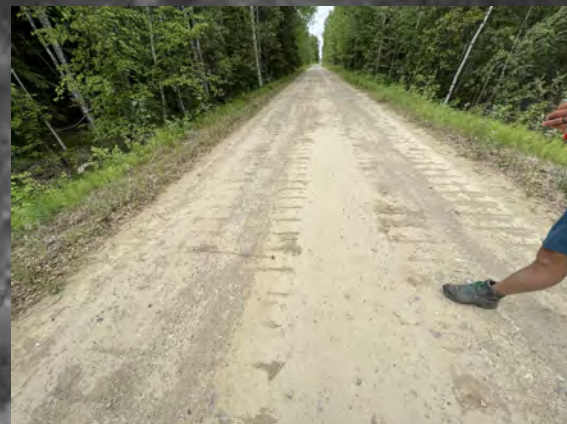
Culvert Found
 Condition: LT out with crushed. RT is good
 Culvert replace if budget is allowed.
 Road wide: 14 FT, Road condition is good.
 Brush clearing: Yes

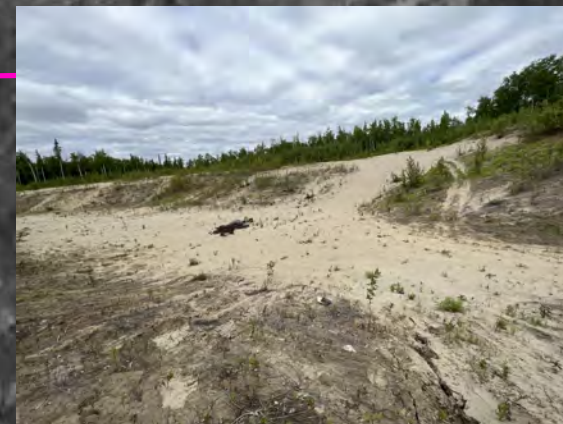
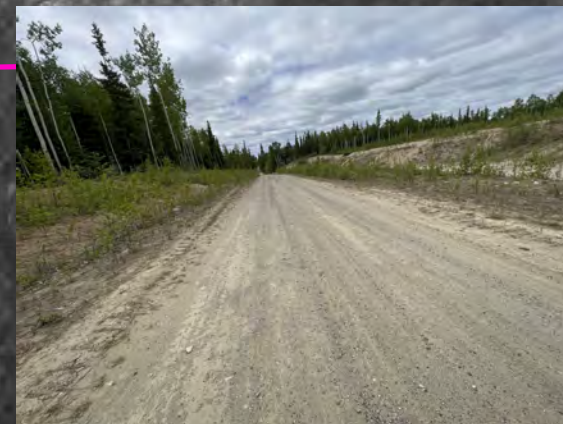
Road wide: 18 FT
 Condition: Good Shape
 Old MS. - Sand /Staging area
 Turnout (RT side)
 Brush clearing: Yes

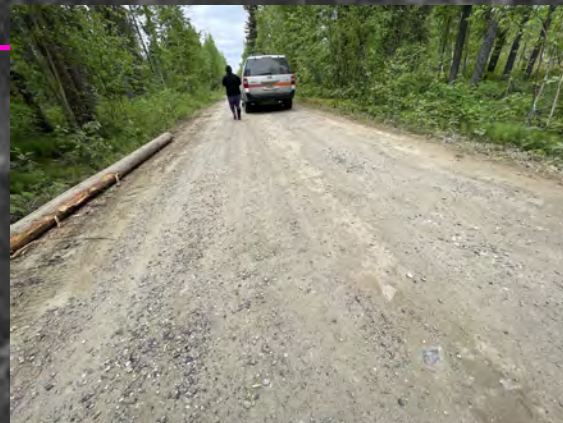
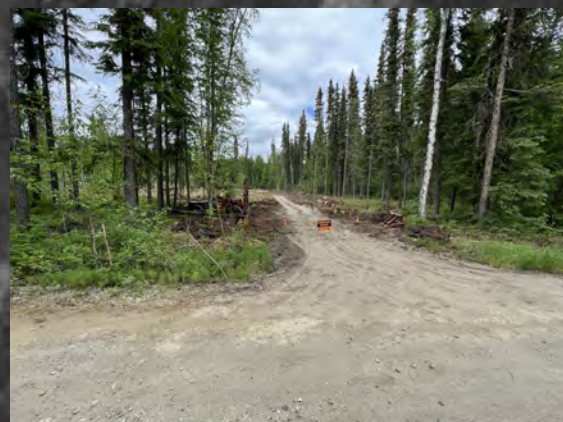
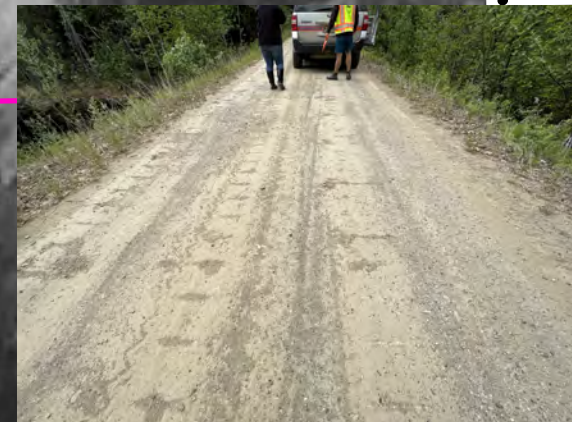
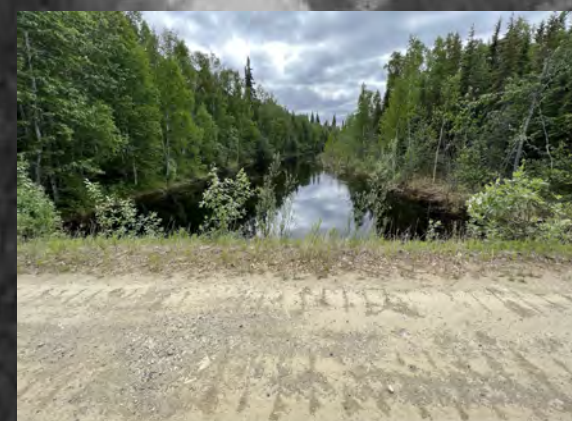
Figure 8

Commercial harvest area - Privately owned
Sandy area.
Road wide: 14.5FT
Brush clearing: Yes

Culvert Found
Condition: Good, Might need to add an extra culvert and guard rail if budget is allowed.
Road wide: 13.5FT
Brush clearing: Yes
