STATE OF ALASKA
Department of Transportation and Public Facilities
2301 Peger Road Fairbanks, AK 99709

Date: 7/18/2022

Nenana - Totchaket Road

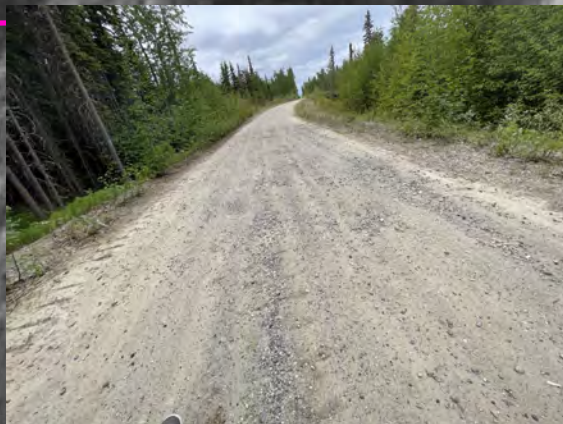
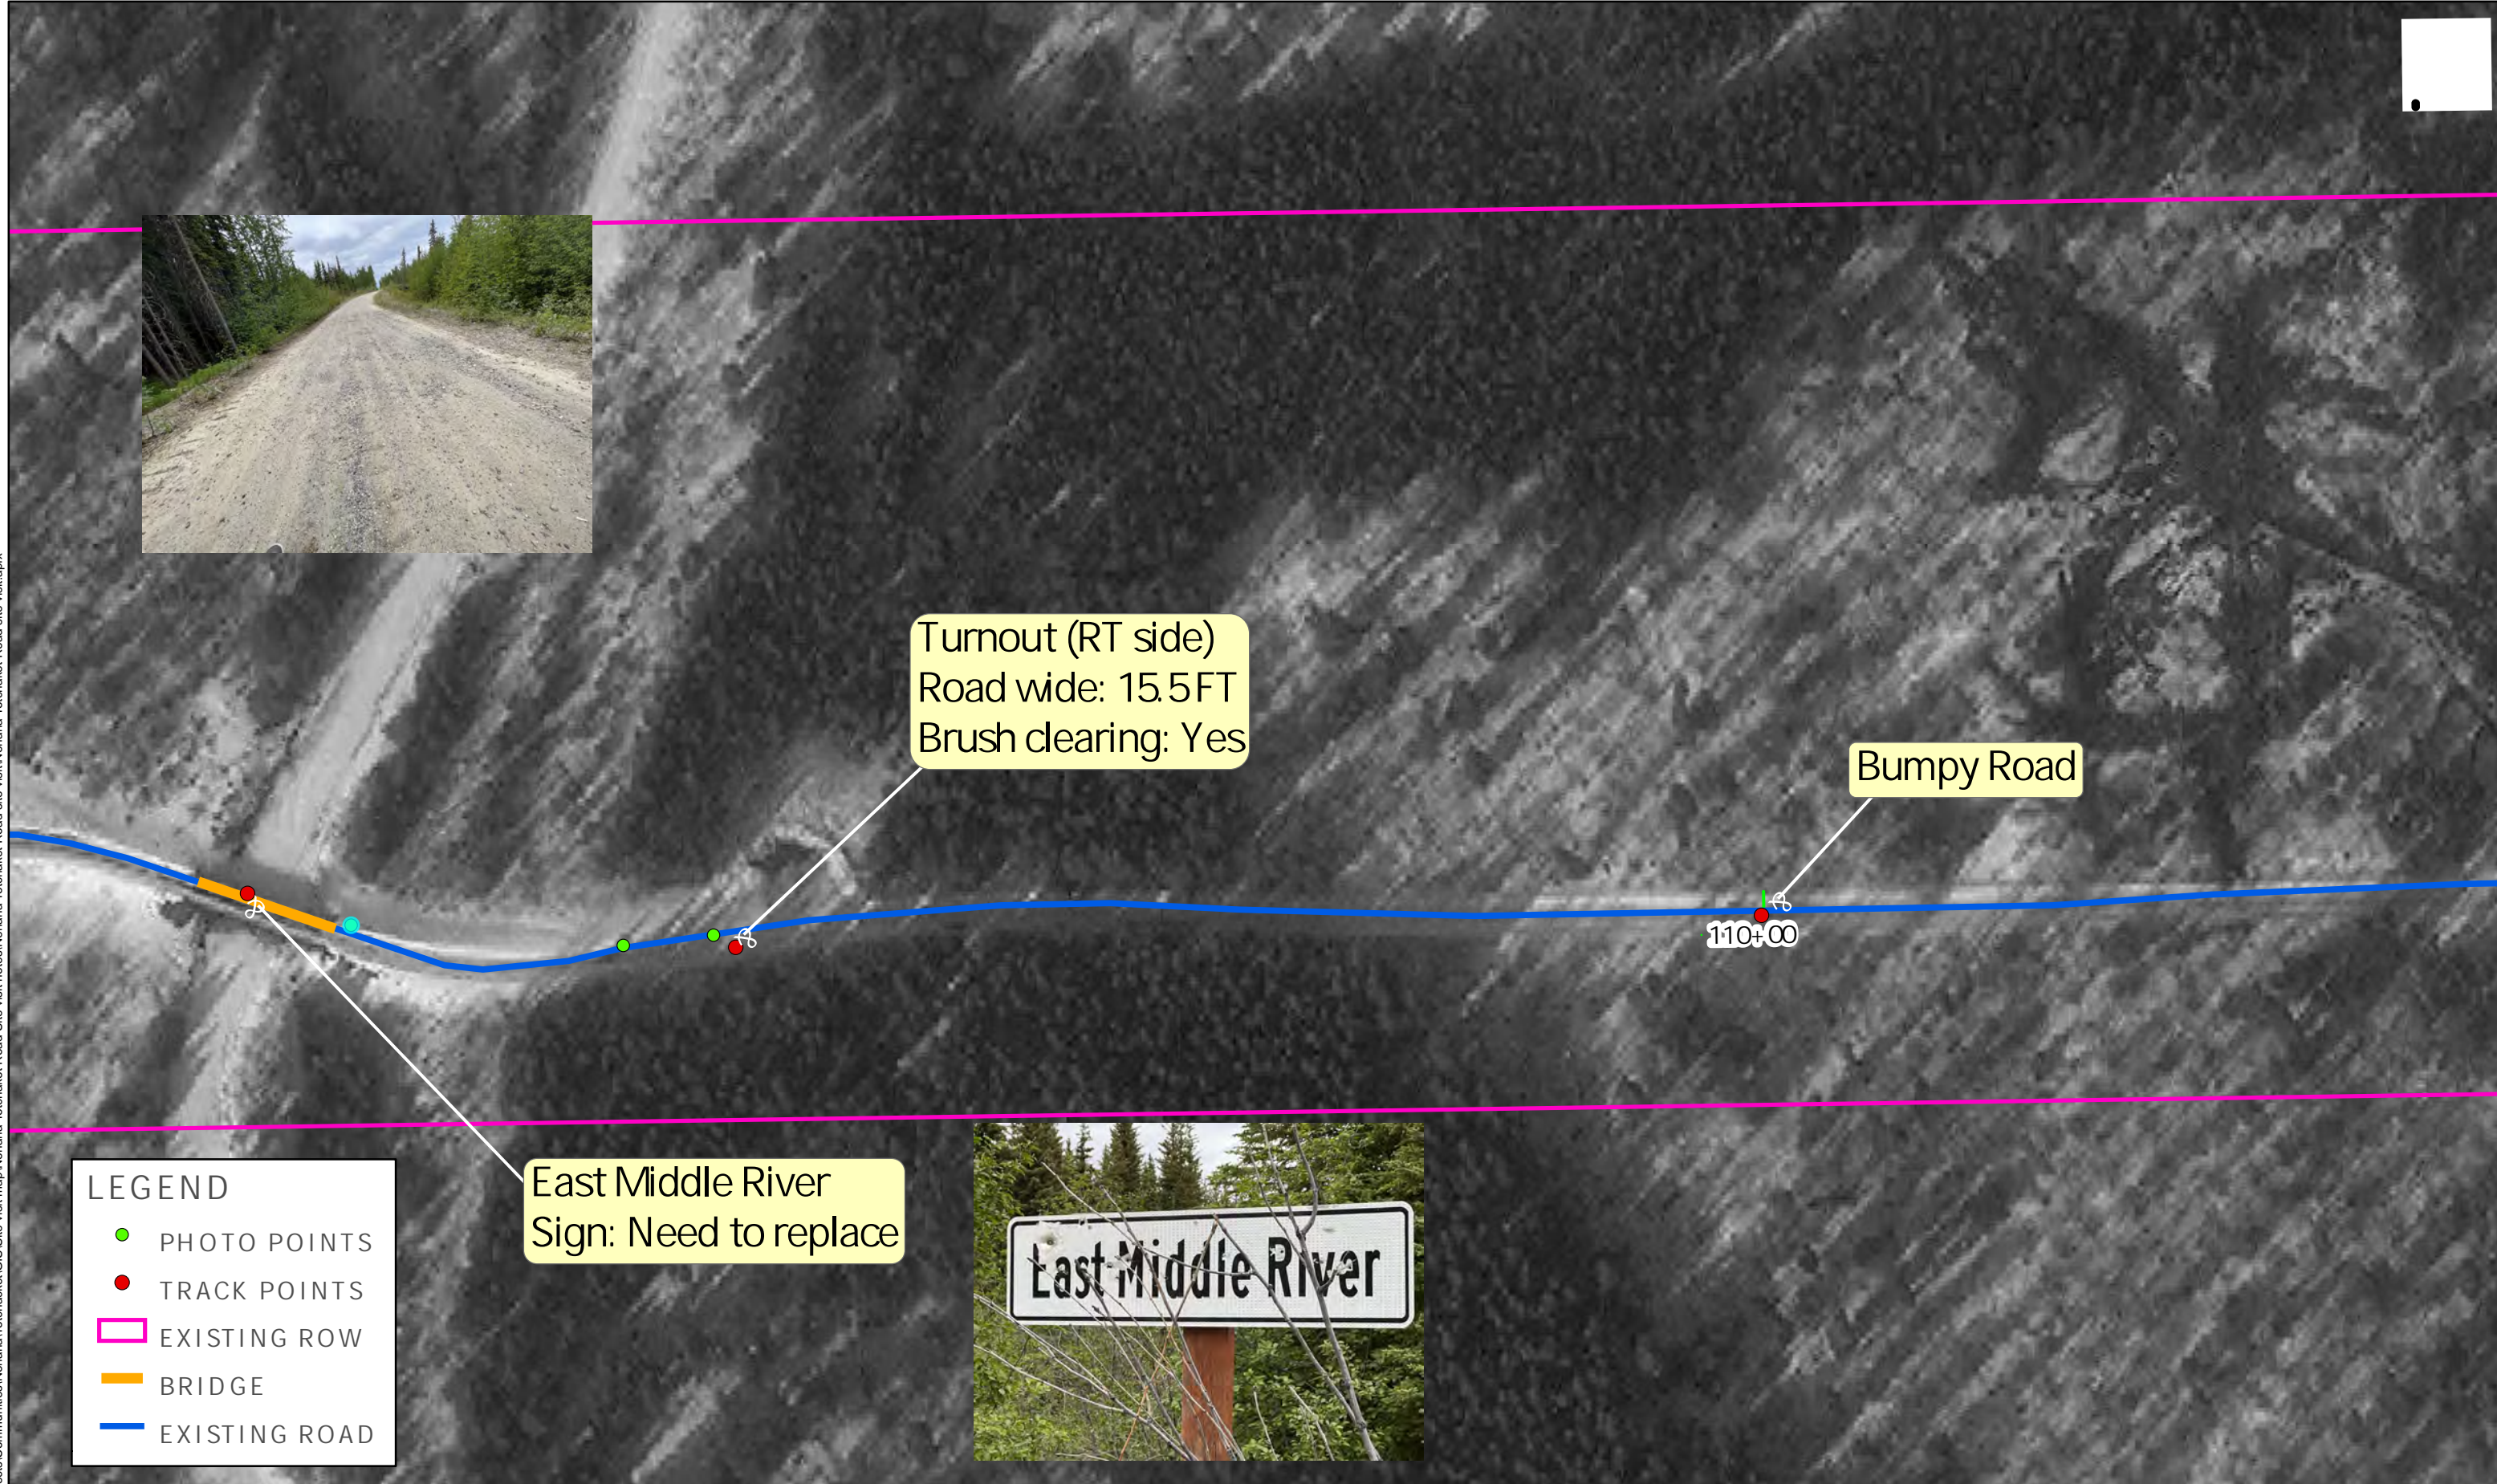
Figure 9

Turnout (RT side)
Road wide: 15.5 FT
Brush clearing: Yes

Bumpy Road

East Middle River
Sign: Need to replace

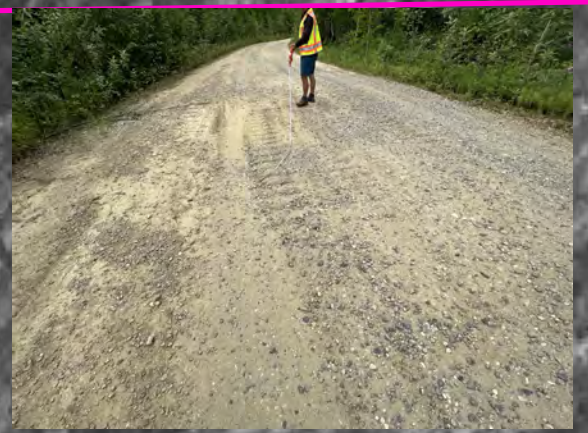
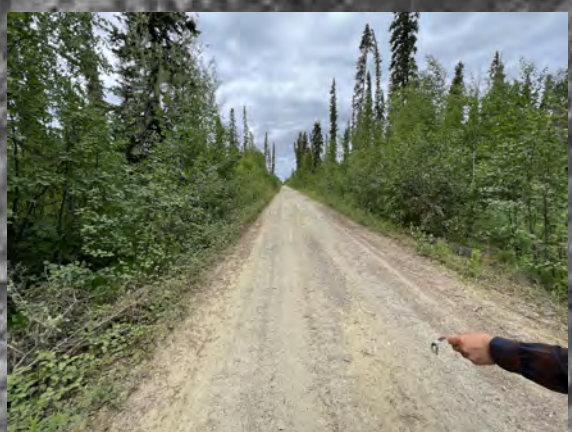
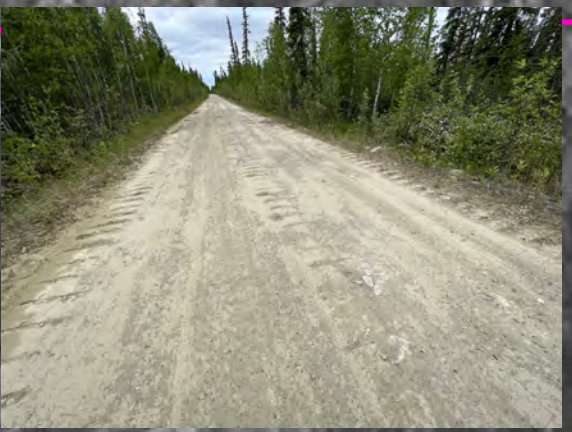
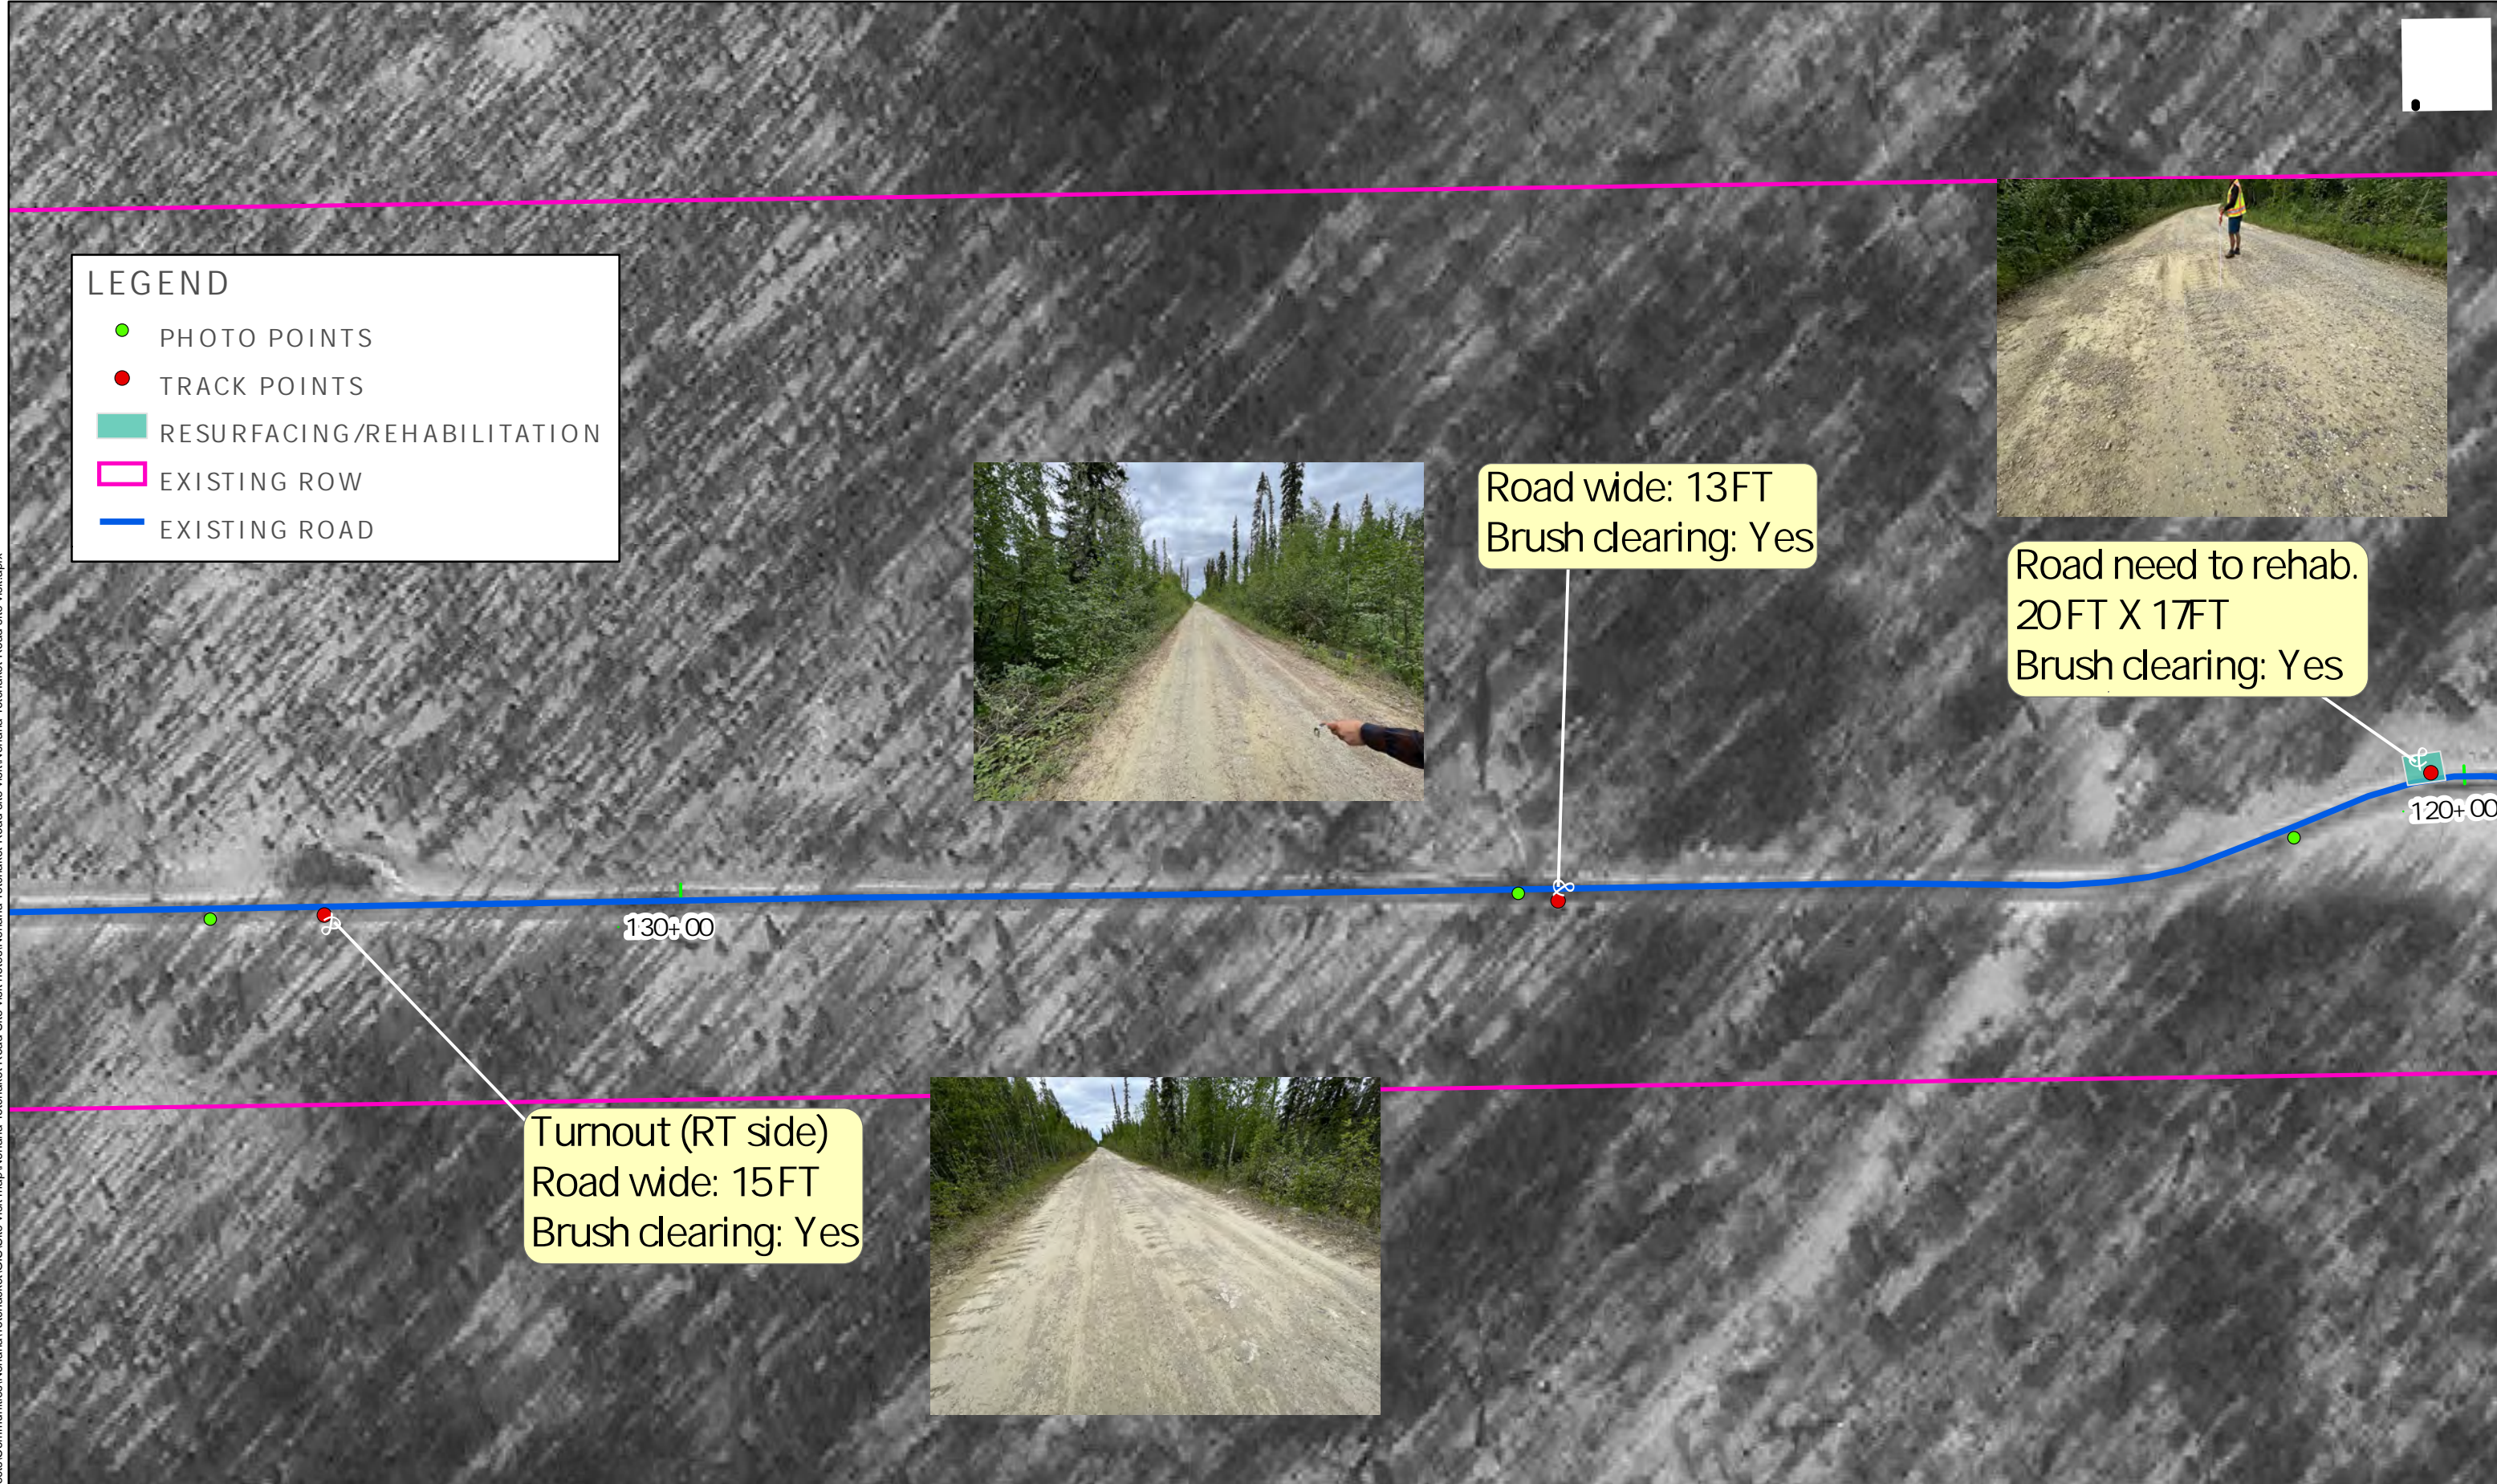
Date: 7/18/2022 Figure 10

Road wide: 13FT
Brush clearing: Yes

Road need to rehab.
20FT X 17FT
Brush clearing: Yes

Turnout (RT side)
Road wide: 15FT
Brush clearing: Yes

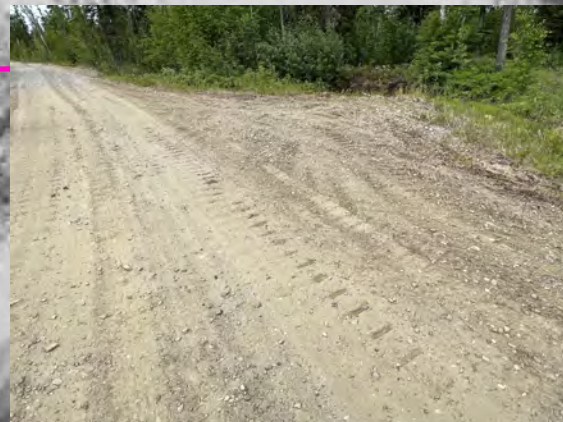
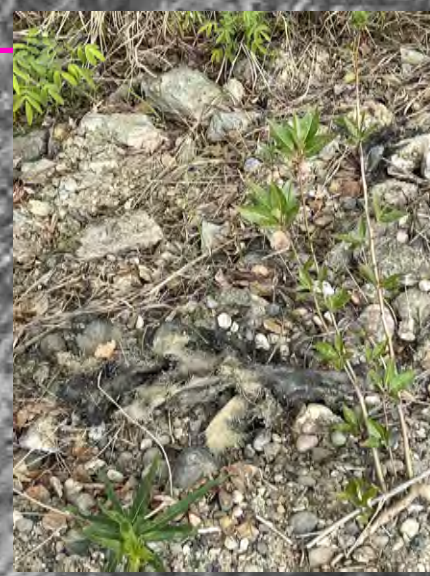
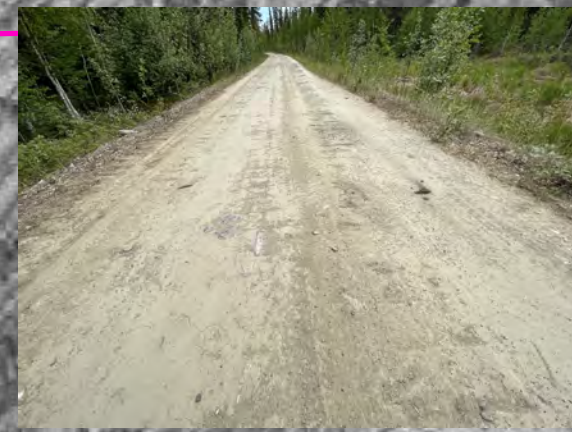
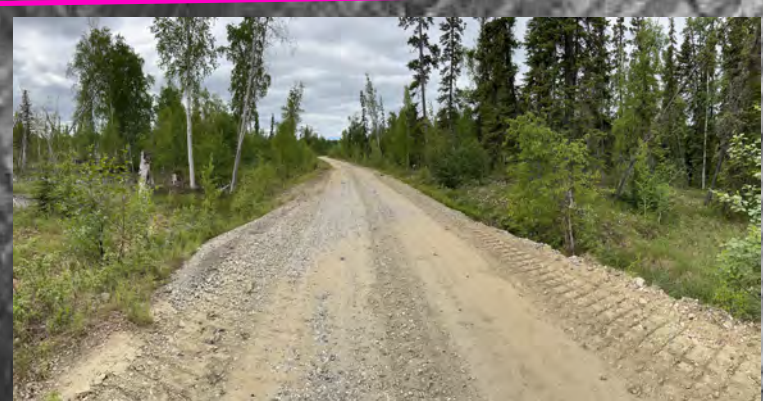
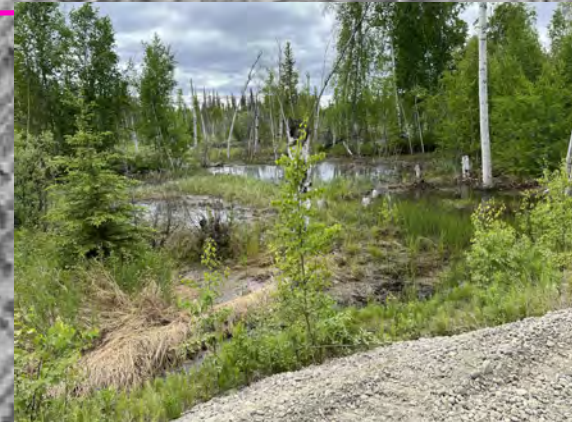
Figure 11

Turnout (RT side)
Brush clearing: Yes

Road fabric is showing
& need to resurfacing
Road wide: 14.5FT
Brush clearing: Yes

Wetland with no culvert. (Investigation)
Improve wetlands to add culvert
Road wide: 15FT
Brush clearing: Yes

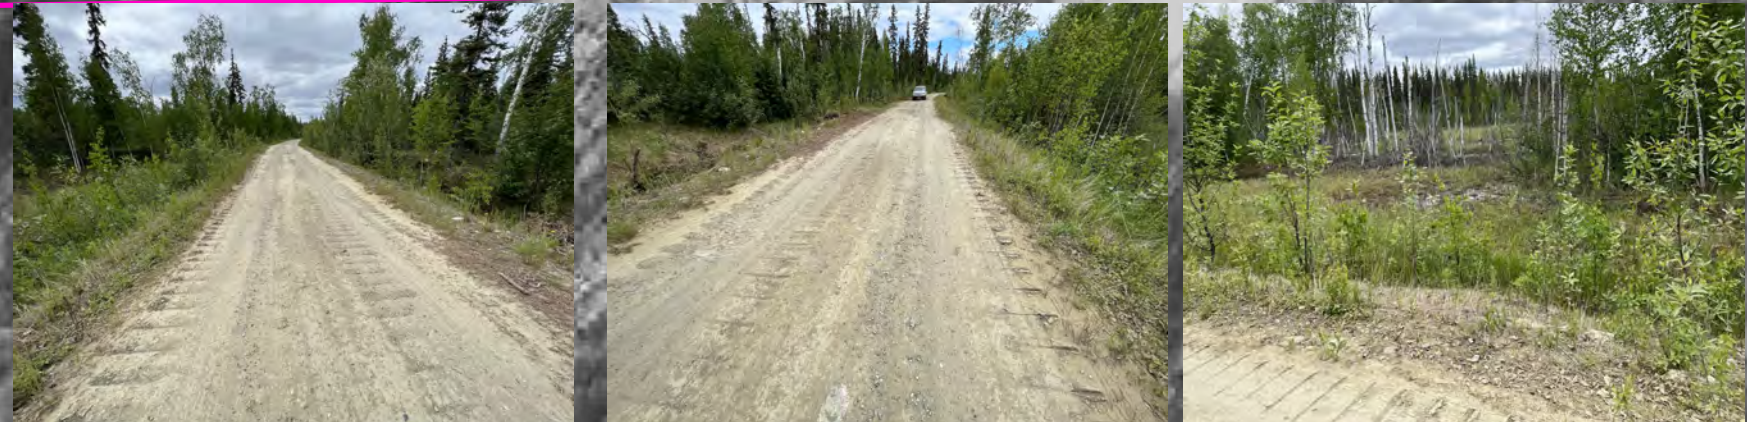
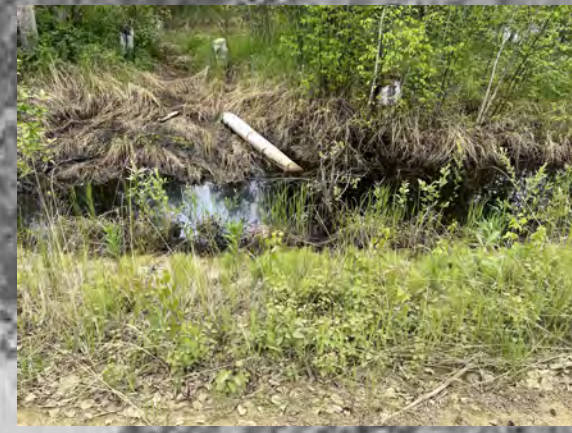
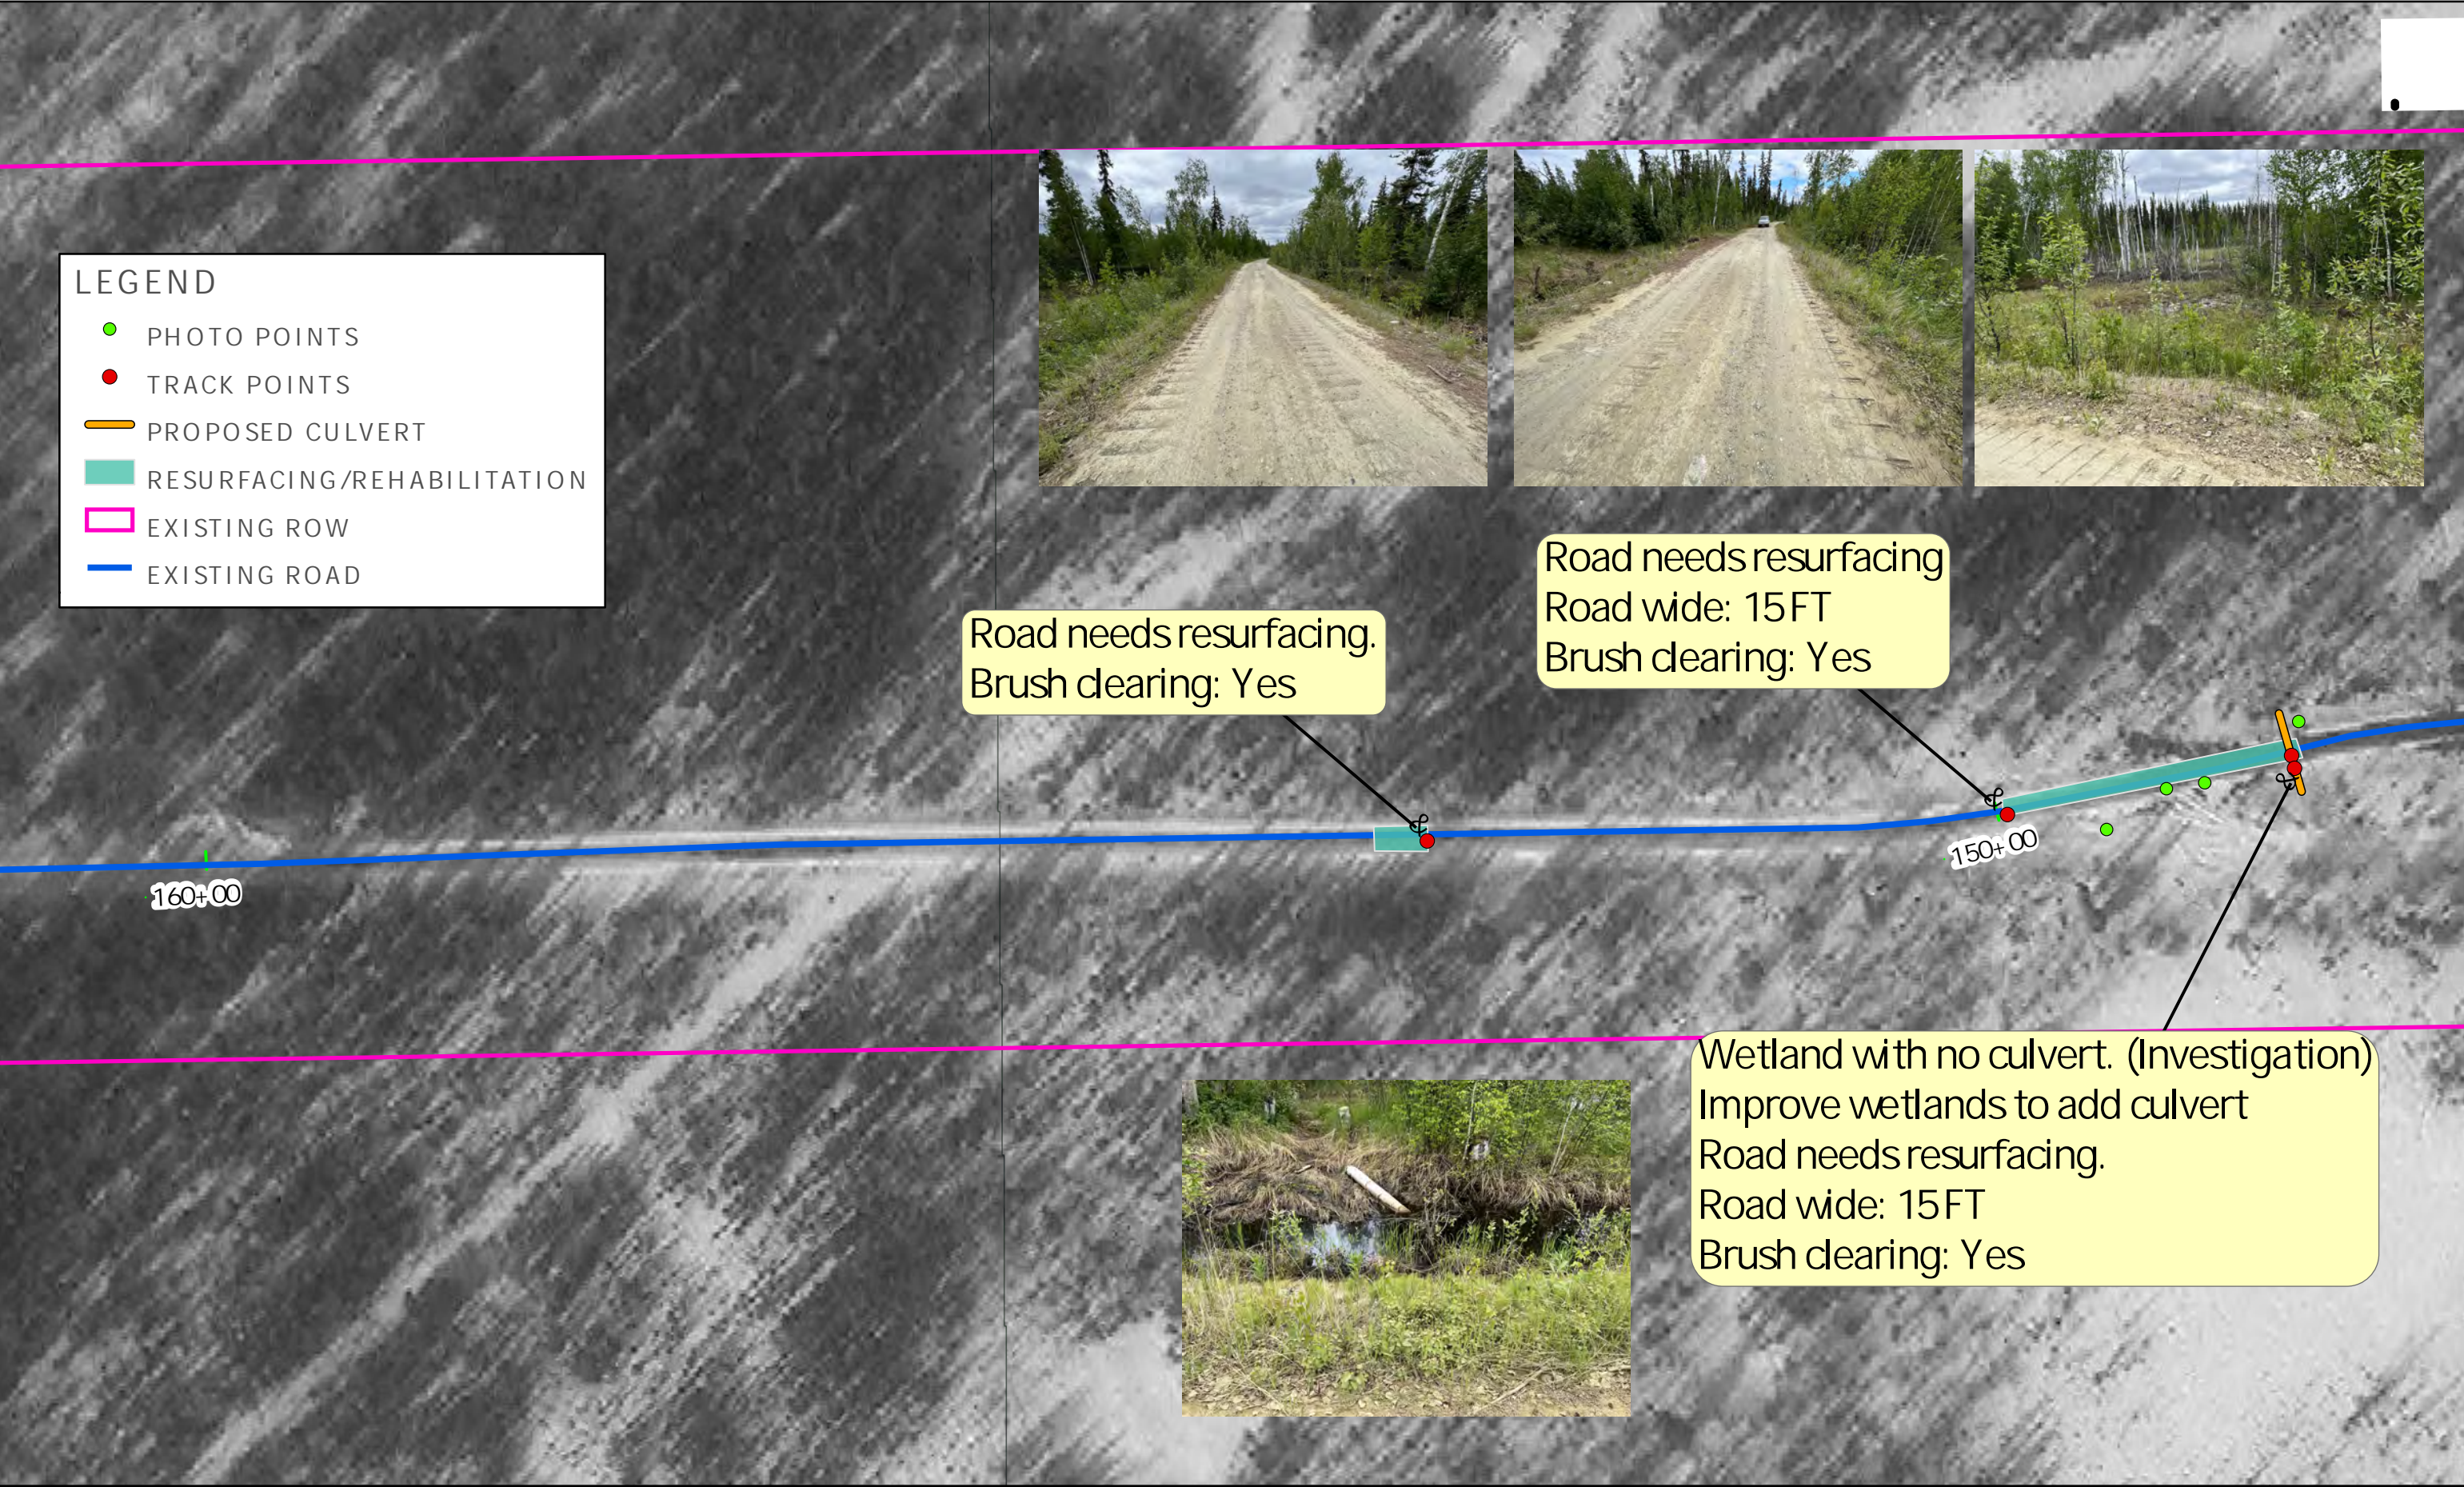
Road needs resurfacing.
Brush clearing: Yes

Road needs resurfacing
Road wide: 15 FT
Brush clearing: Yes

Wetland with no culvert. (Investigation)
Improve wetlands to add culvert
Road needs resurfacing.
Road wide: 15 FT
Brush clearing: Yes

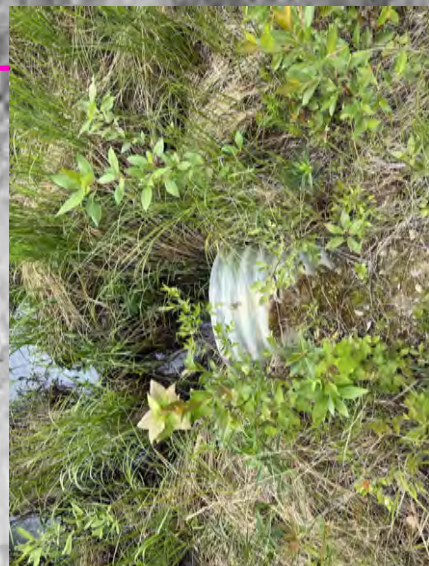
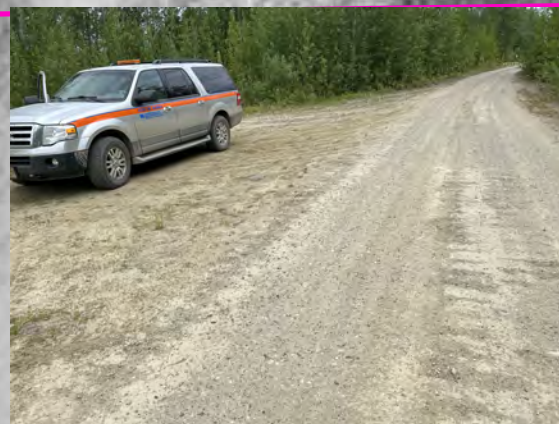
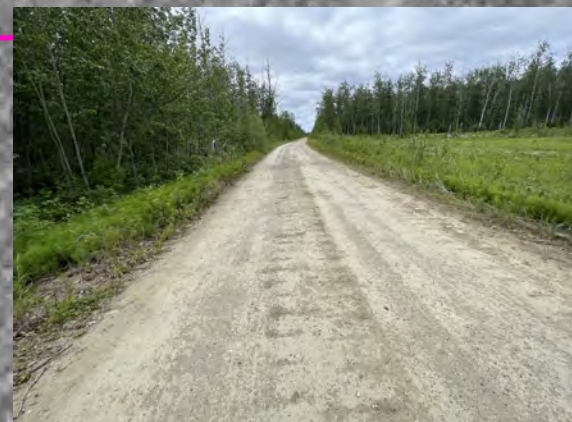
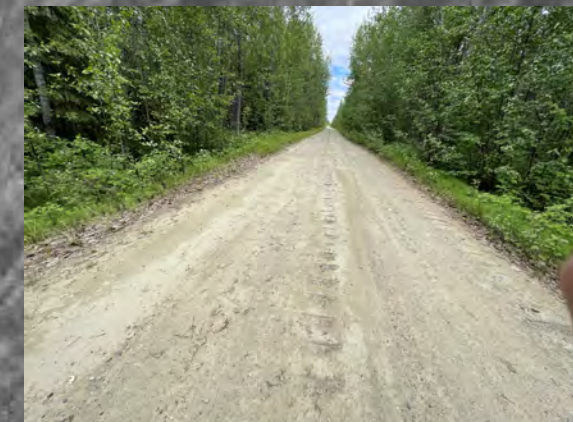
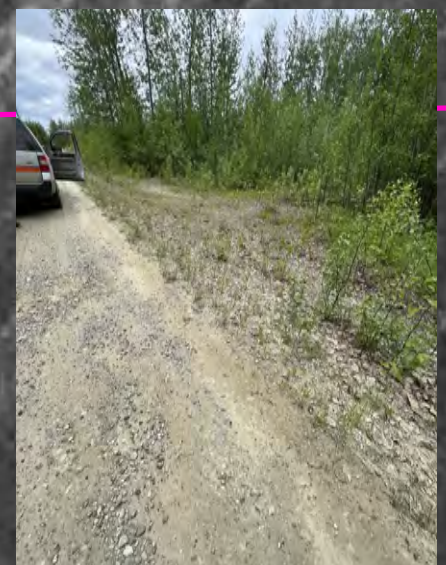
Figure 13

Turnout (RT side)
Road wide: 15FT
Brush clearing: Yes

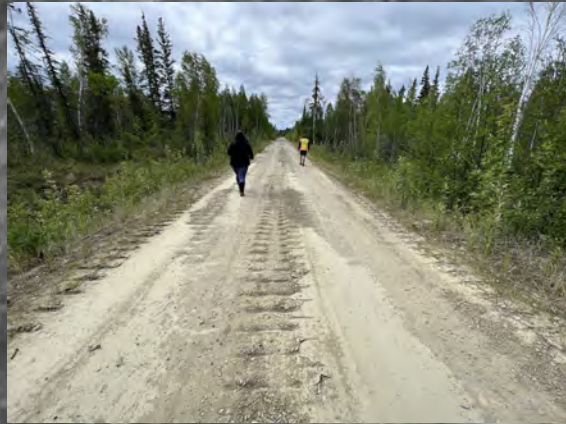
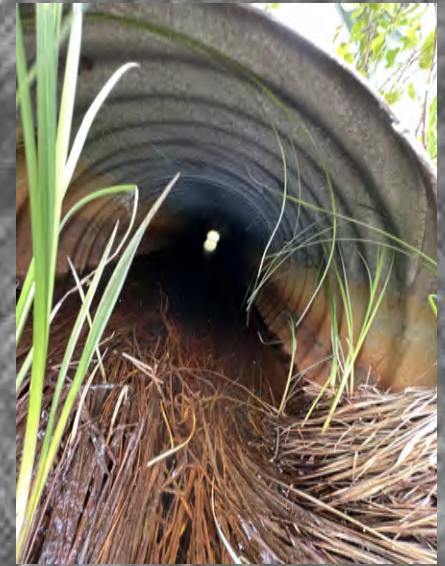
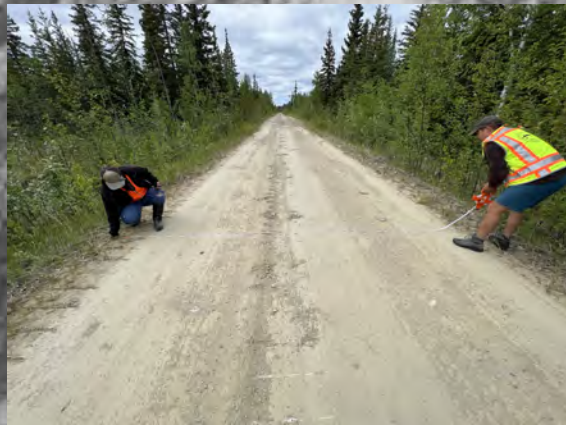
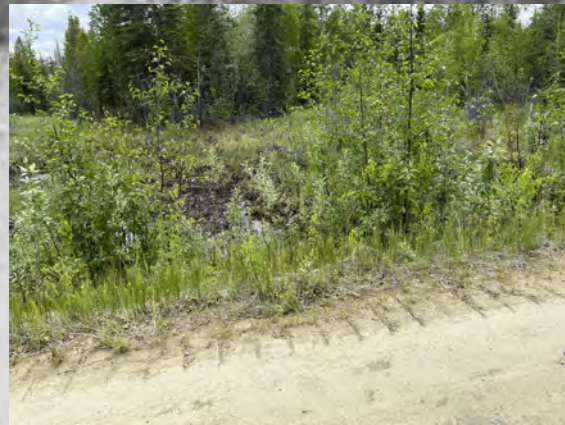
Figure 14

Resurfacing Start
Road wide: 15FT
Brush clearing: Yes

Culvert Found
Condition: Good shape
Road wide: 15FT
Brush clearing: Yes

Wetland with no culvert. (Investigation)
Improve wetlands to add culvert
Road needs resurfacing.
Road wide: 14 FT
Brush clearing: Yes

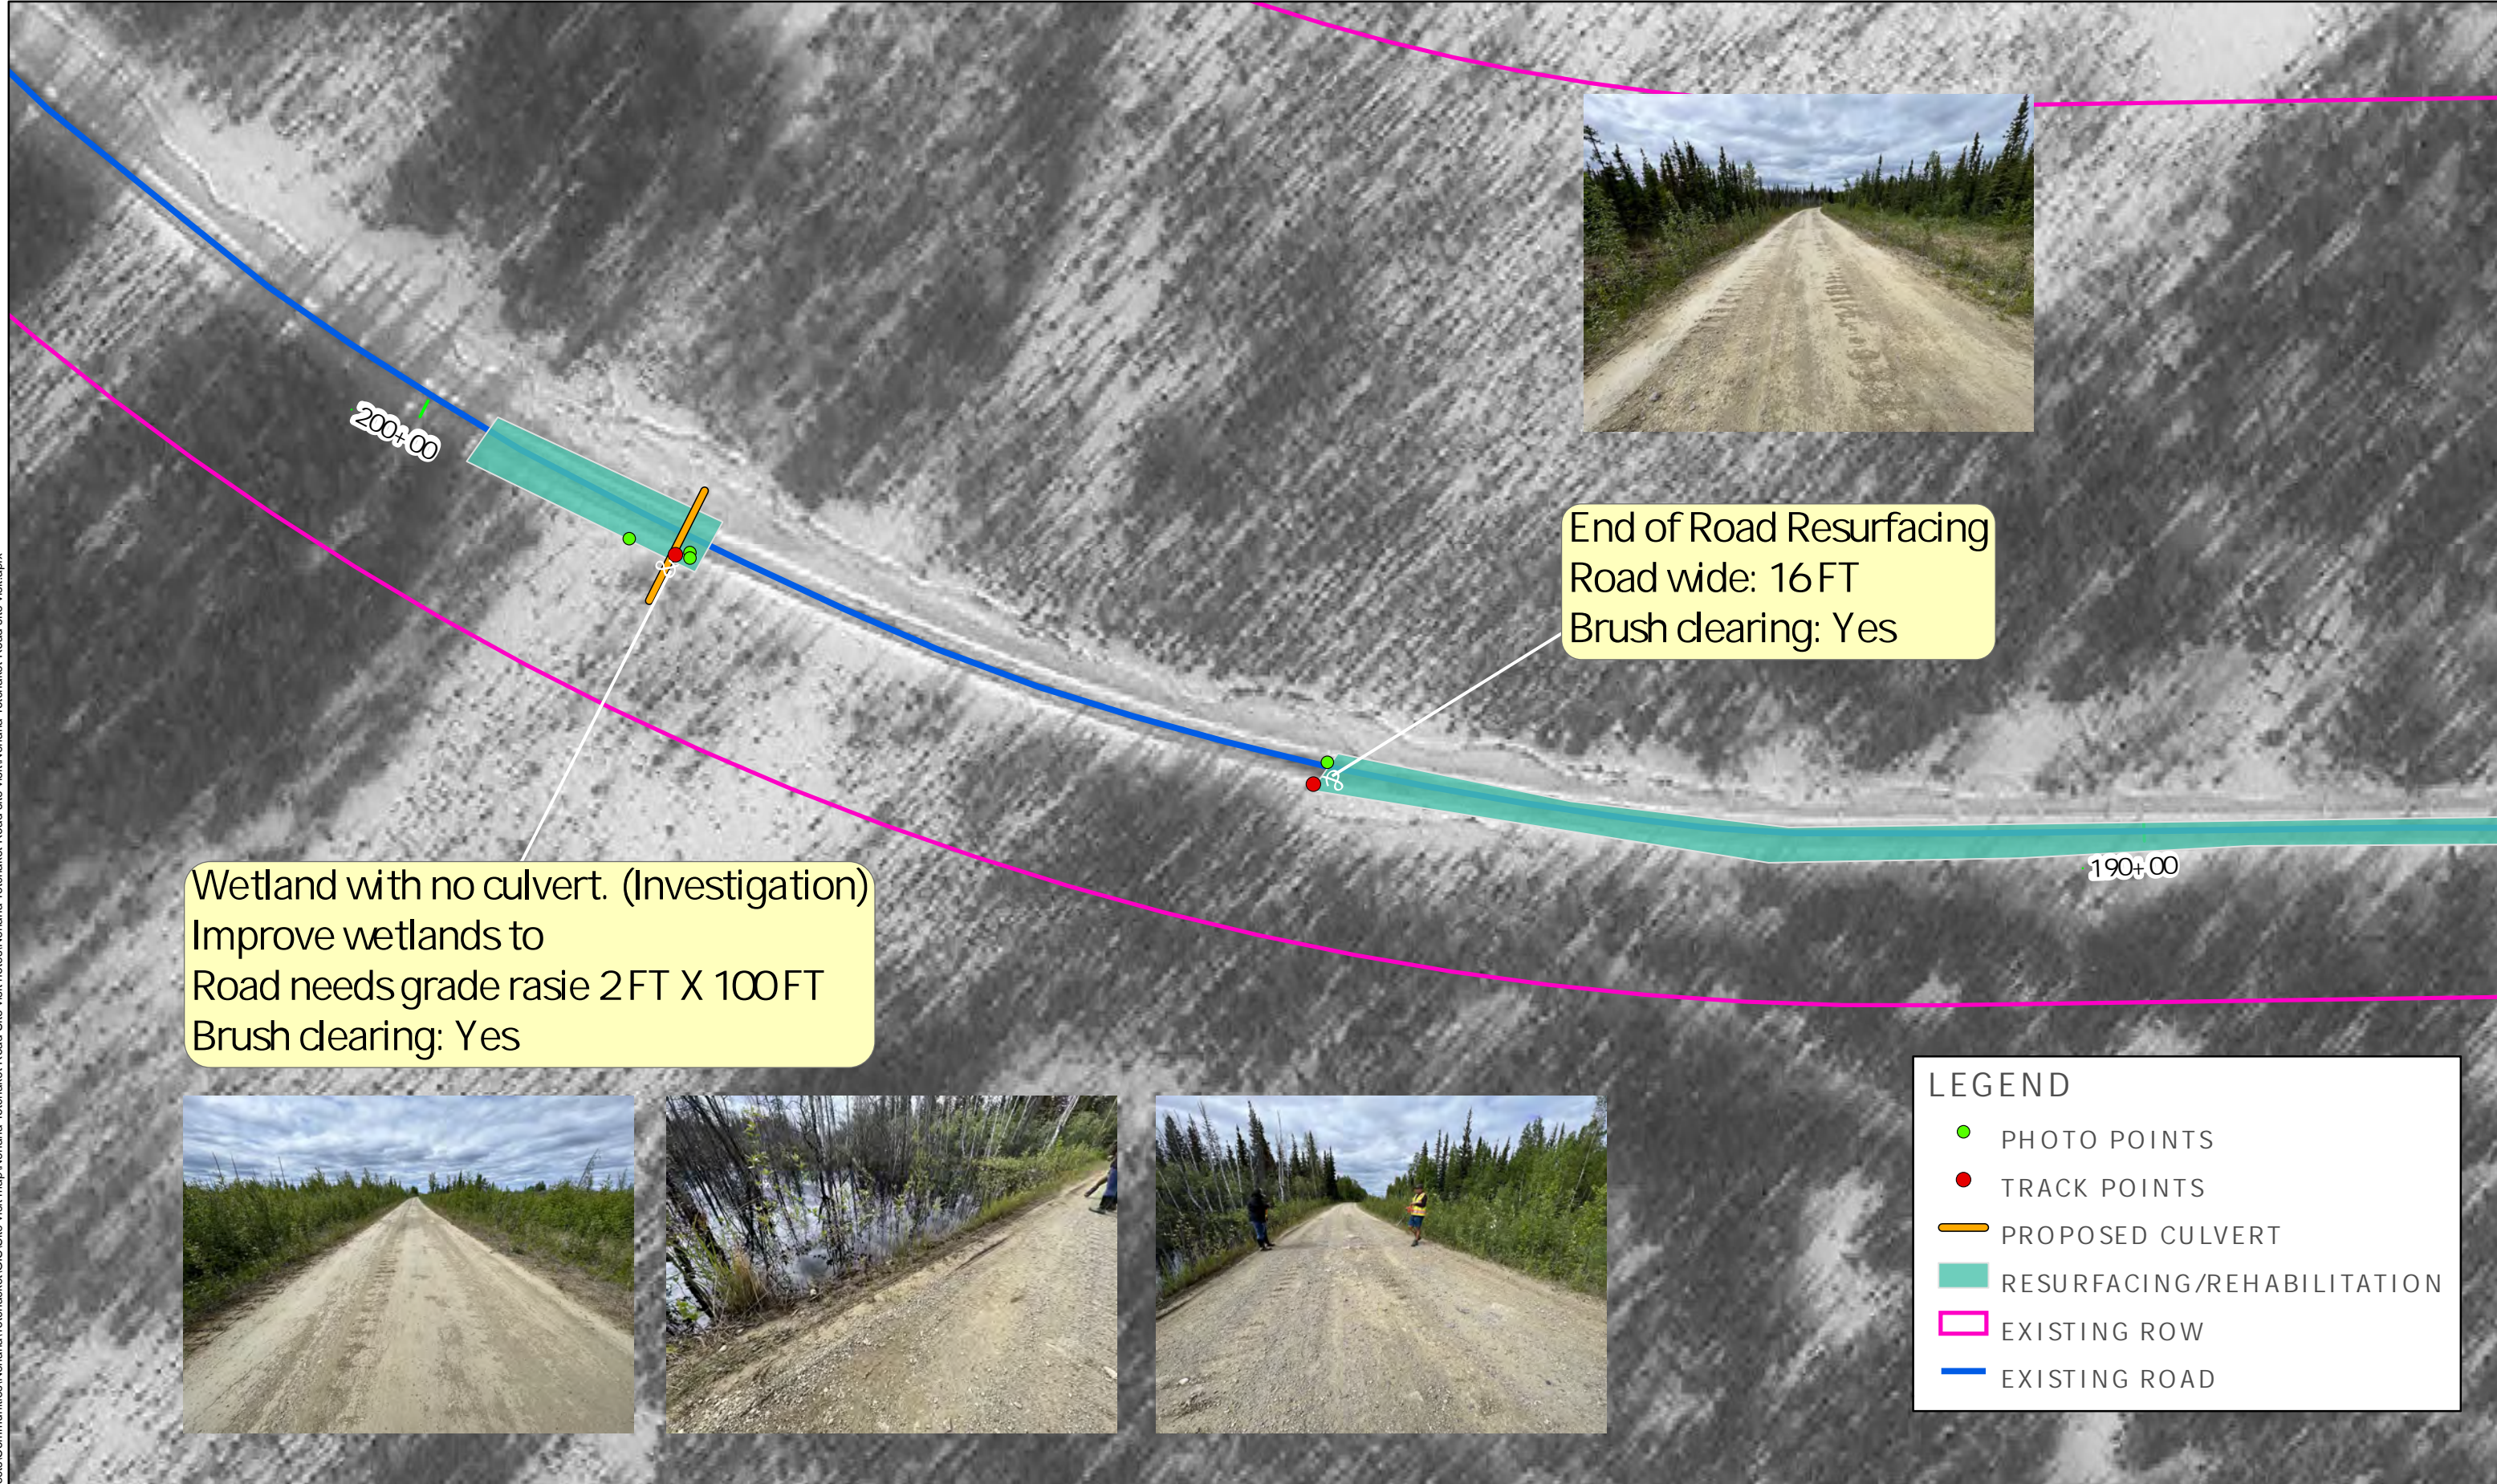
Wetland with no culvert. (Investigation)
Improve wetlands to
Road needs grade raise 2 FT X 100 FT
Brush clearing: Yes

End of Road Resurfacing
Road wide: 16 FT
Brush clearing: Yes
