STATE OF ALASKA
Department of Transportation and Public Facilities
2301 Peger Road Fairbanks, AK 99709

Date: 7/18/2022

Nenana - Totchaket Road

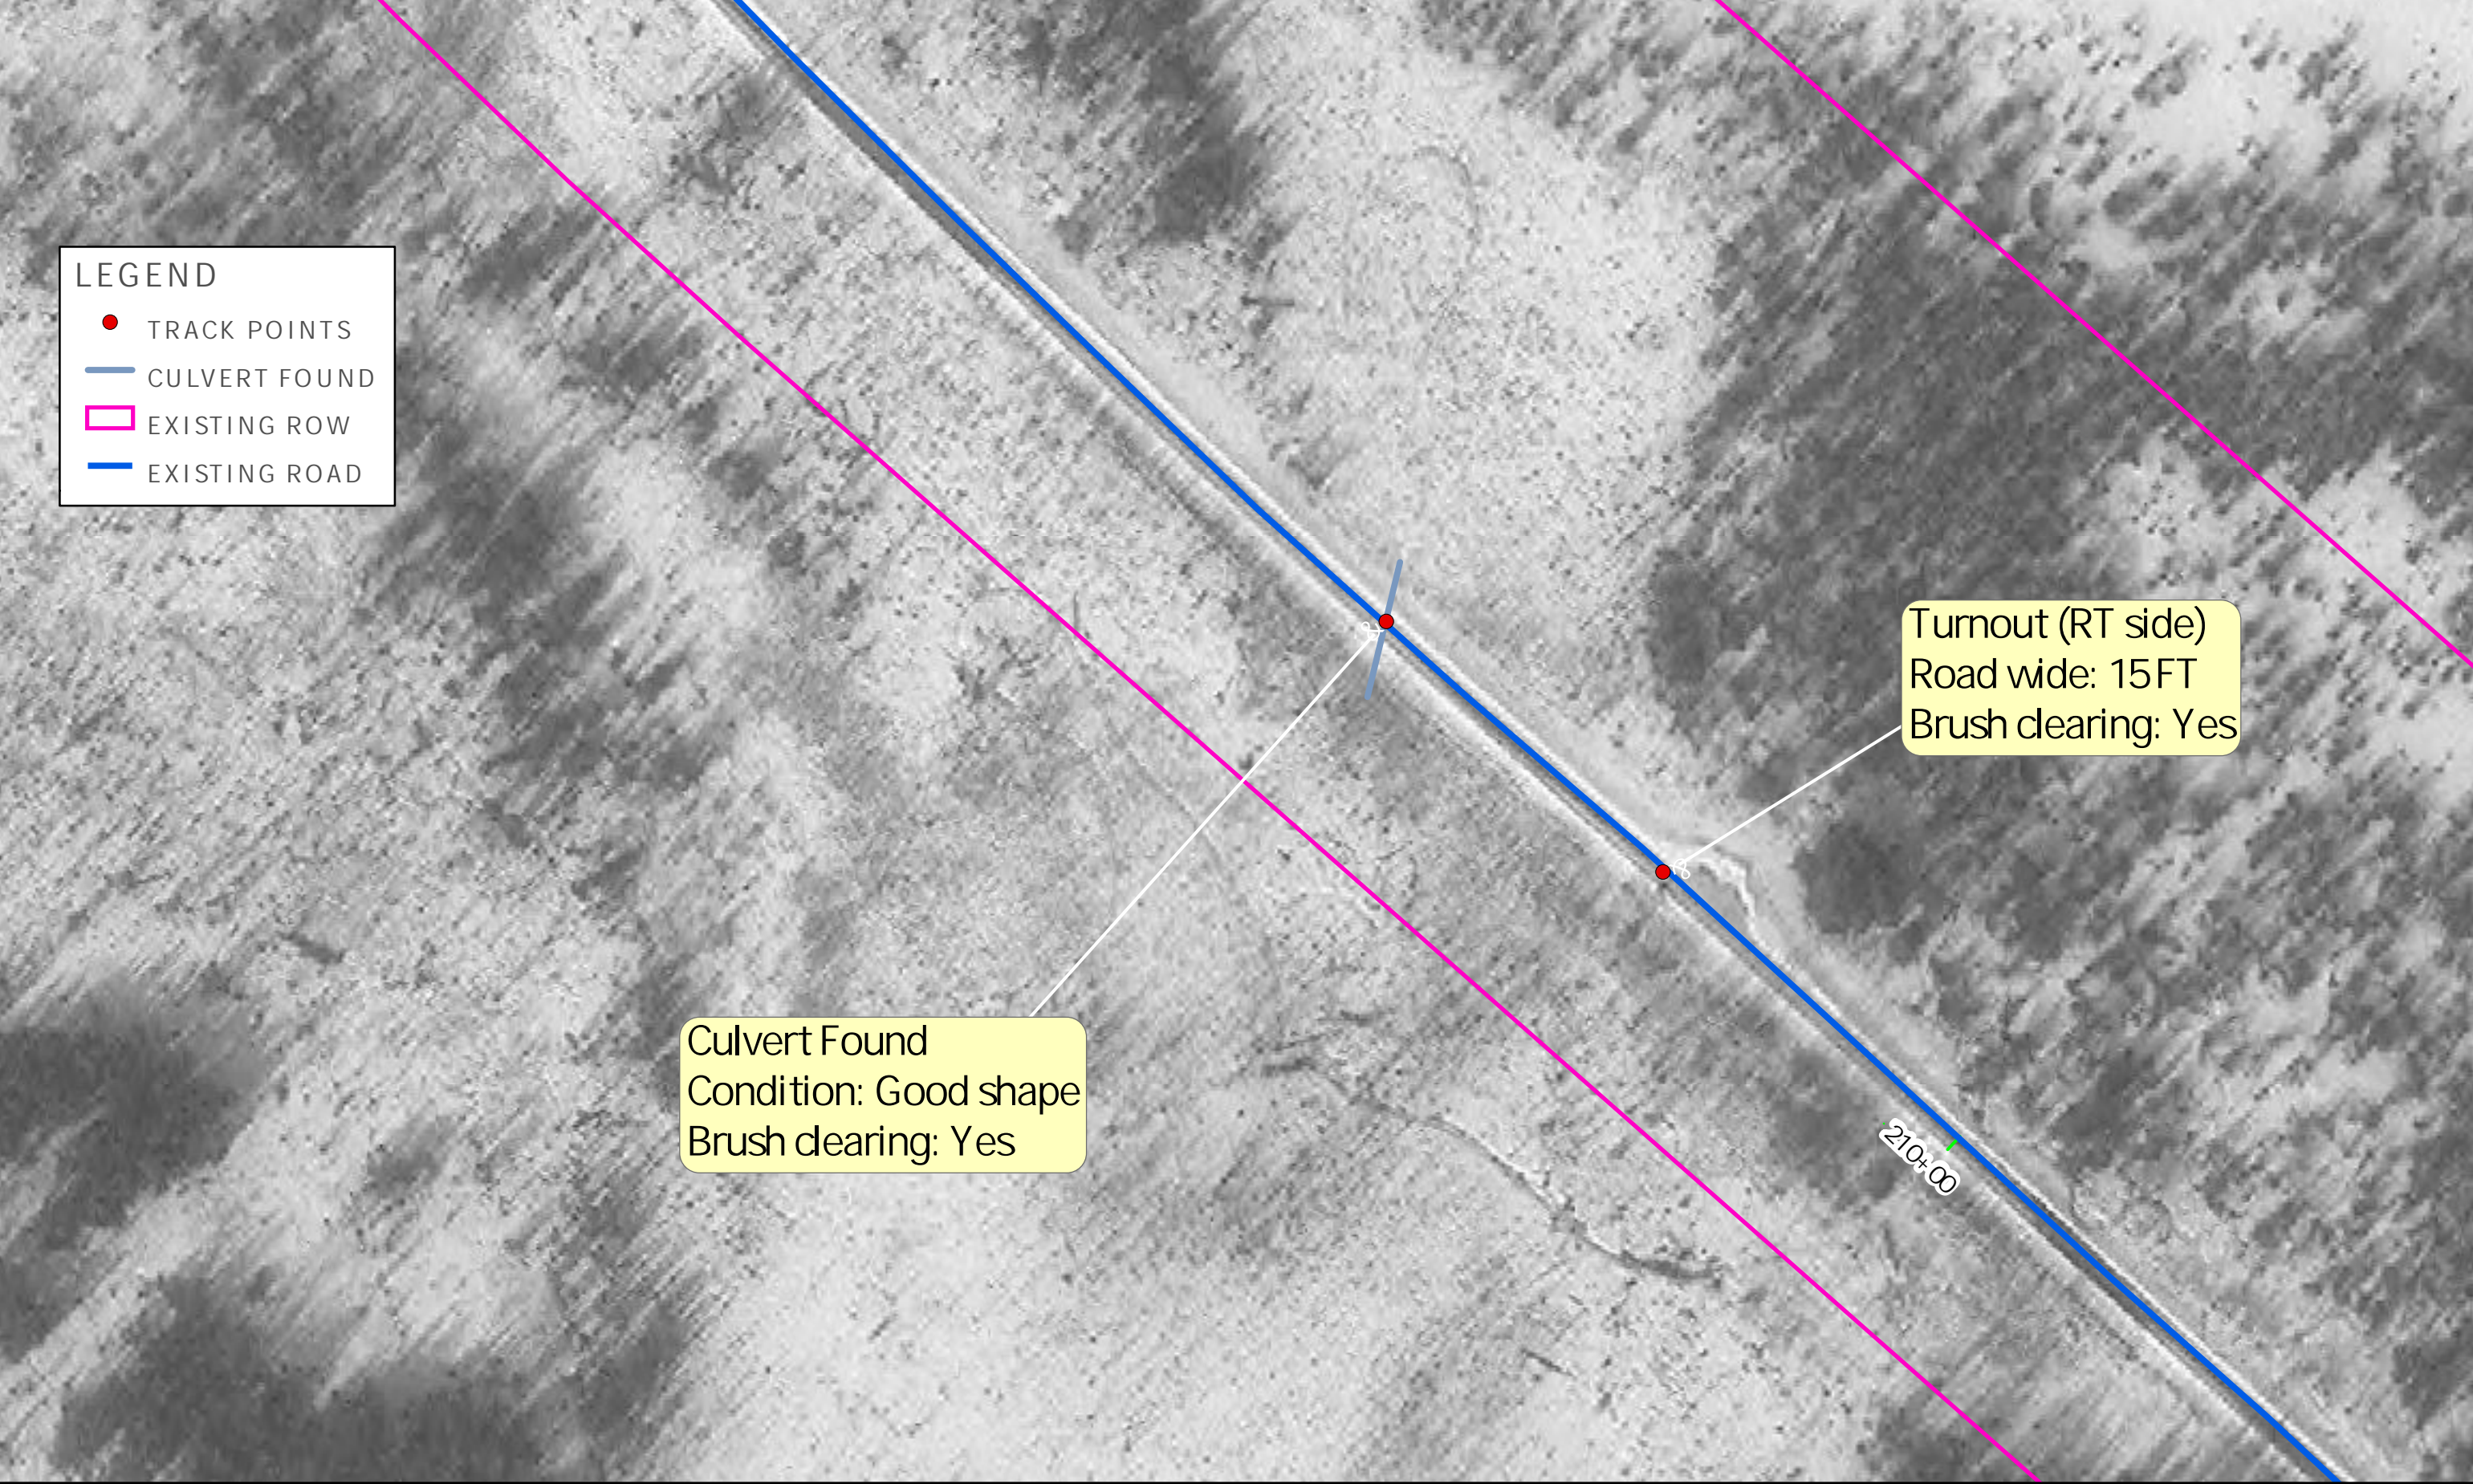
Culvert Found
 Condition: Good shape
 Brush clearing: Yes

Turnout (RT side)
 Road wide: 15FT
 Brush clearing: Yes

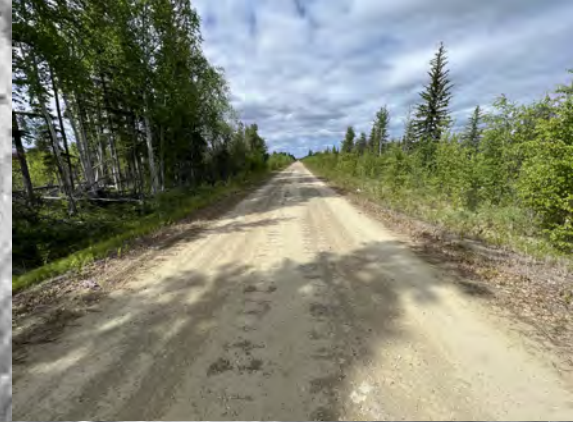
Figure 17

Turnout Start (RT side)
Road wide: 15FT
Brush clearing: Yes

Turnout End (RT side)
Brush clearing: Yes

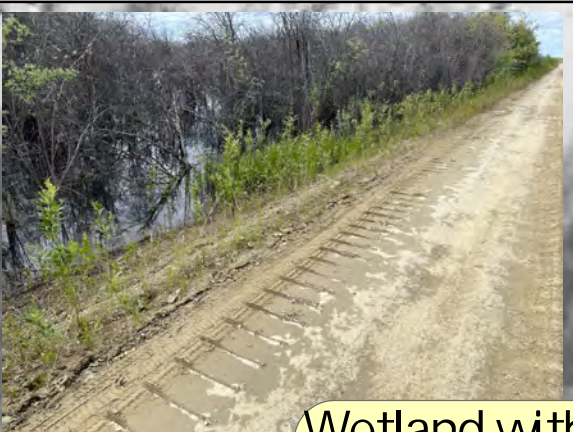
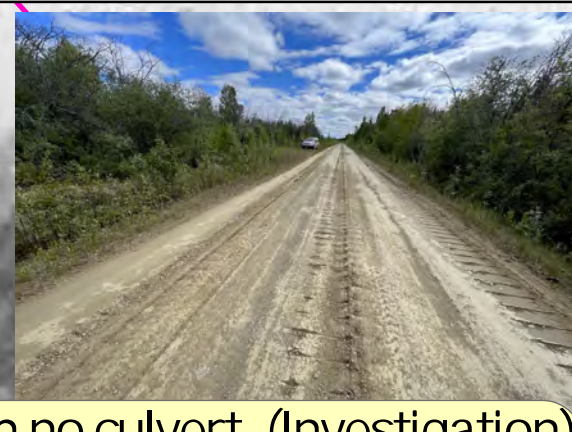
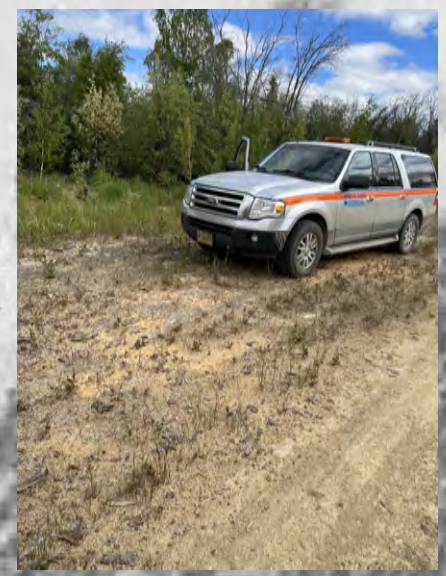
Figure 18

Wetland with no culvert. (Investigation)
 Improve wetlands to add culvert
 Road needs grade raise 1 FT
 (Road Rehabilitation)
 Brush clearing: Yes

Turnout End (RT side)
 Road wide: 17FT
 Brush clearing: Yes

Turnout Start (RT side)
 Brush clearing: Yes

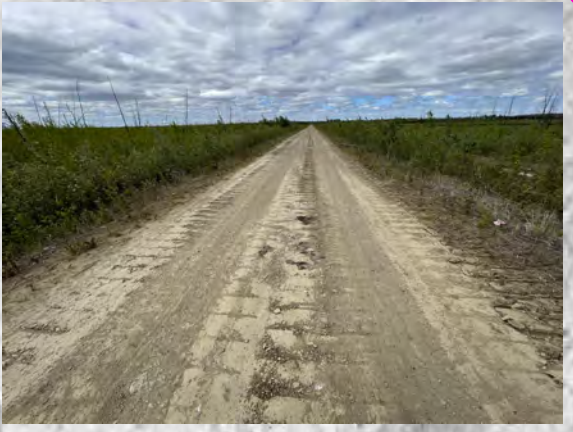
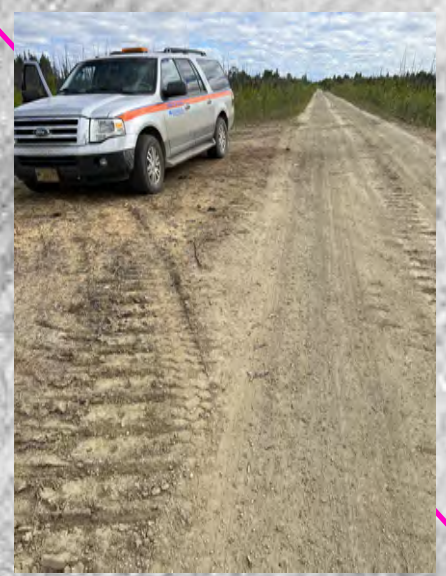
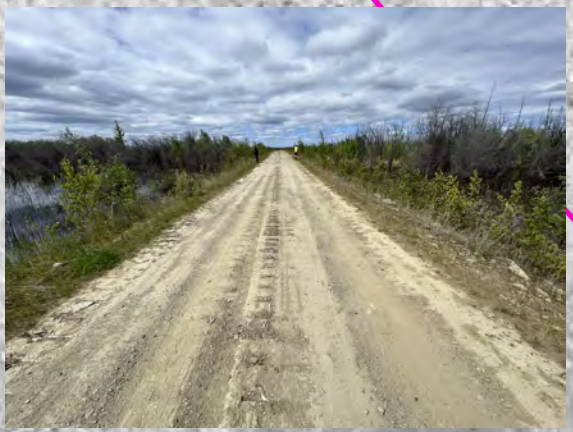
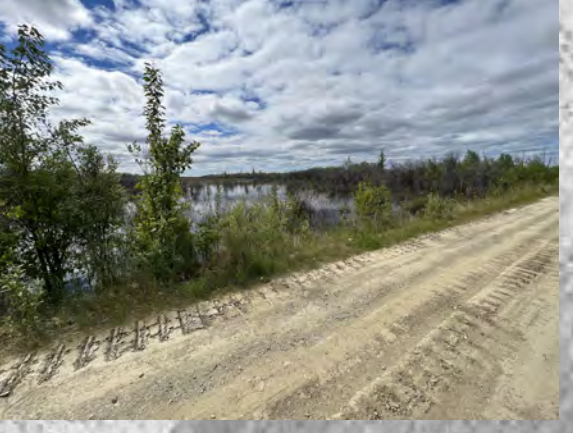
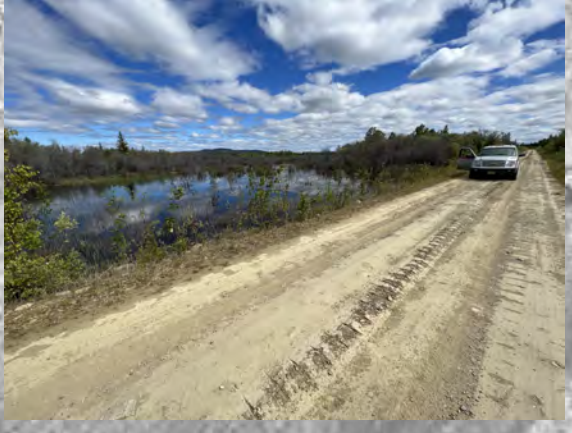
Figure 19

Turnout Start (RT side)
 Road wide: 16 FT
 Brush clearing: Yes

Wetland with no culvert. (Investigation)
 Improve wetlands to add
 2 culverts space apart 100 FT
 Road wide: 15 FT
 Brush clearing: Yes

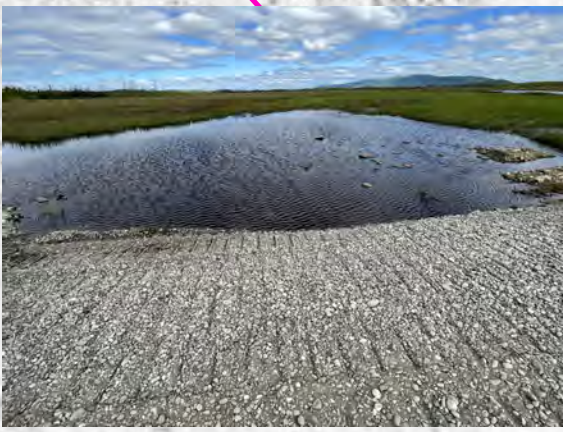
Wetland with no culvert. (Investigation)
 Improve wetlands to add culvert when budget is allowed
 100FT long X 2 FT raise (Road Rehabilitation)
 Road wide: 16 FT
 Brush clearing: Yes

Culvert is under the water (3FT)
 Improve wetlands to add extra culvert (Investigation) when budget is allowed
 Brush clearing: Yes

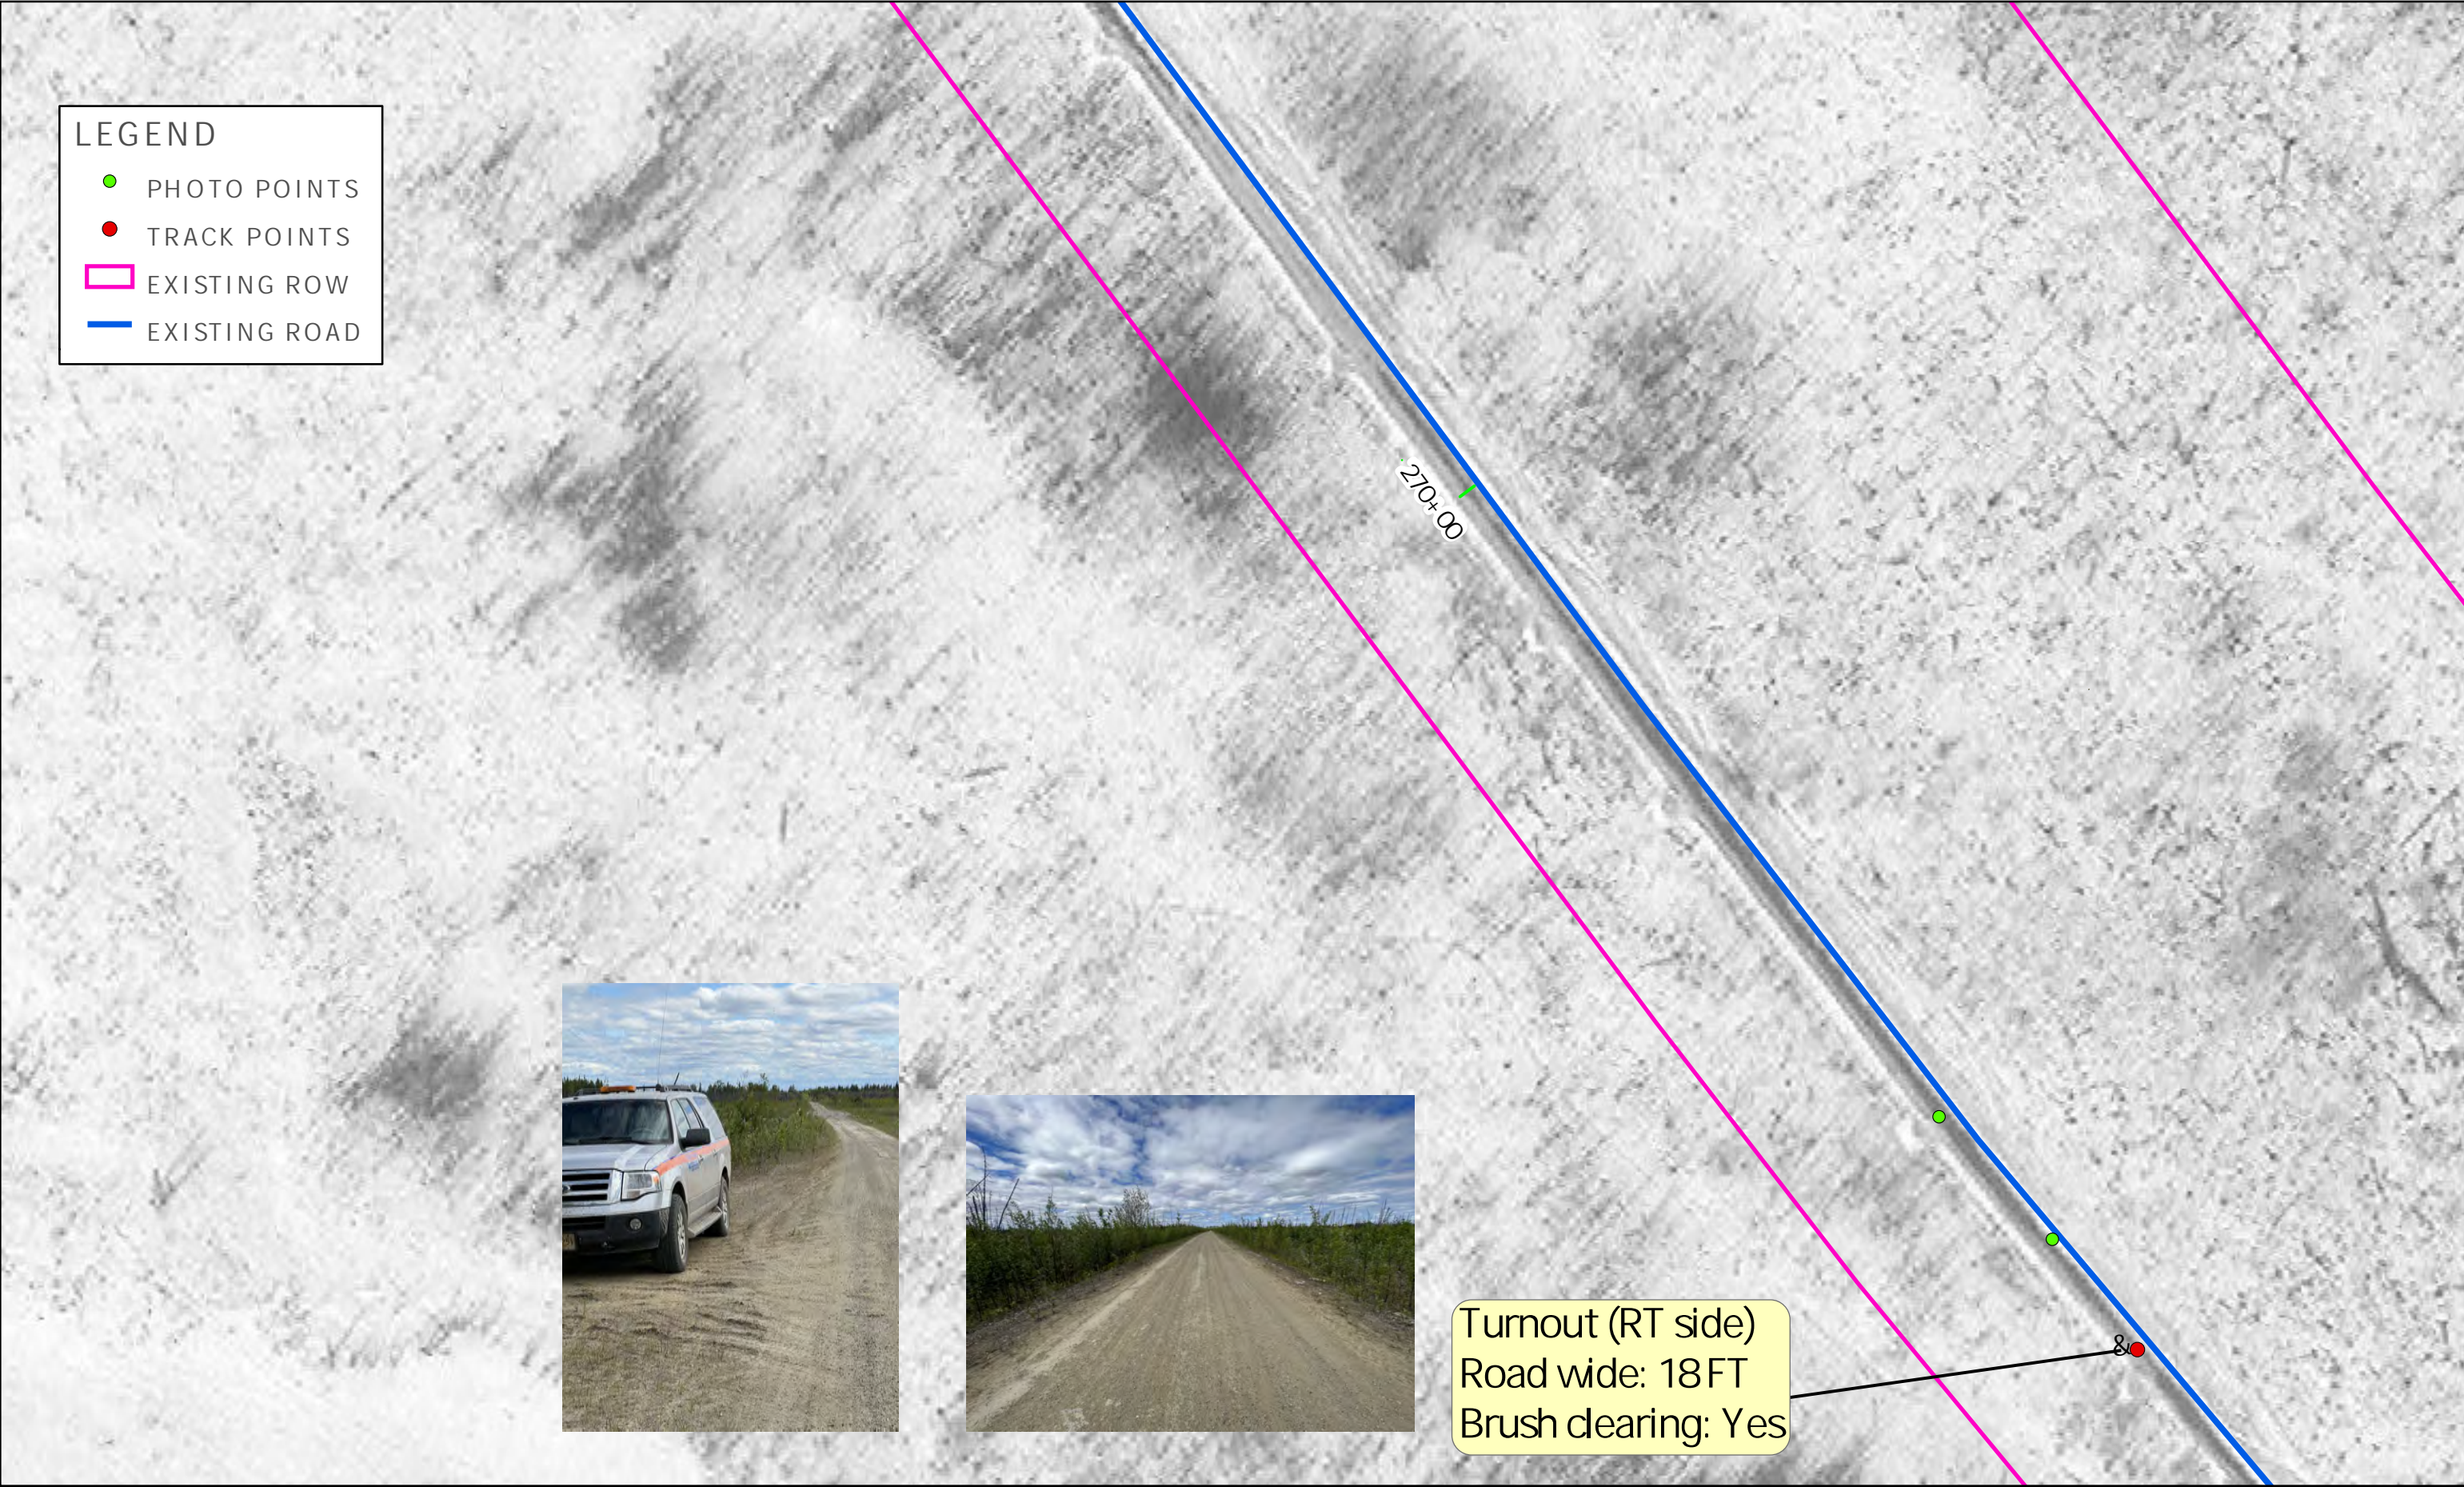
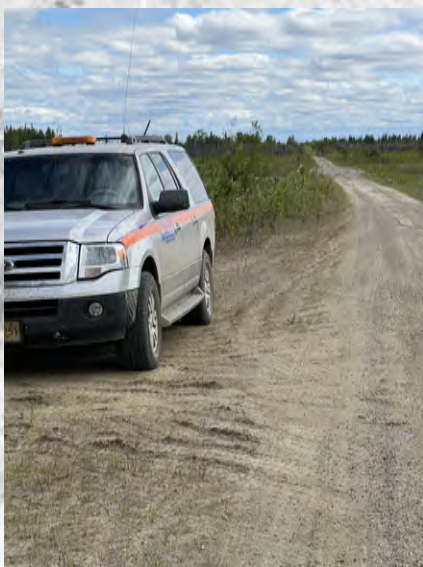
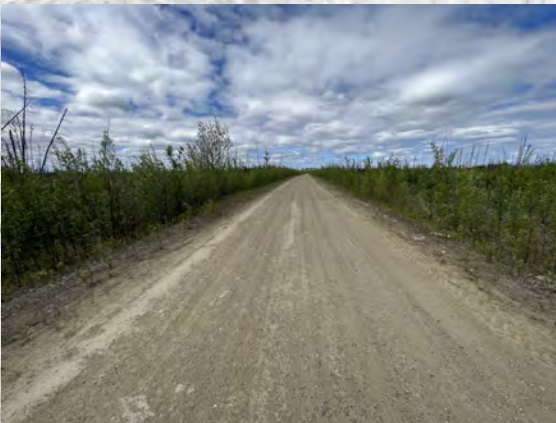
Figure 21

Turnout (RT side)
 Road wide: 18FT
 Brush clearing: Yes

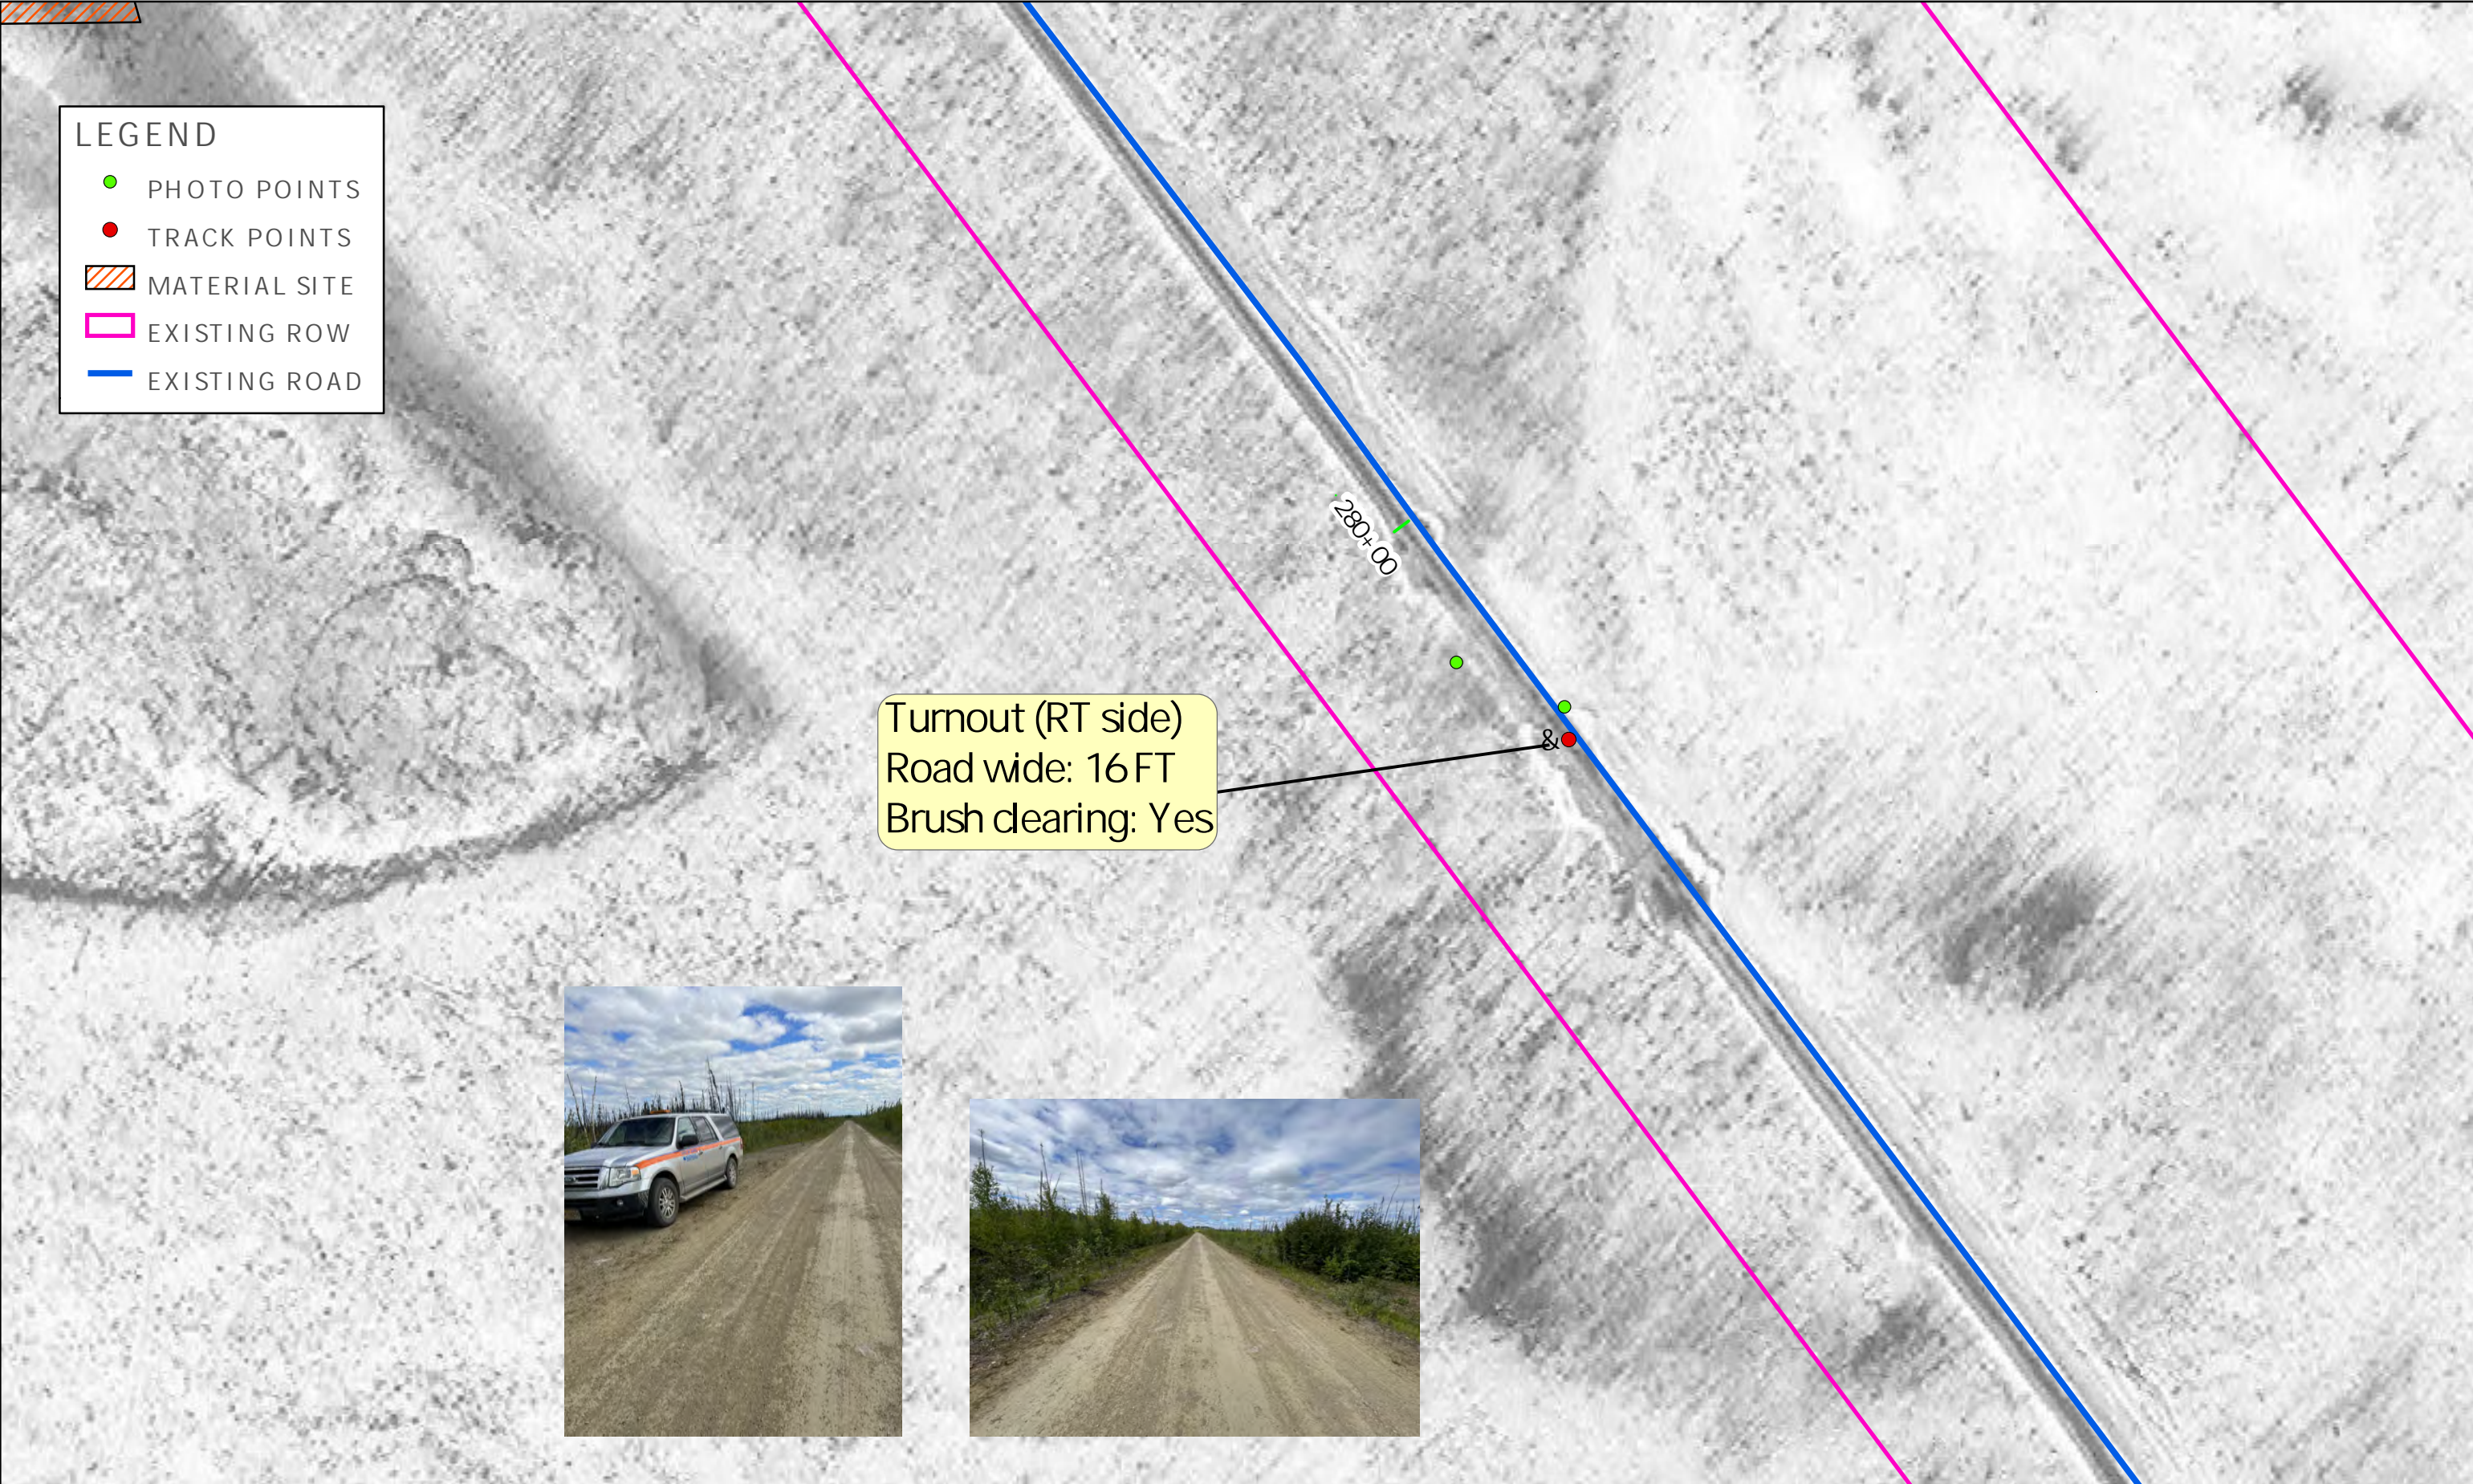
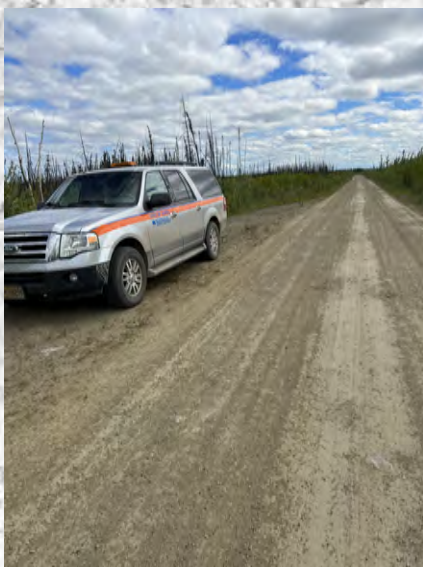
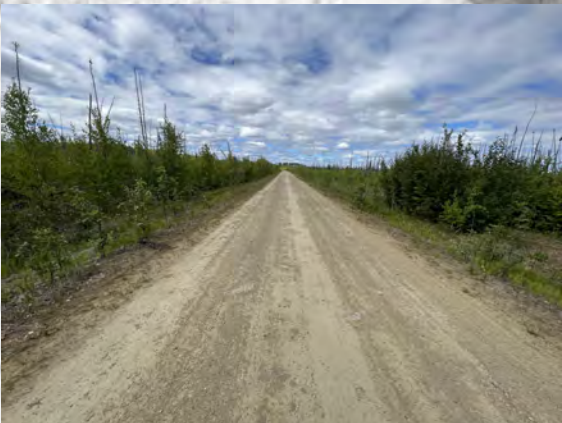
Figure 22

Turnout (RT side)
 Road wide: 16 FT
 Brush clearing: Yes

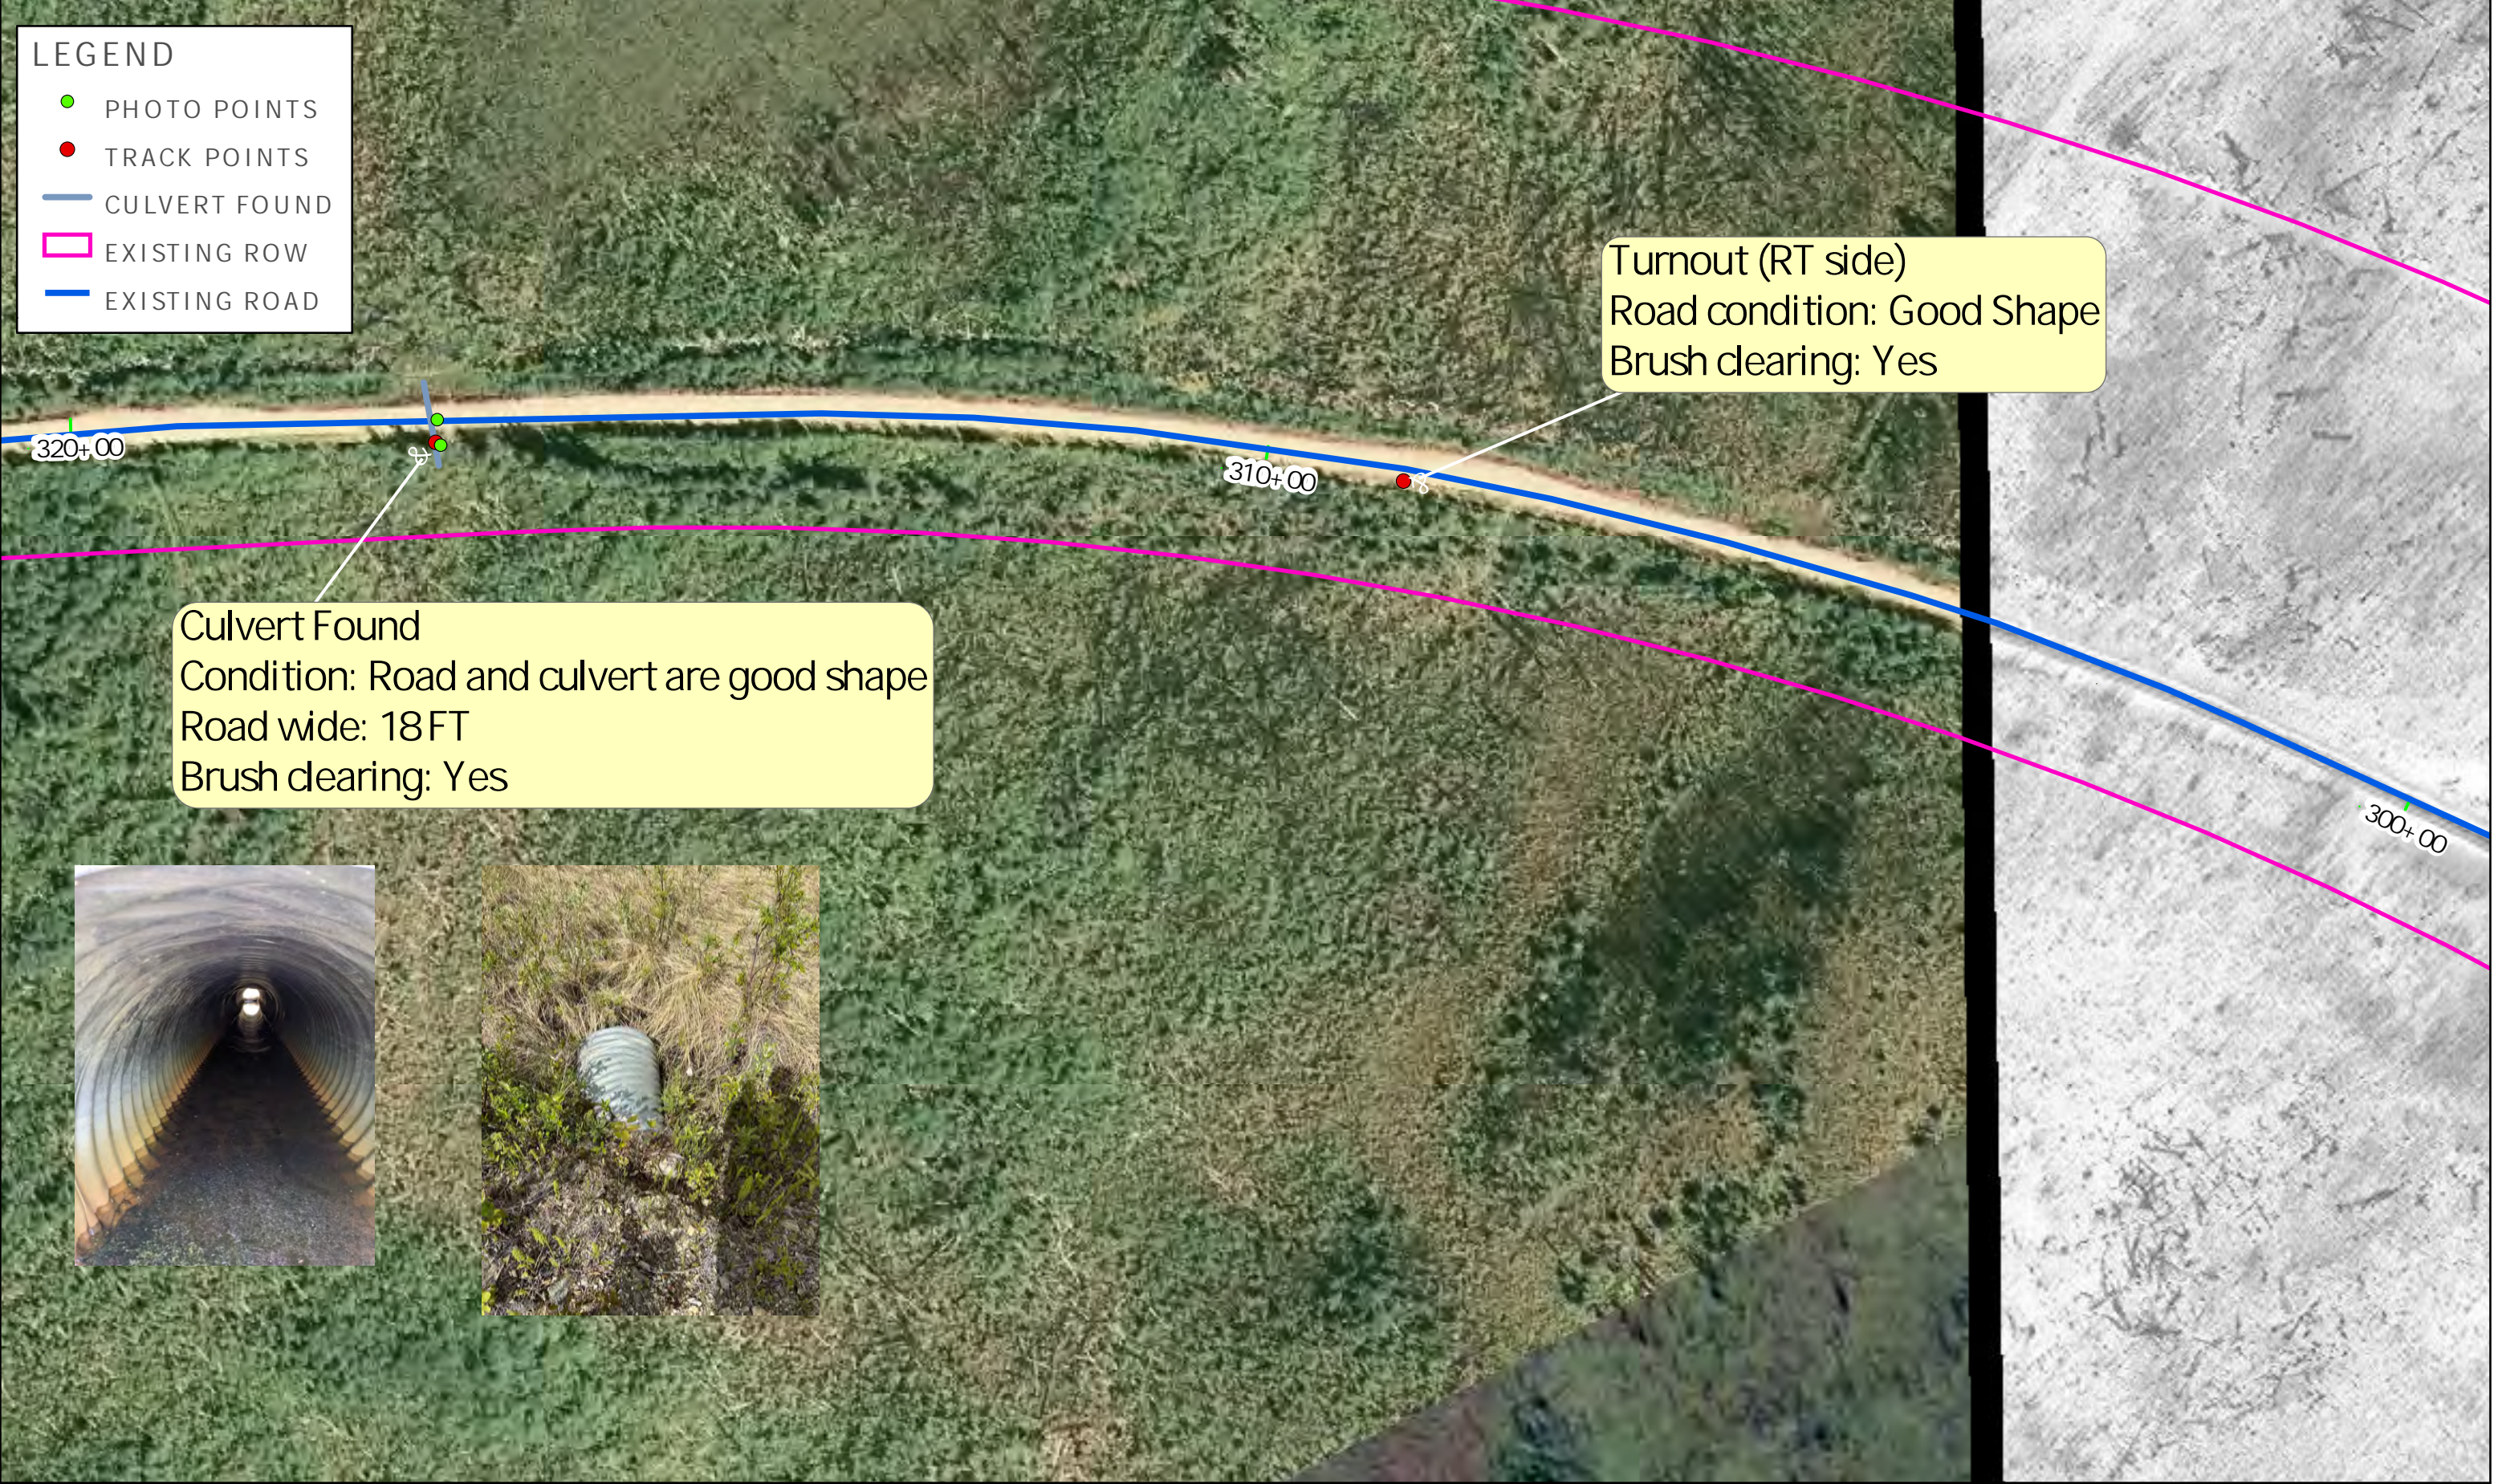
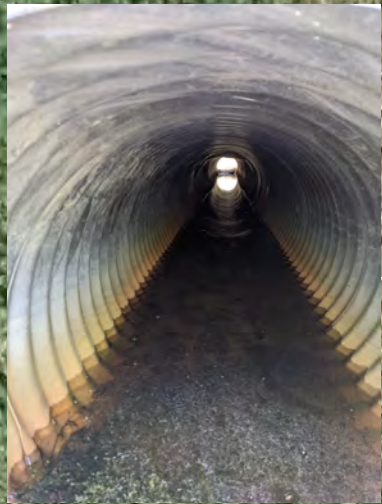
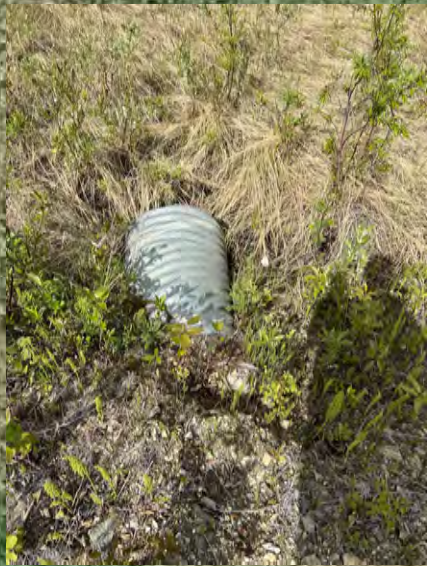
Figure 24

Culvert Found
 Condition: Road and culvert are good shape
 Road wide: 18FT
 Brush clearing: Yes

Turnout (RT side)
 Road condition: Good Shape
 Brush clearing: Yes

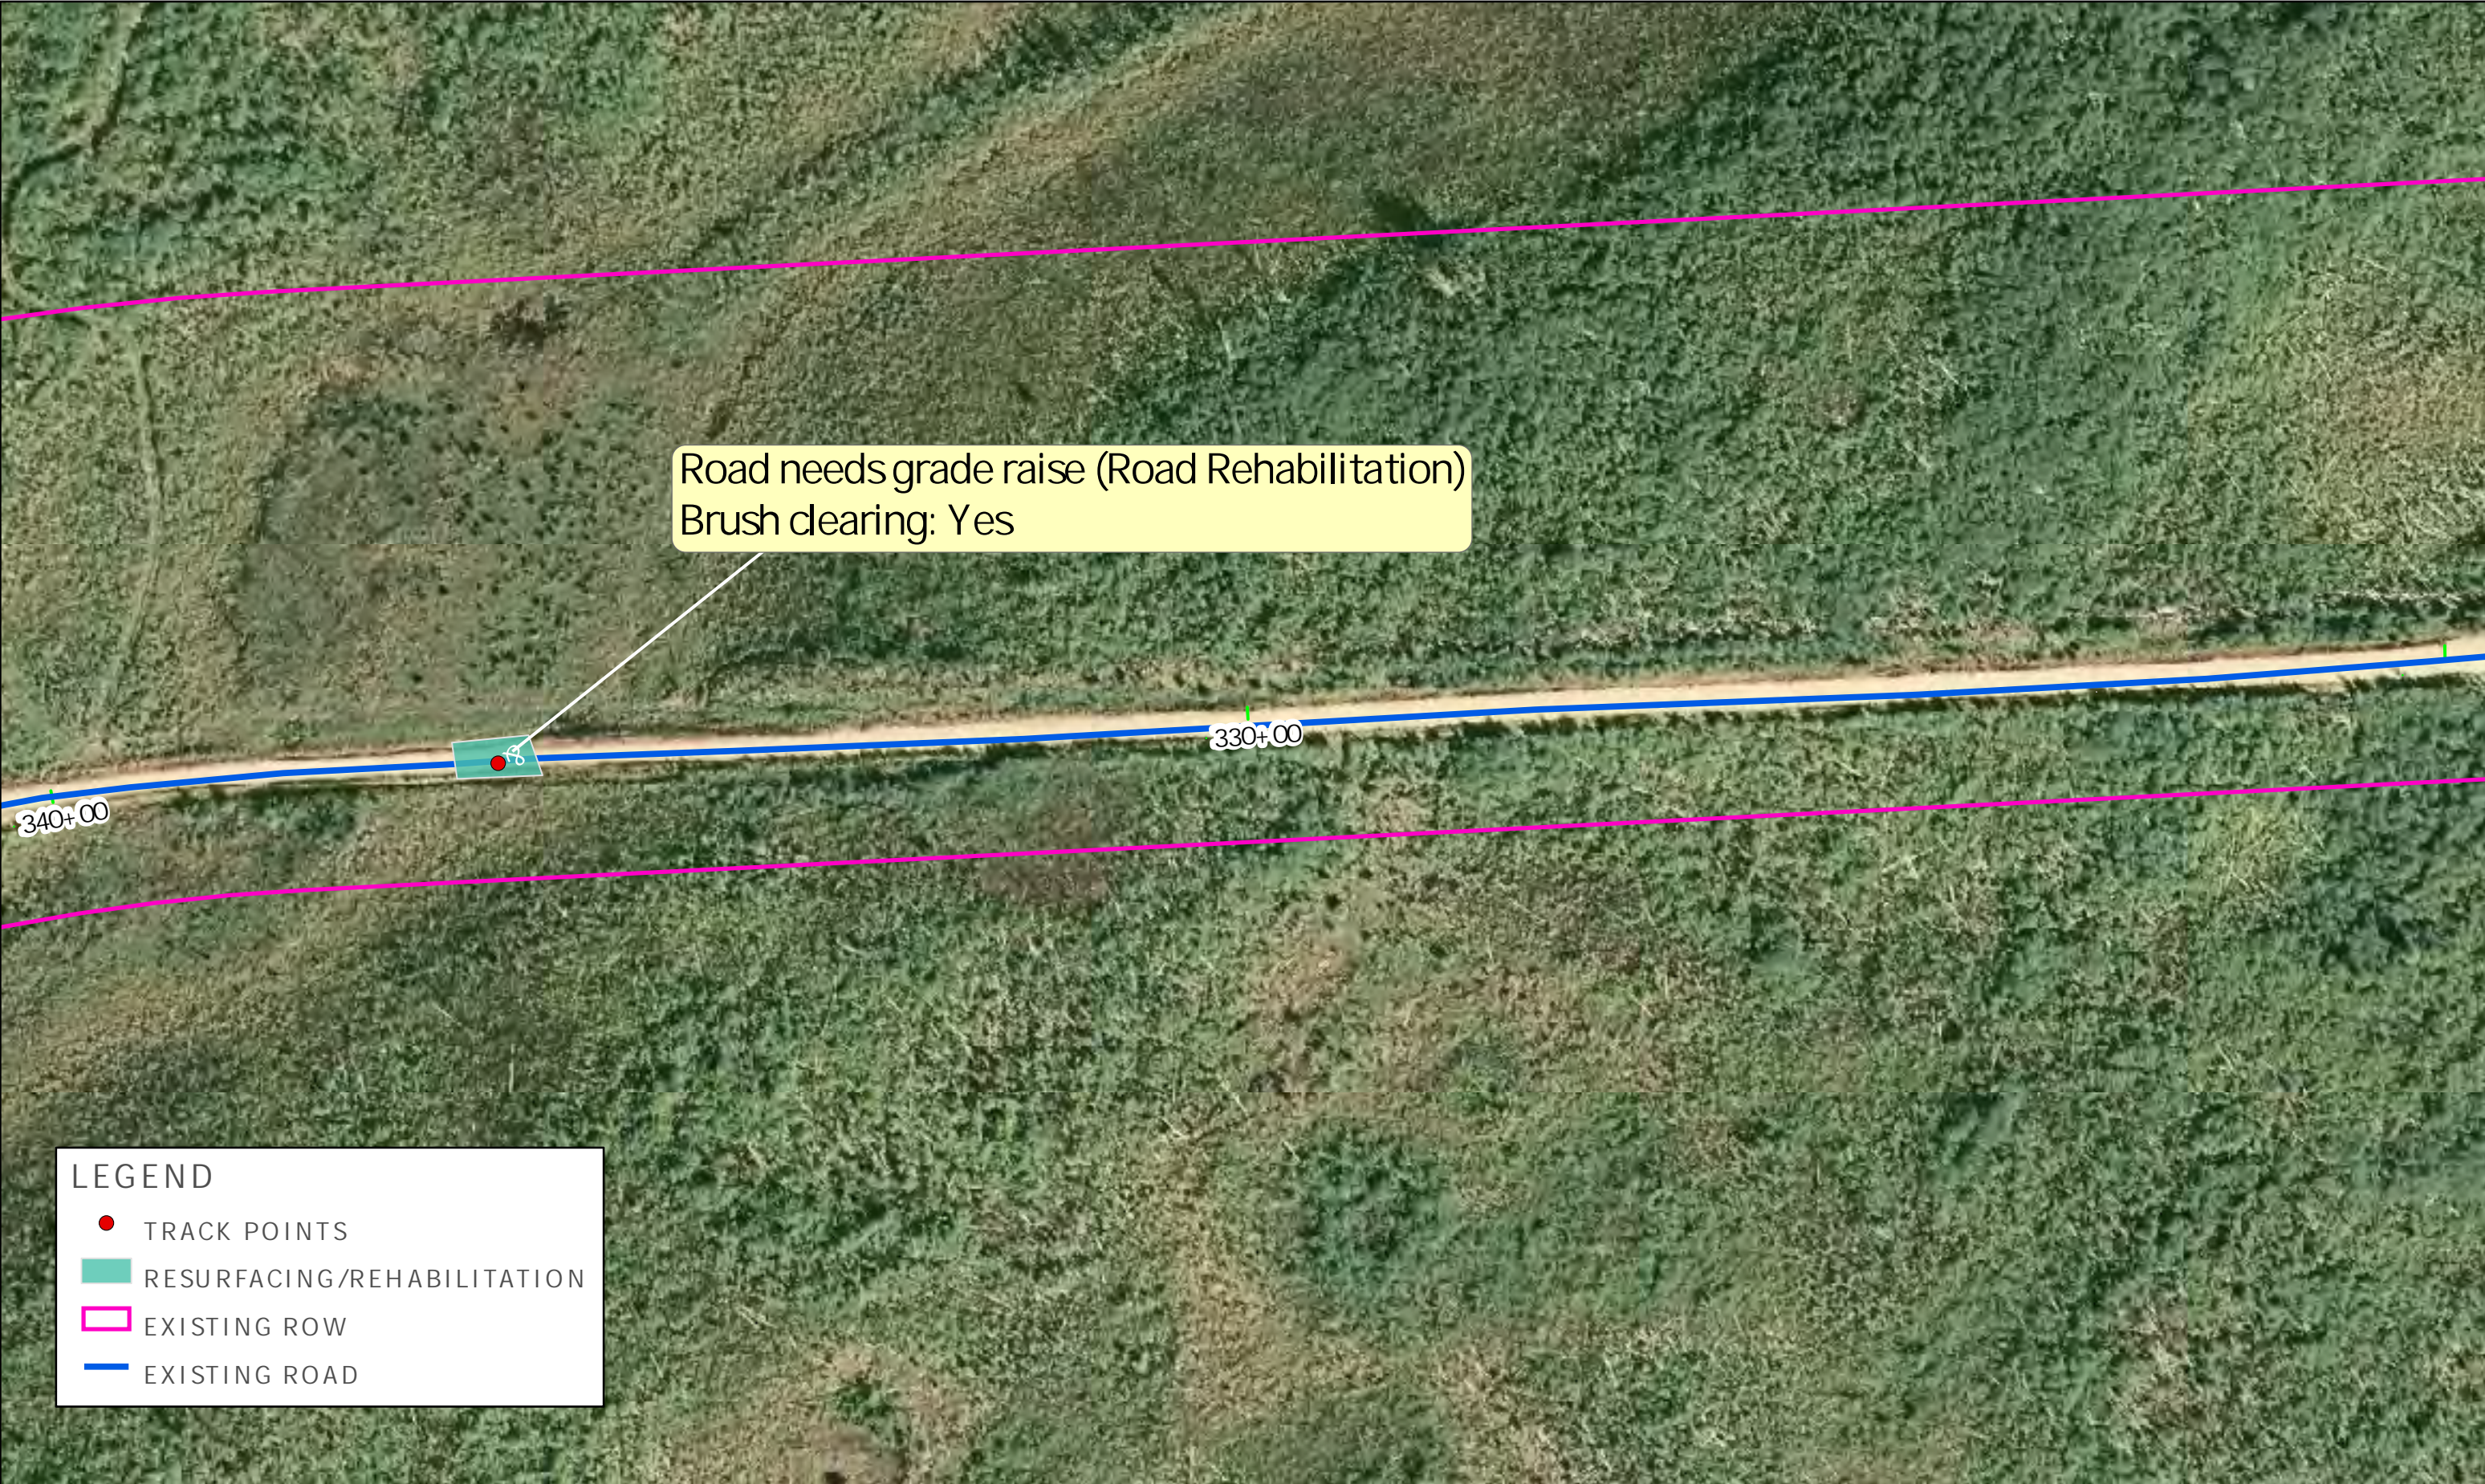
Figure 25

Road needs grade raise (Road Rehabilitation)
Brush clearing: Yes
