STATE OF ALASKA
Department of Transportation and Public Facilities
2301 Peger Road Fairbanks, AK 99709

Date: 7/18/2022

Nenana - Totchaket Road

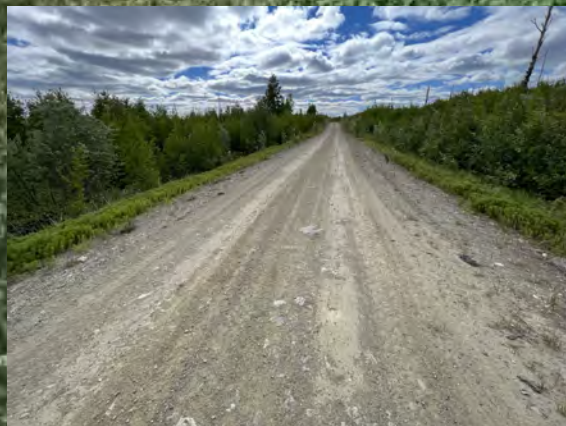
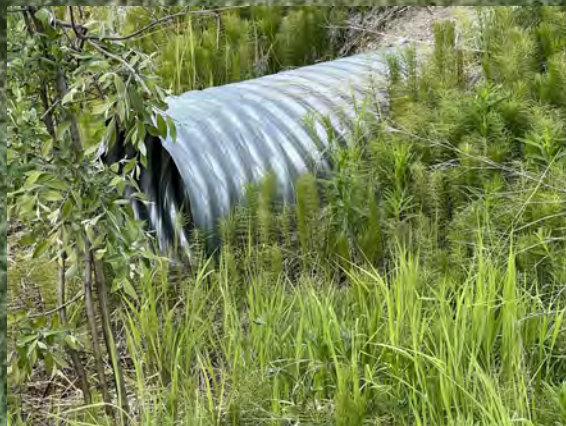
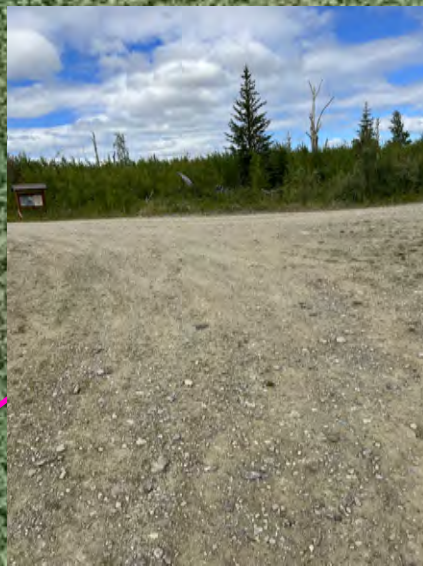
Figure 26

Turnout (RT side) to the farm area
Culvert Found
Condition: Culvert left is good
but right side crushed replace when budget allowed
Road is good condition
Road wide: 15FT
Brush clearing: Yes

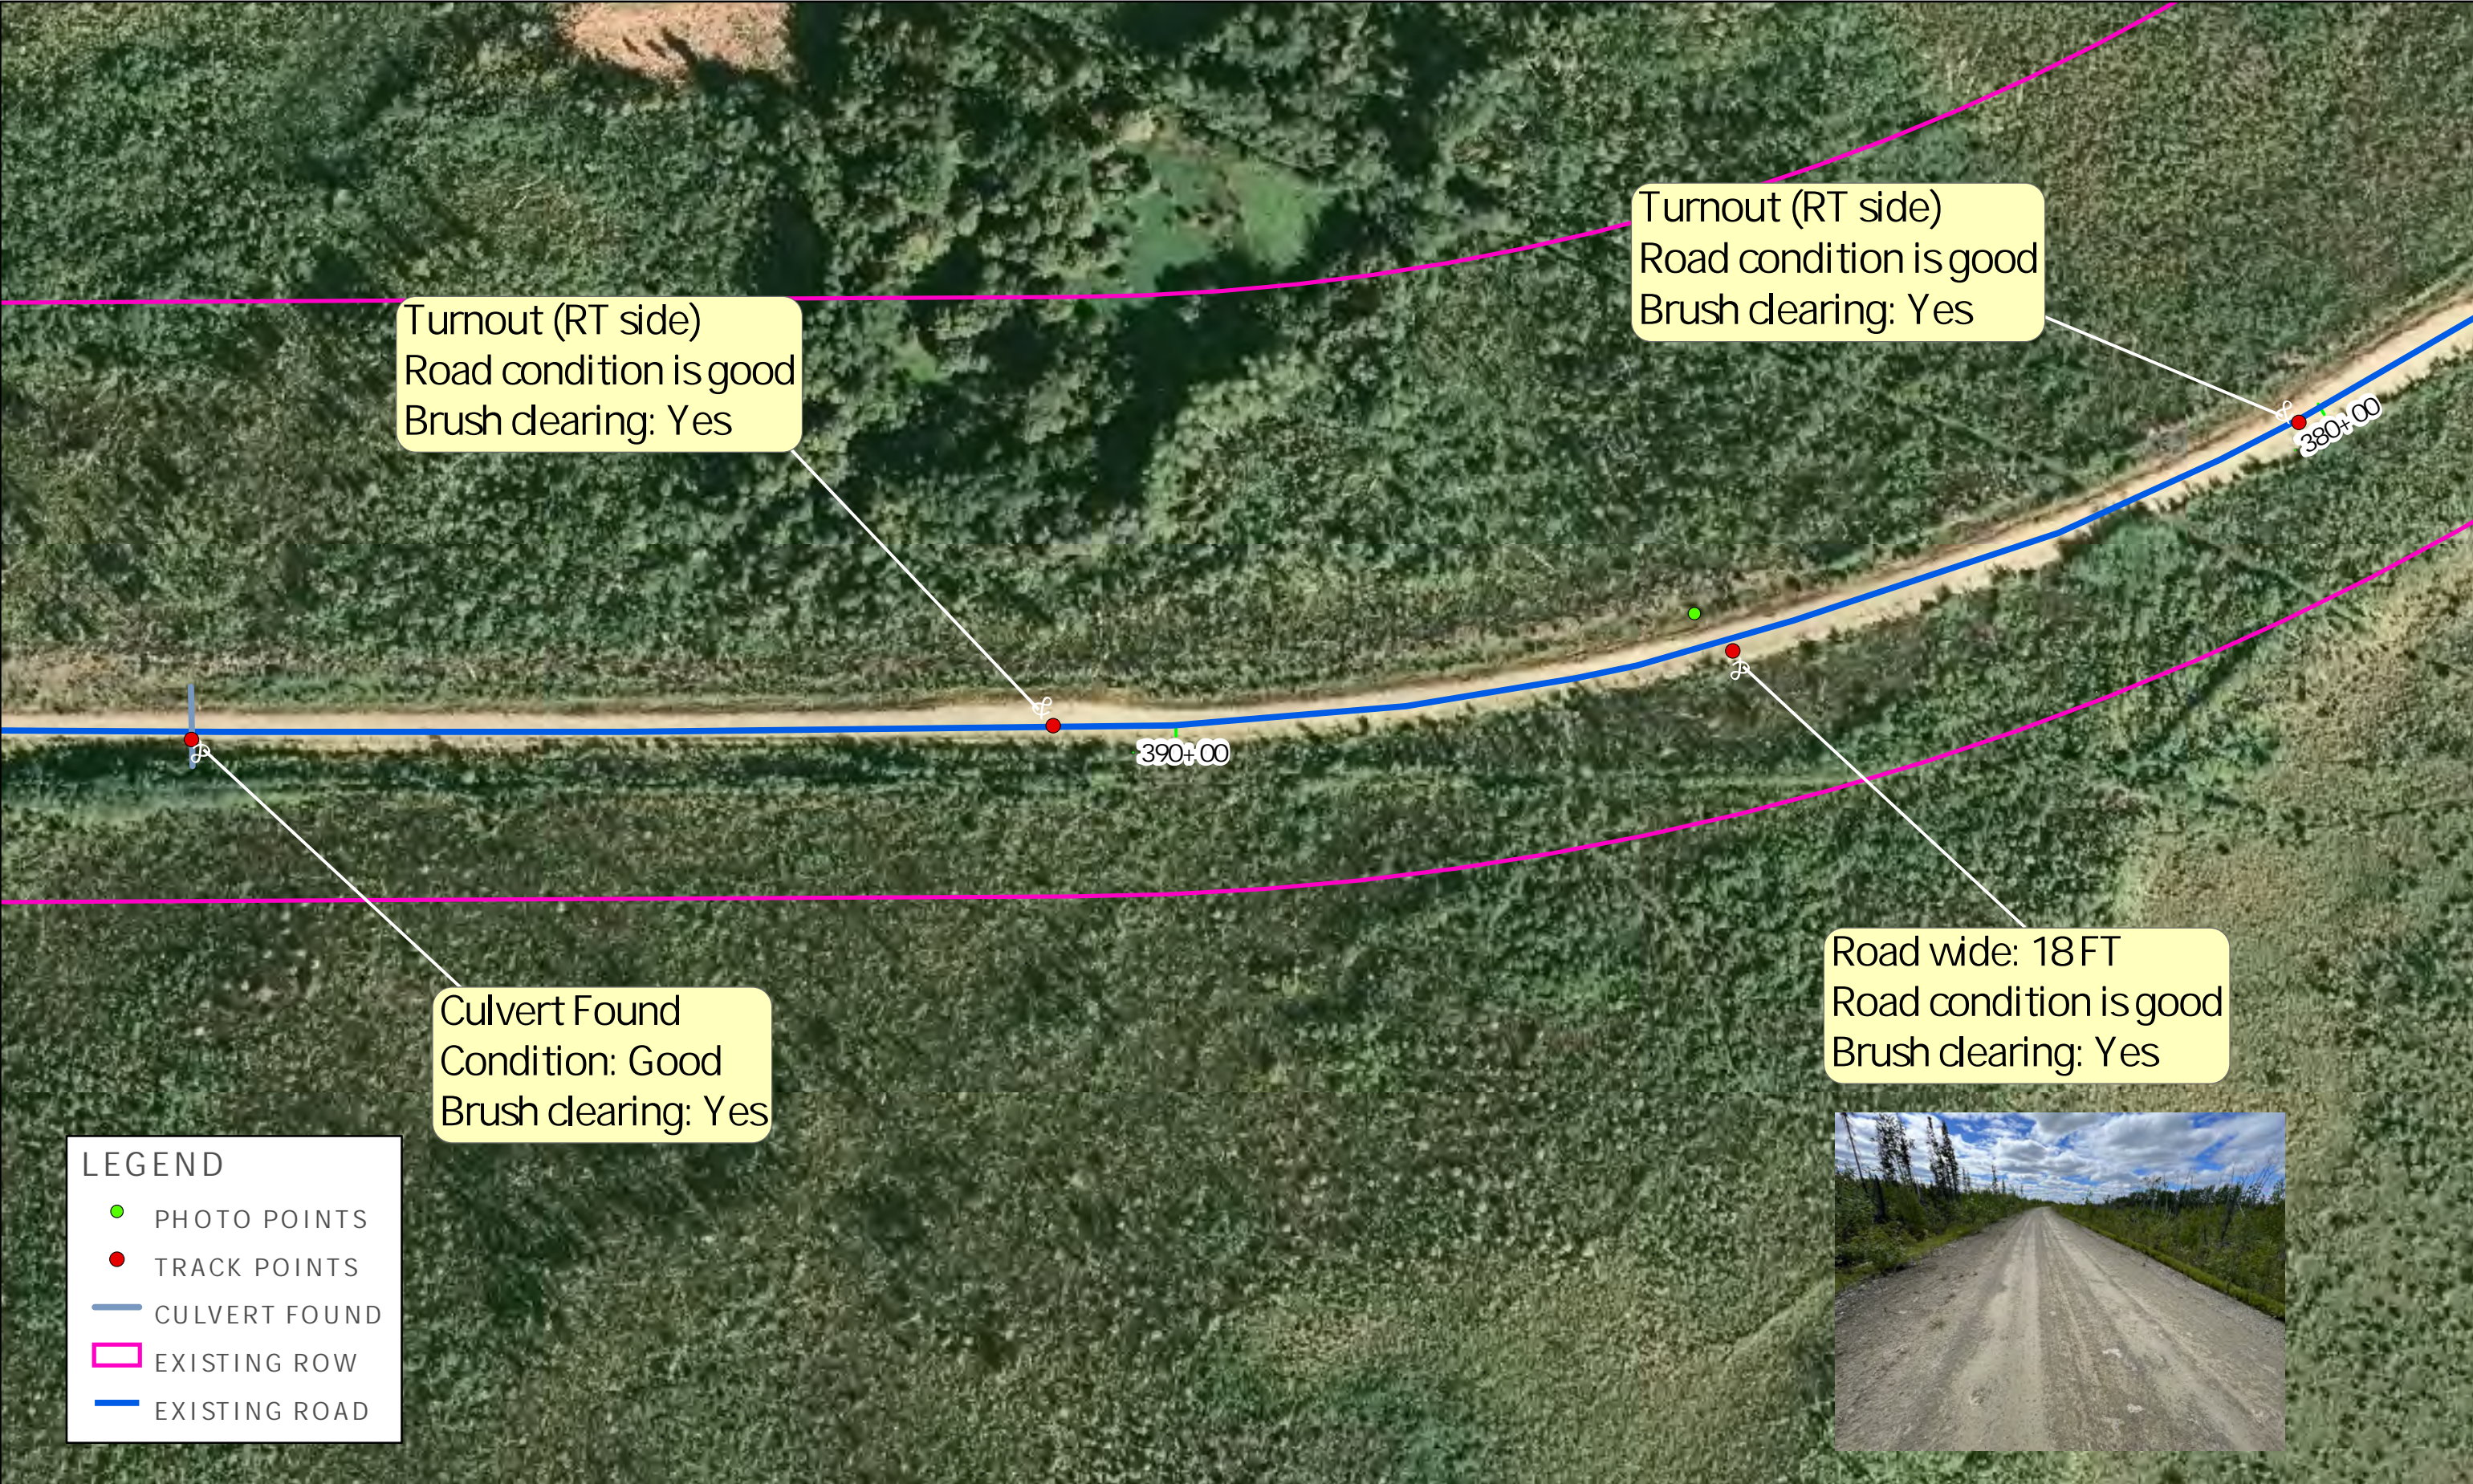
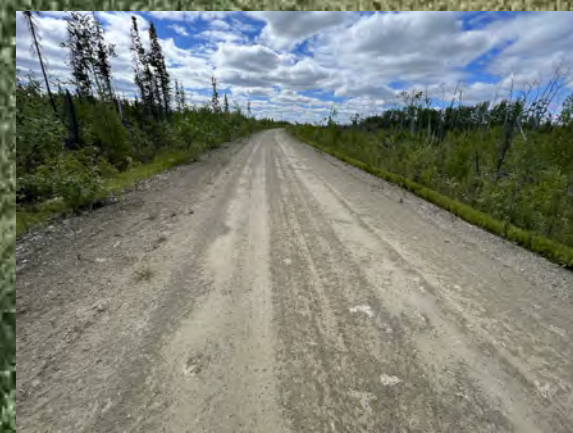
Turnout (RT side)
Road condition is good
Brush clearing: Yes

Culvert Found
Condition: Good
Brush clearing: Yes

Road wide: 18FT
Road condition is good
Brush clearing: Yes

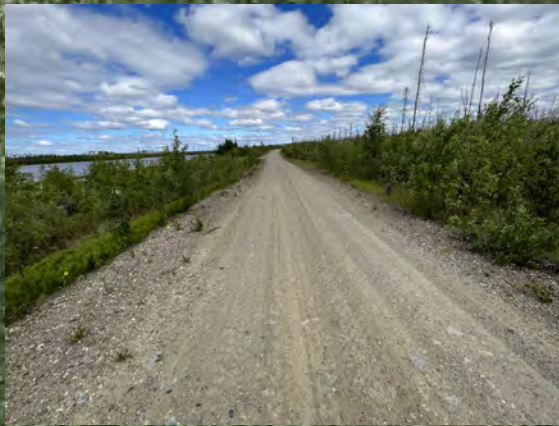
Road wide: 12.5FT
Road condition is good
Brush clearing: Yes

No Culvert Found

Culvert Found
Condtion: Good shape
Road wide: 18 FT
Road condition is good
Brush clearing: Yes

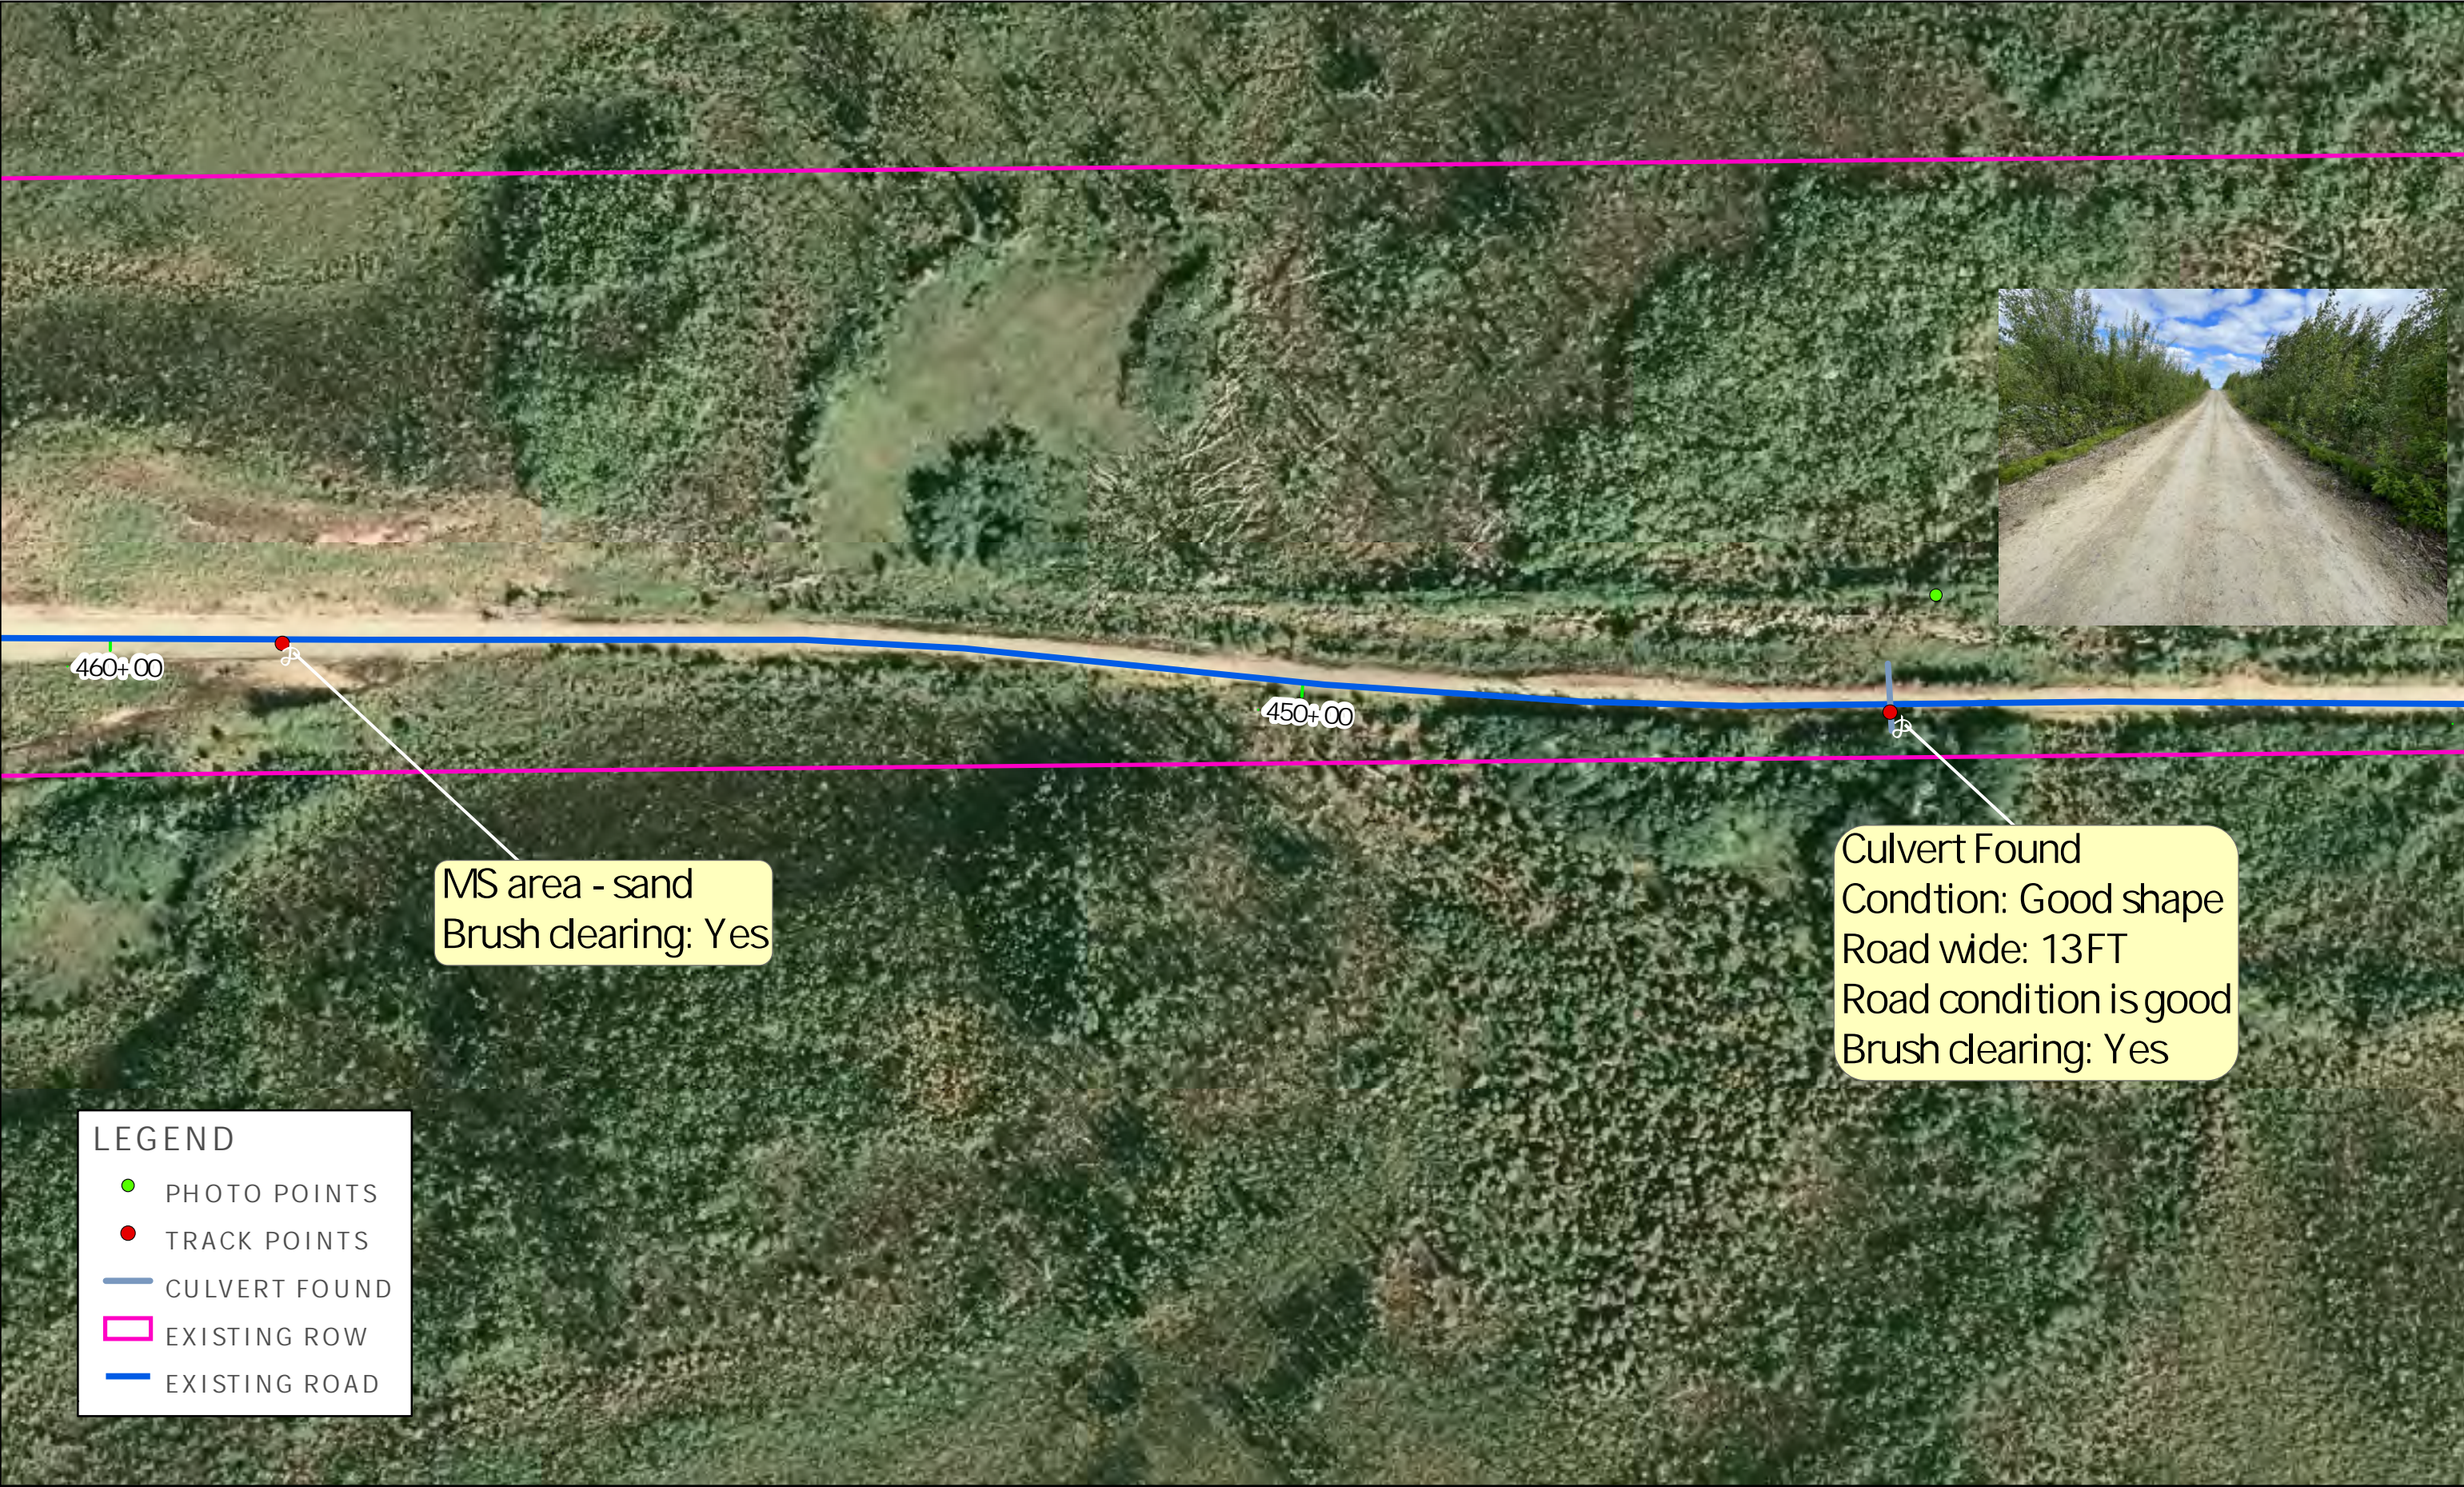
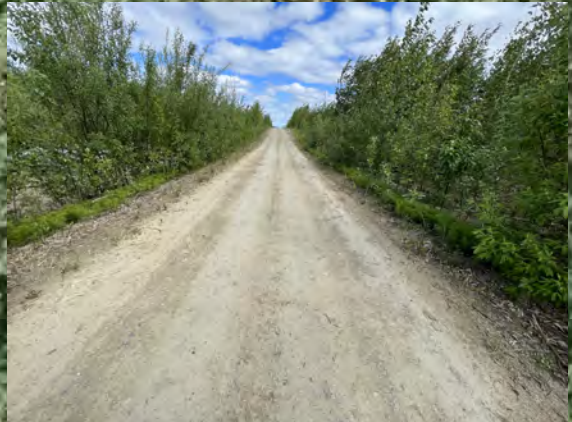
Figure 31

MS area - sand
Brush clearing: Yes

Culvert Found
Condition: Good shape
Road wide: 13FT
Road condition is good
Brush clearing: Yes

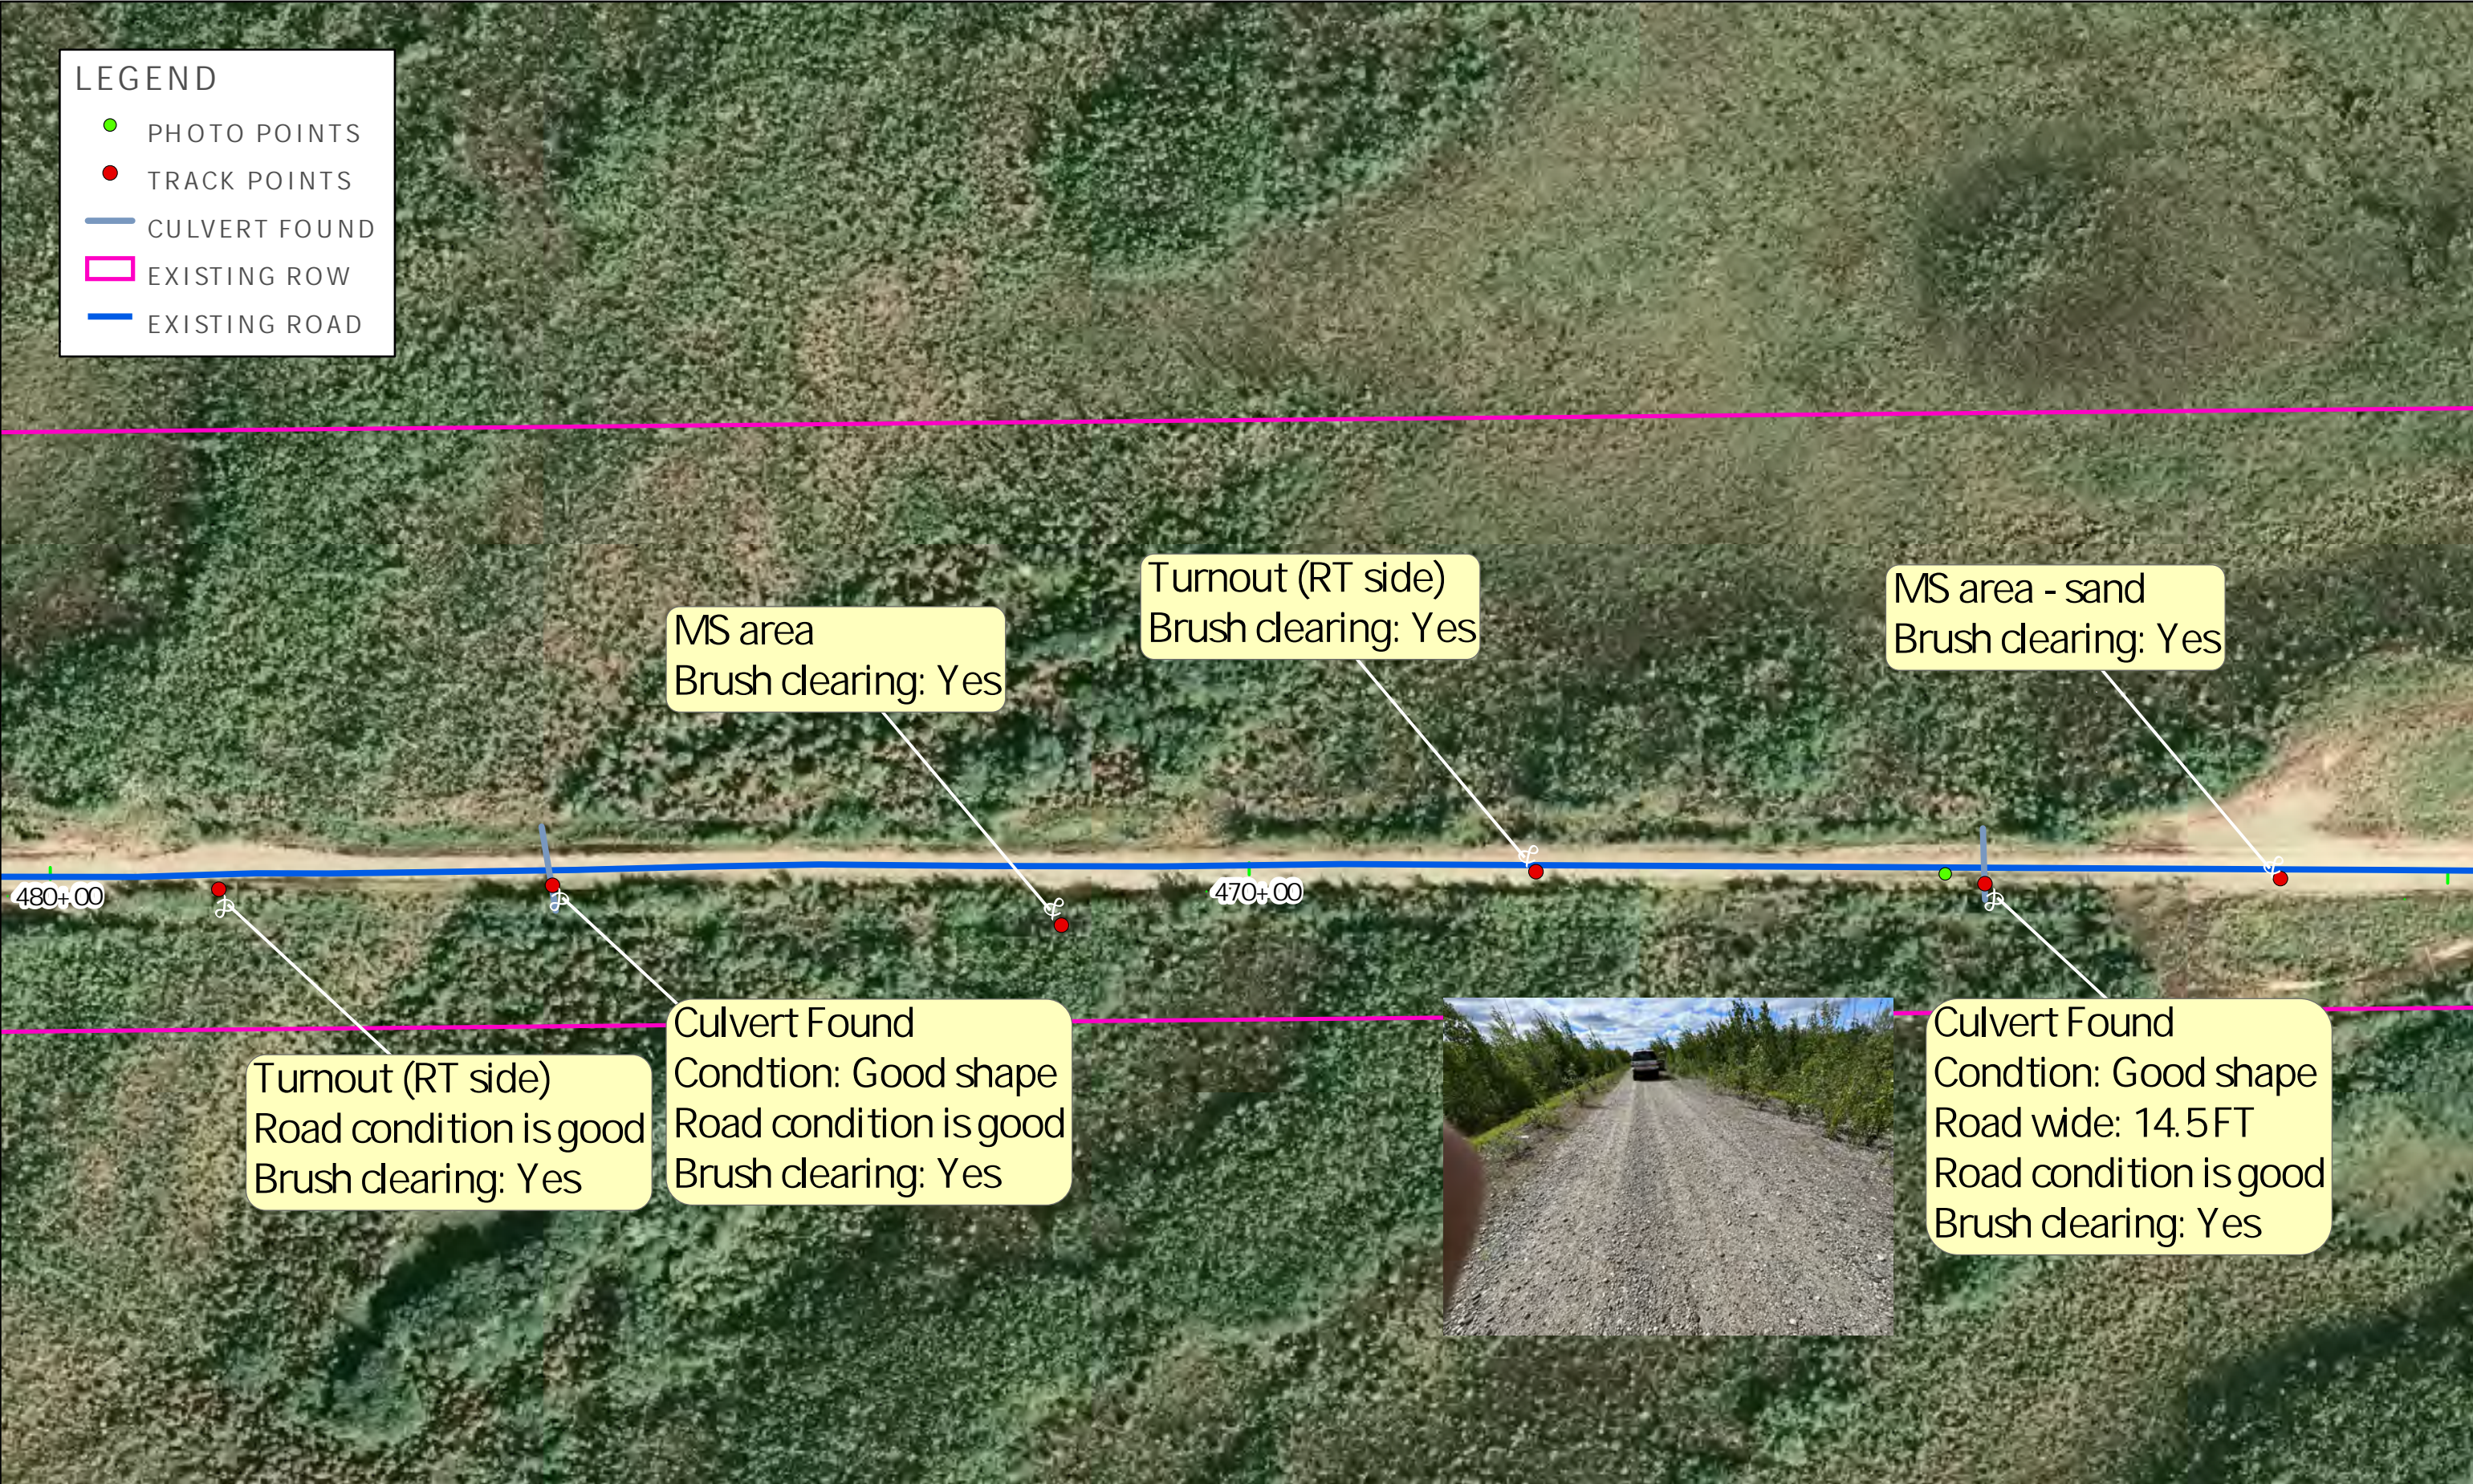
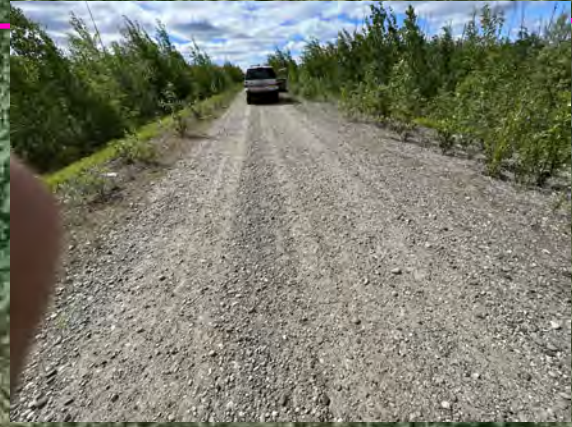
Figure 32

Turnout (RT side)
Road condition is good
Brush clearing: Yes

Culvert Found
Condition: Good shape
Road condition is good
Brush clearing: Yes

Turnout (RT side)
Brush clearing: Yes

MS area
Brush clearing: Yes

MS area - sand
Brush clearing: Yes

Culvert Found
Condition: Good shape
Road wide: 14.5FT
Road condition is good
Brush clearing: Yes

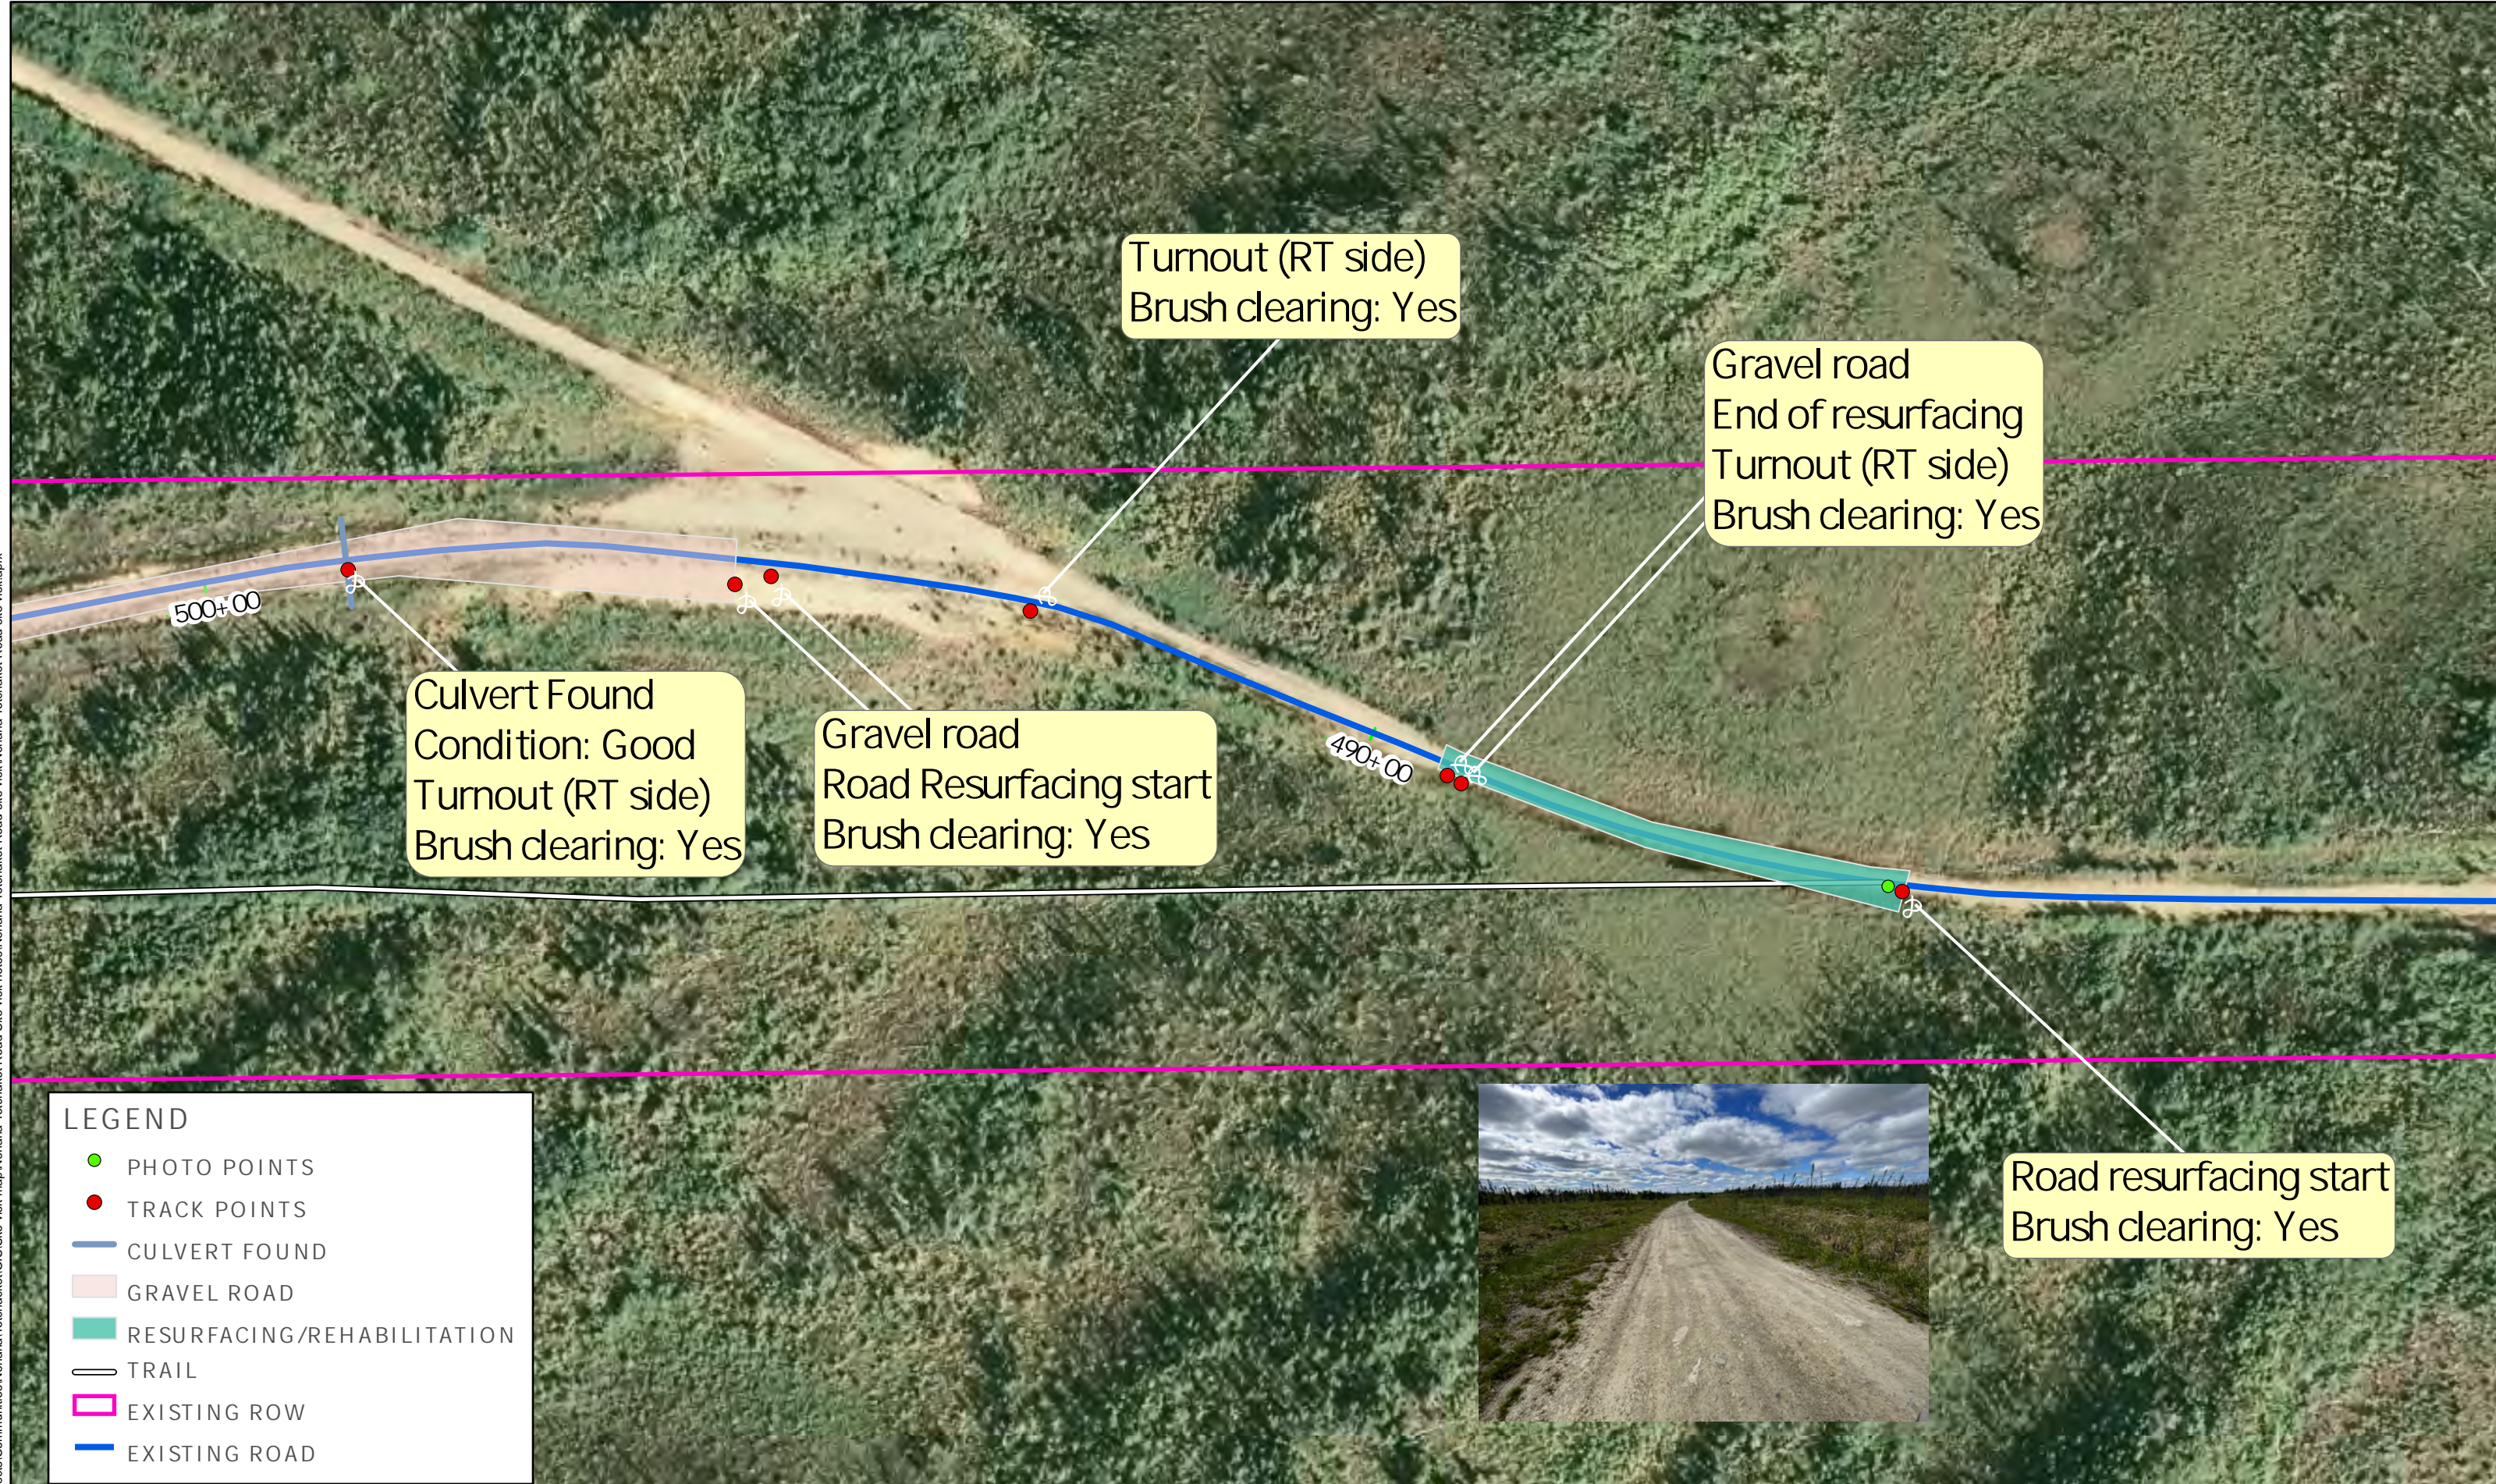
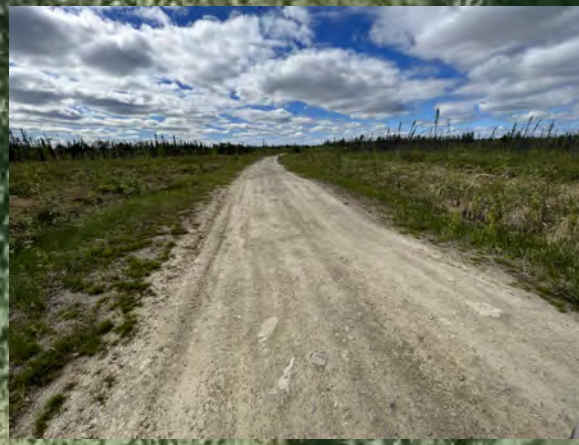
Road resurfacing start
Brush clearing: Yes

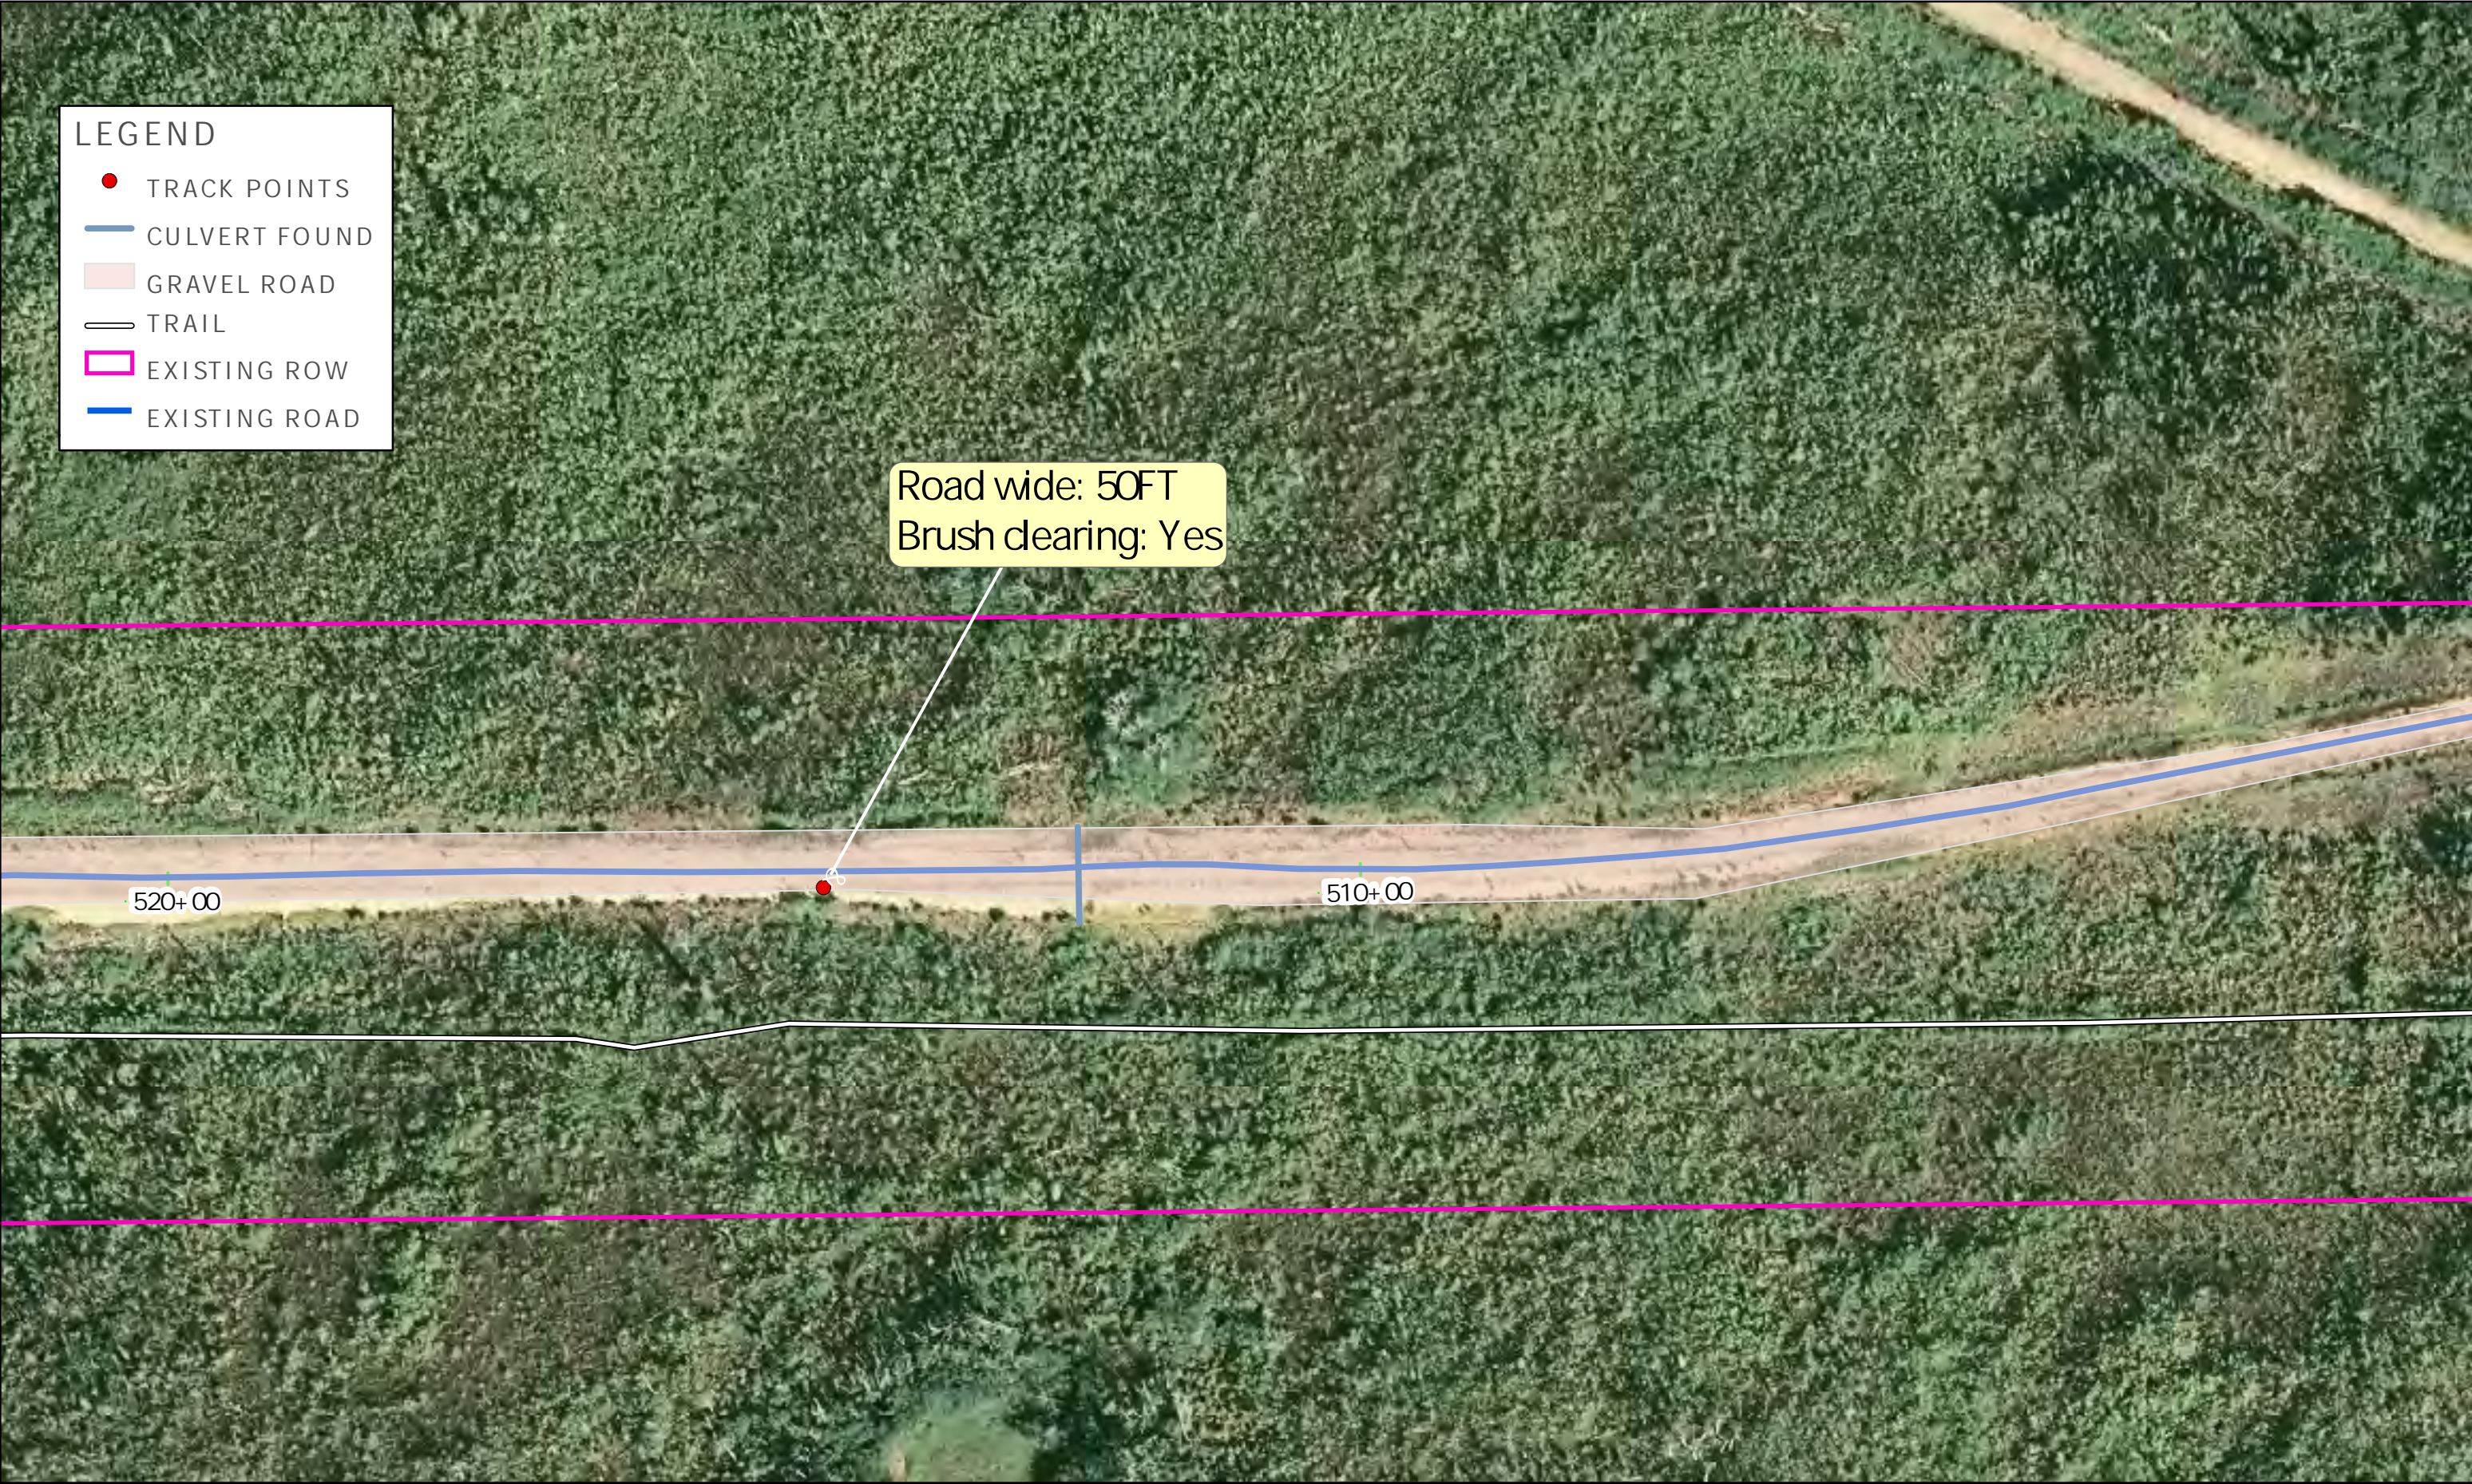
Date: 7/18/2022	Figure 34
Nenana - Totchaket Road

Road wide: 50FT
Brush clearing: Yes
