STATE OF ALASKA
Department of Transportation and Public Facilities
2301 Peger Road Fairbanks, AK 99709

Date: 7/18/2022

Nenana - Totchaket Road

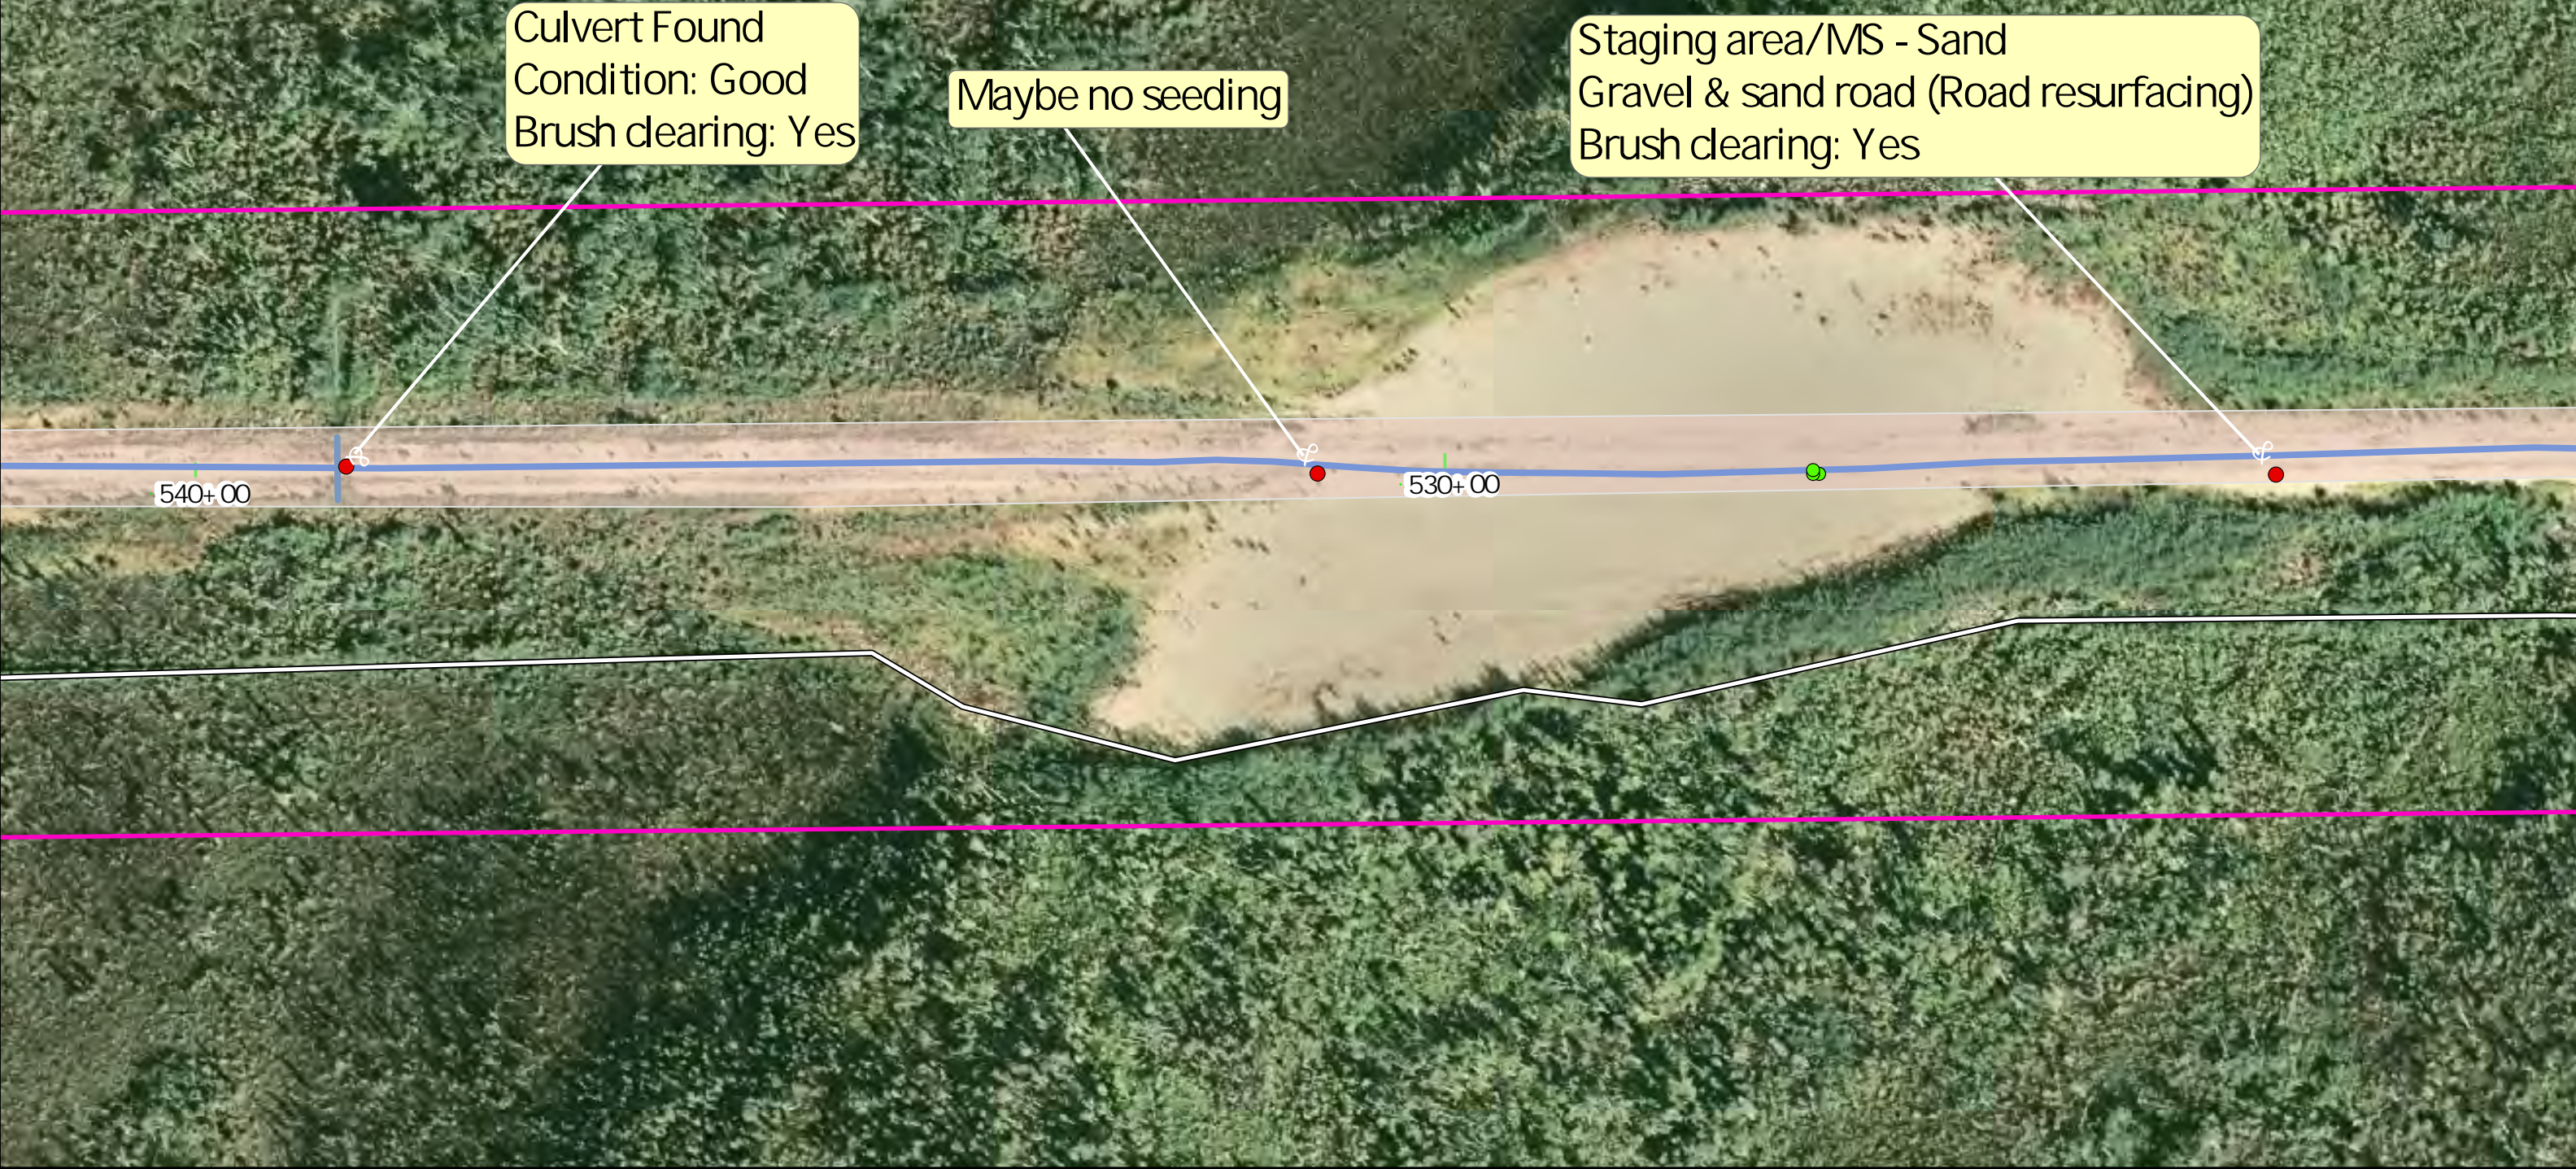
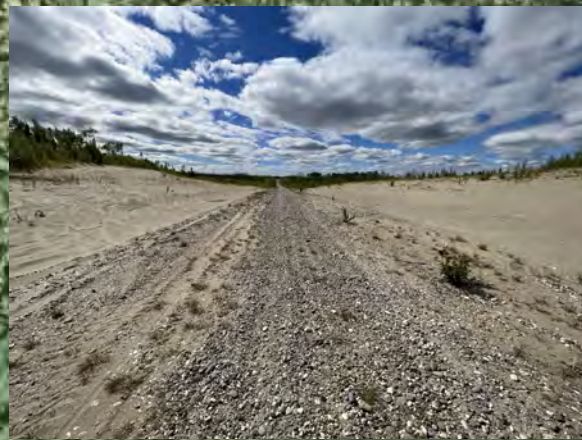
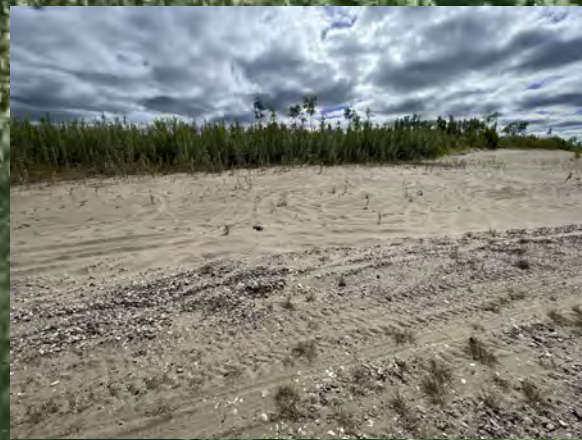
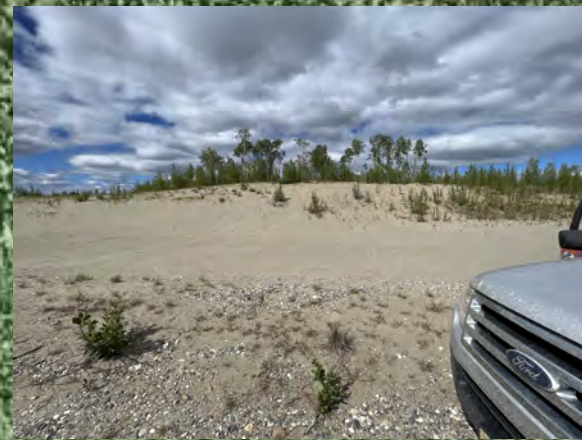
Figure 35

Culvert Found
Condition: Good
Brush clearing: Yes

Maybe no seeding

Staging area/MS - Sand
Gravel & sand road (Road resurfacing)
Brush clearing: Yes

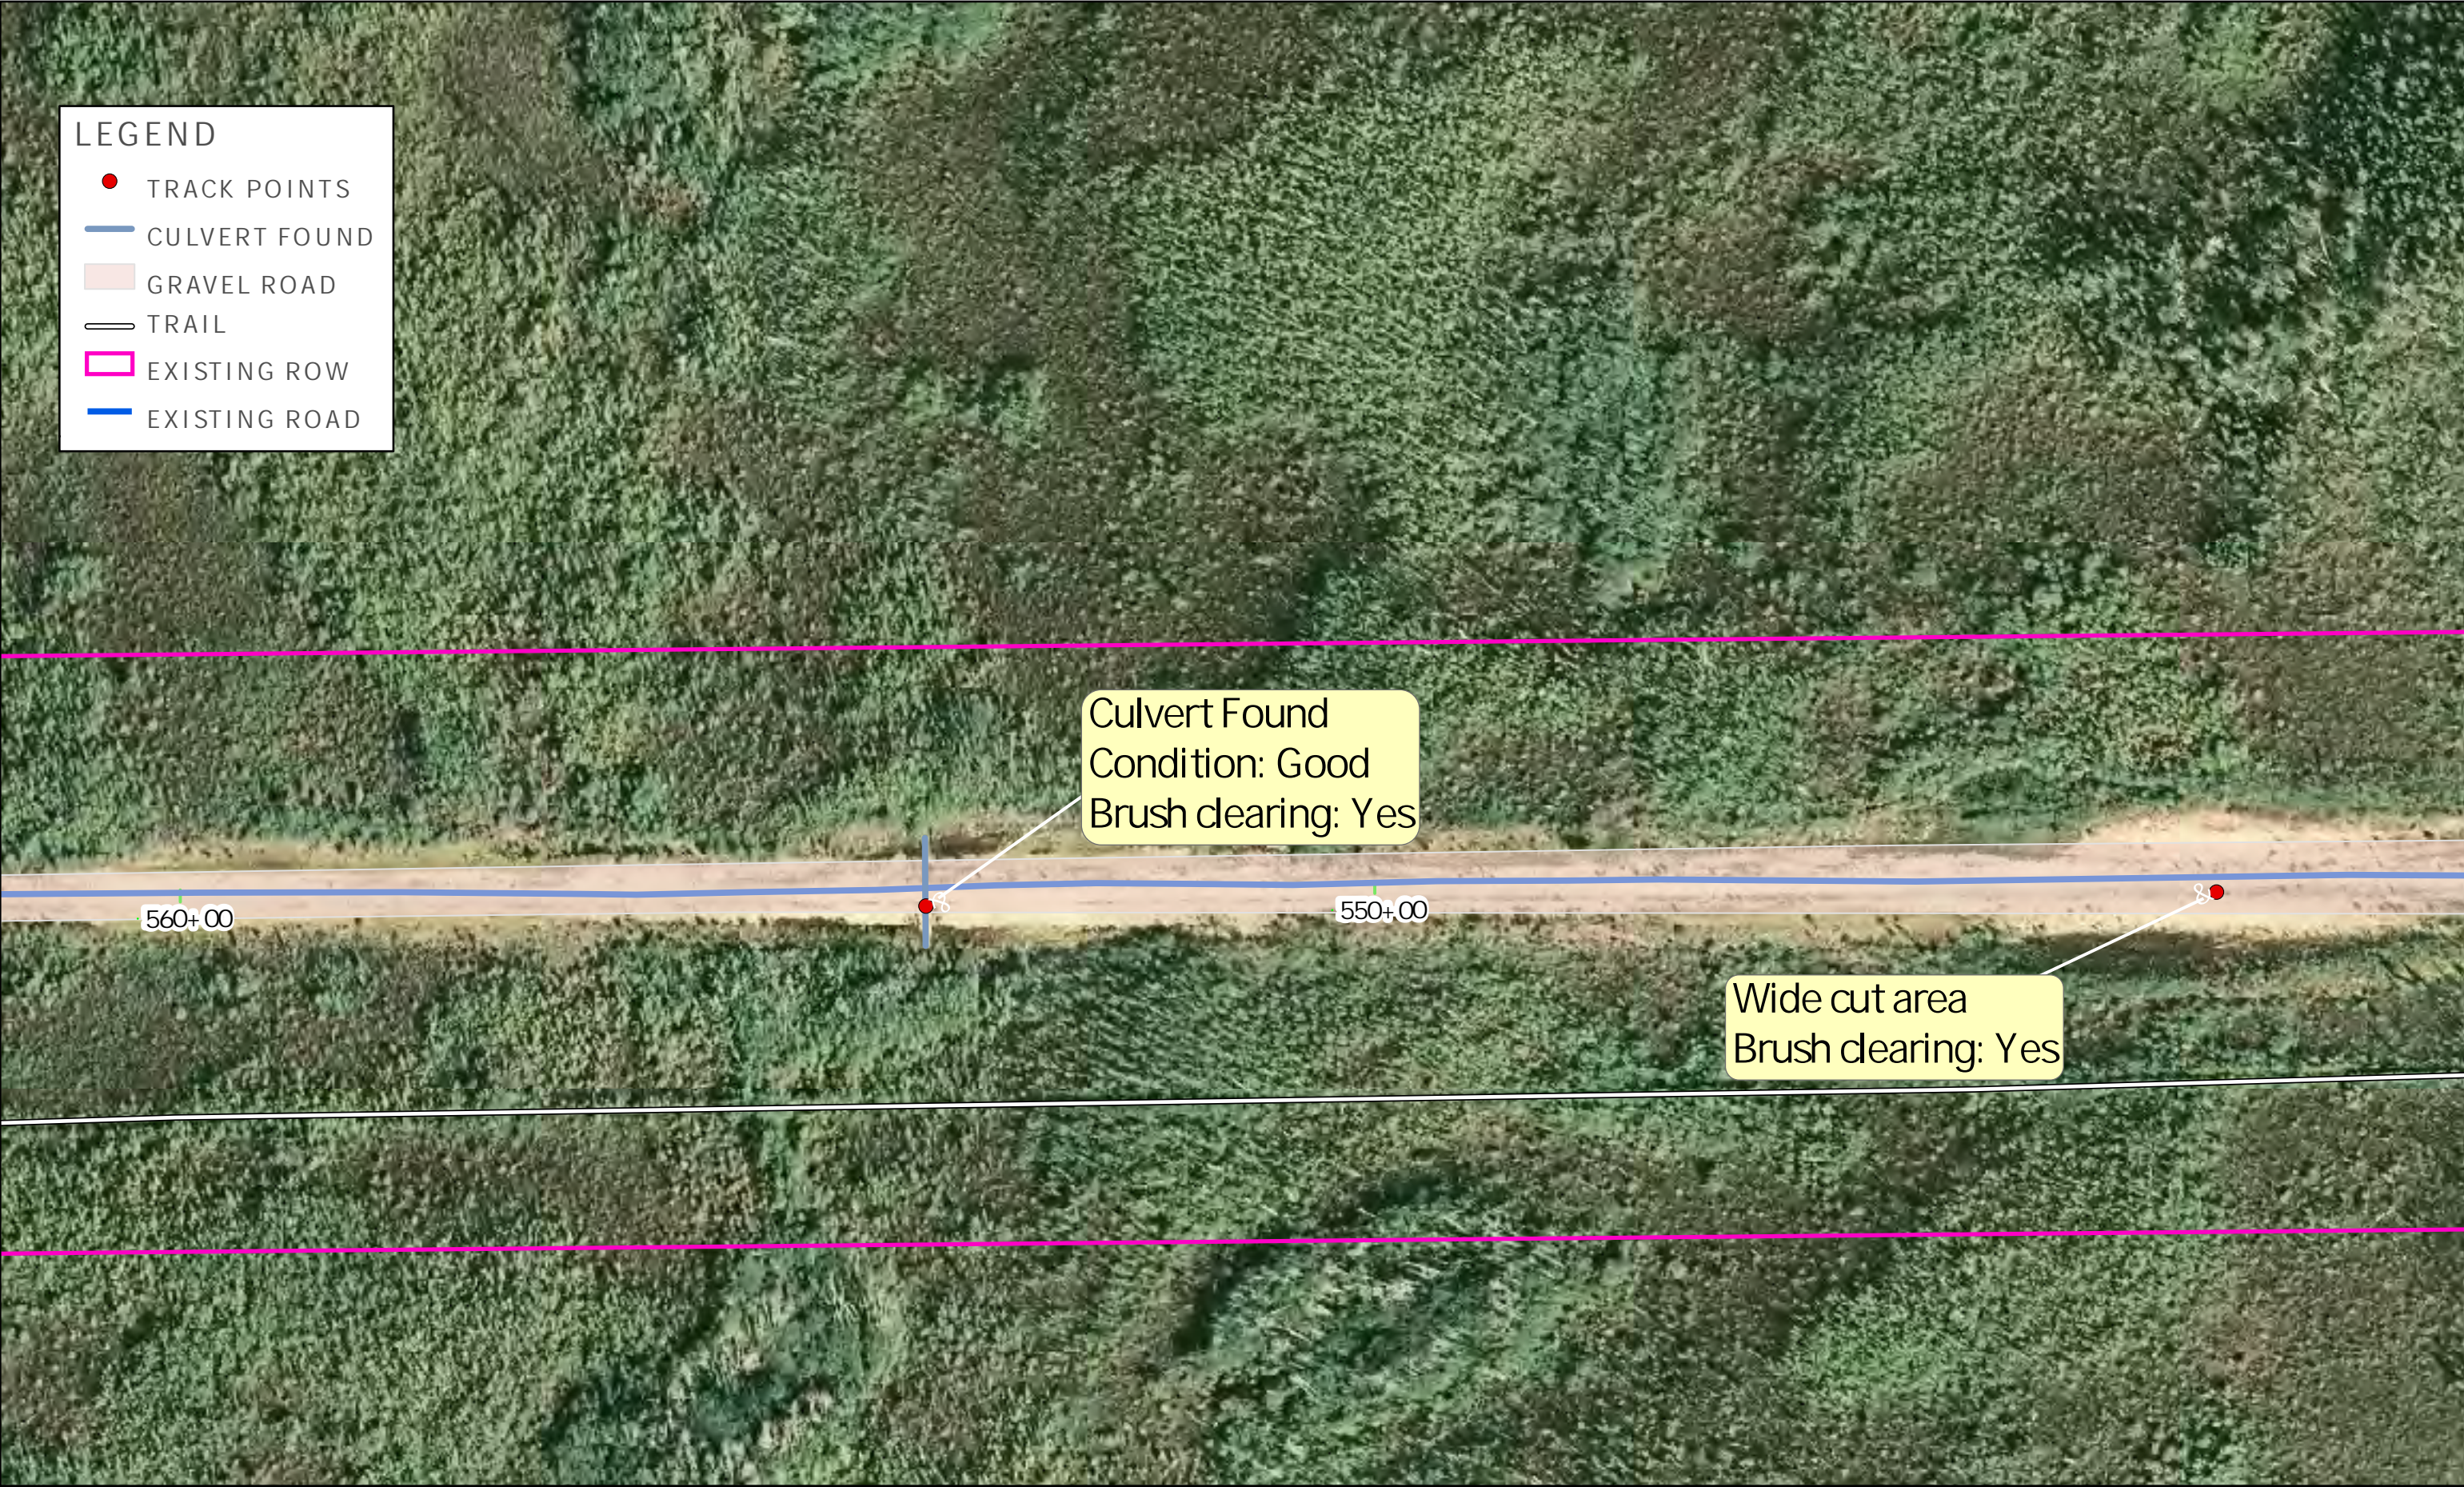
Figure 36

Culvert Found
 Condition: Good
 Brush clearing: Yes

Wide cut area
 Brush clearing: Yes

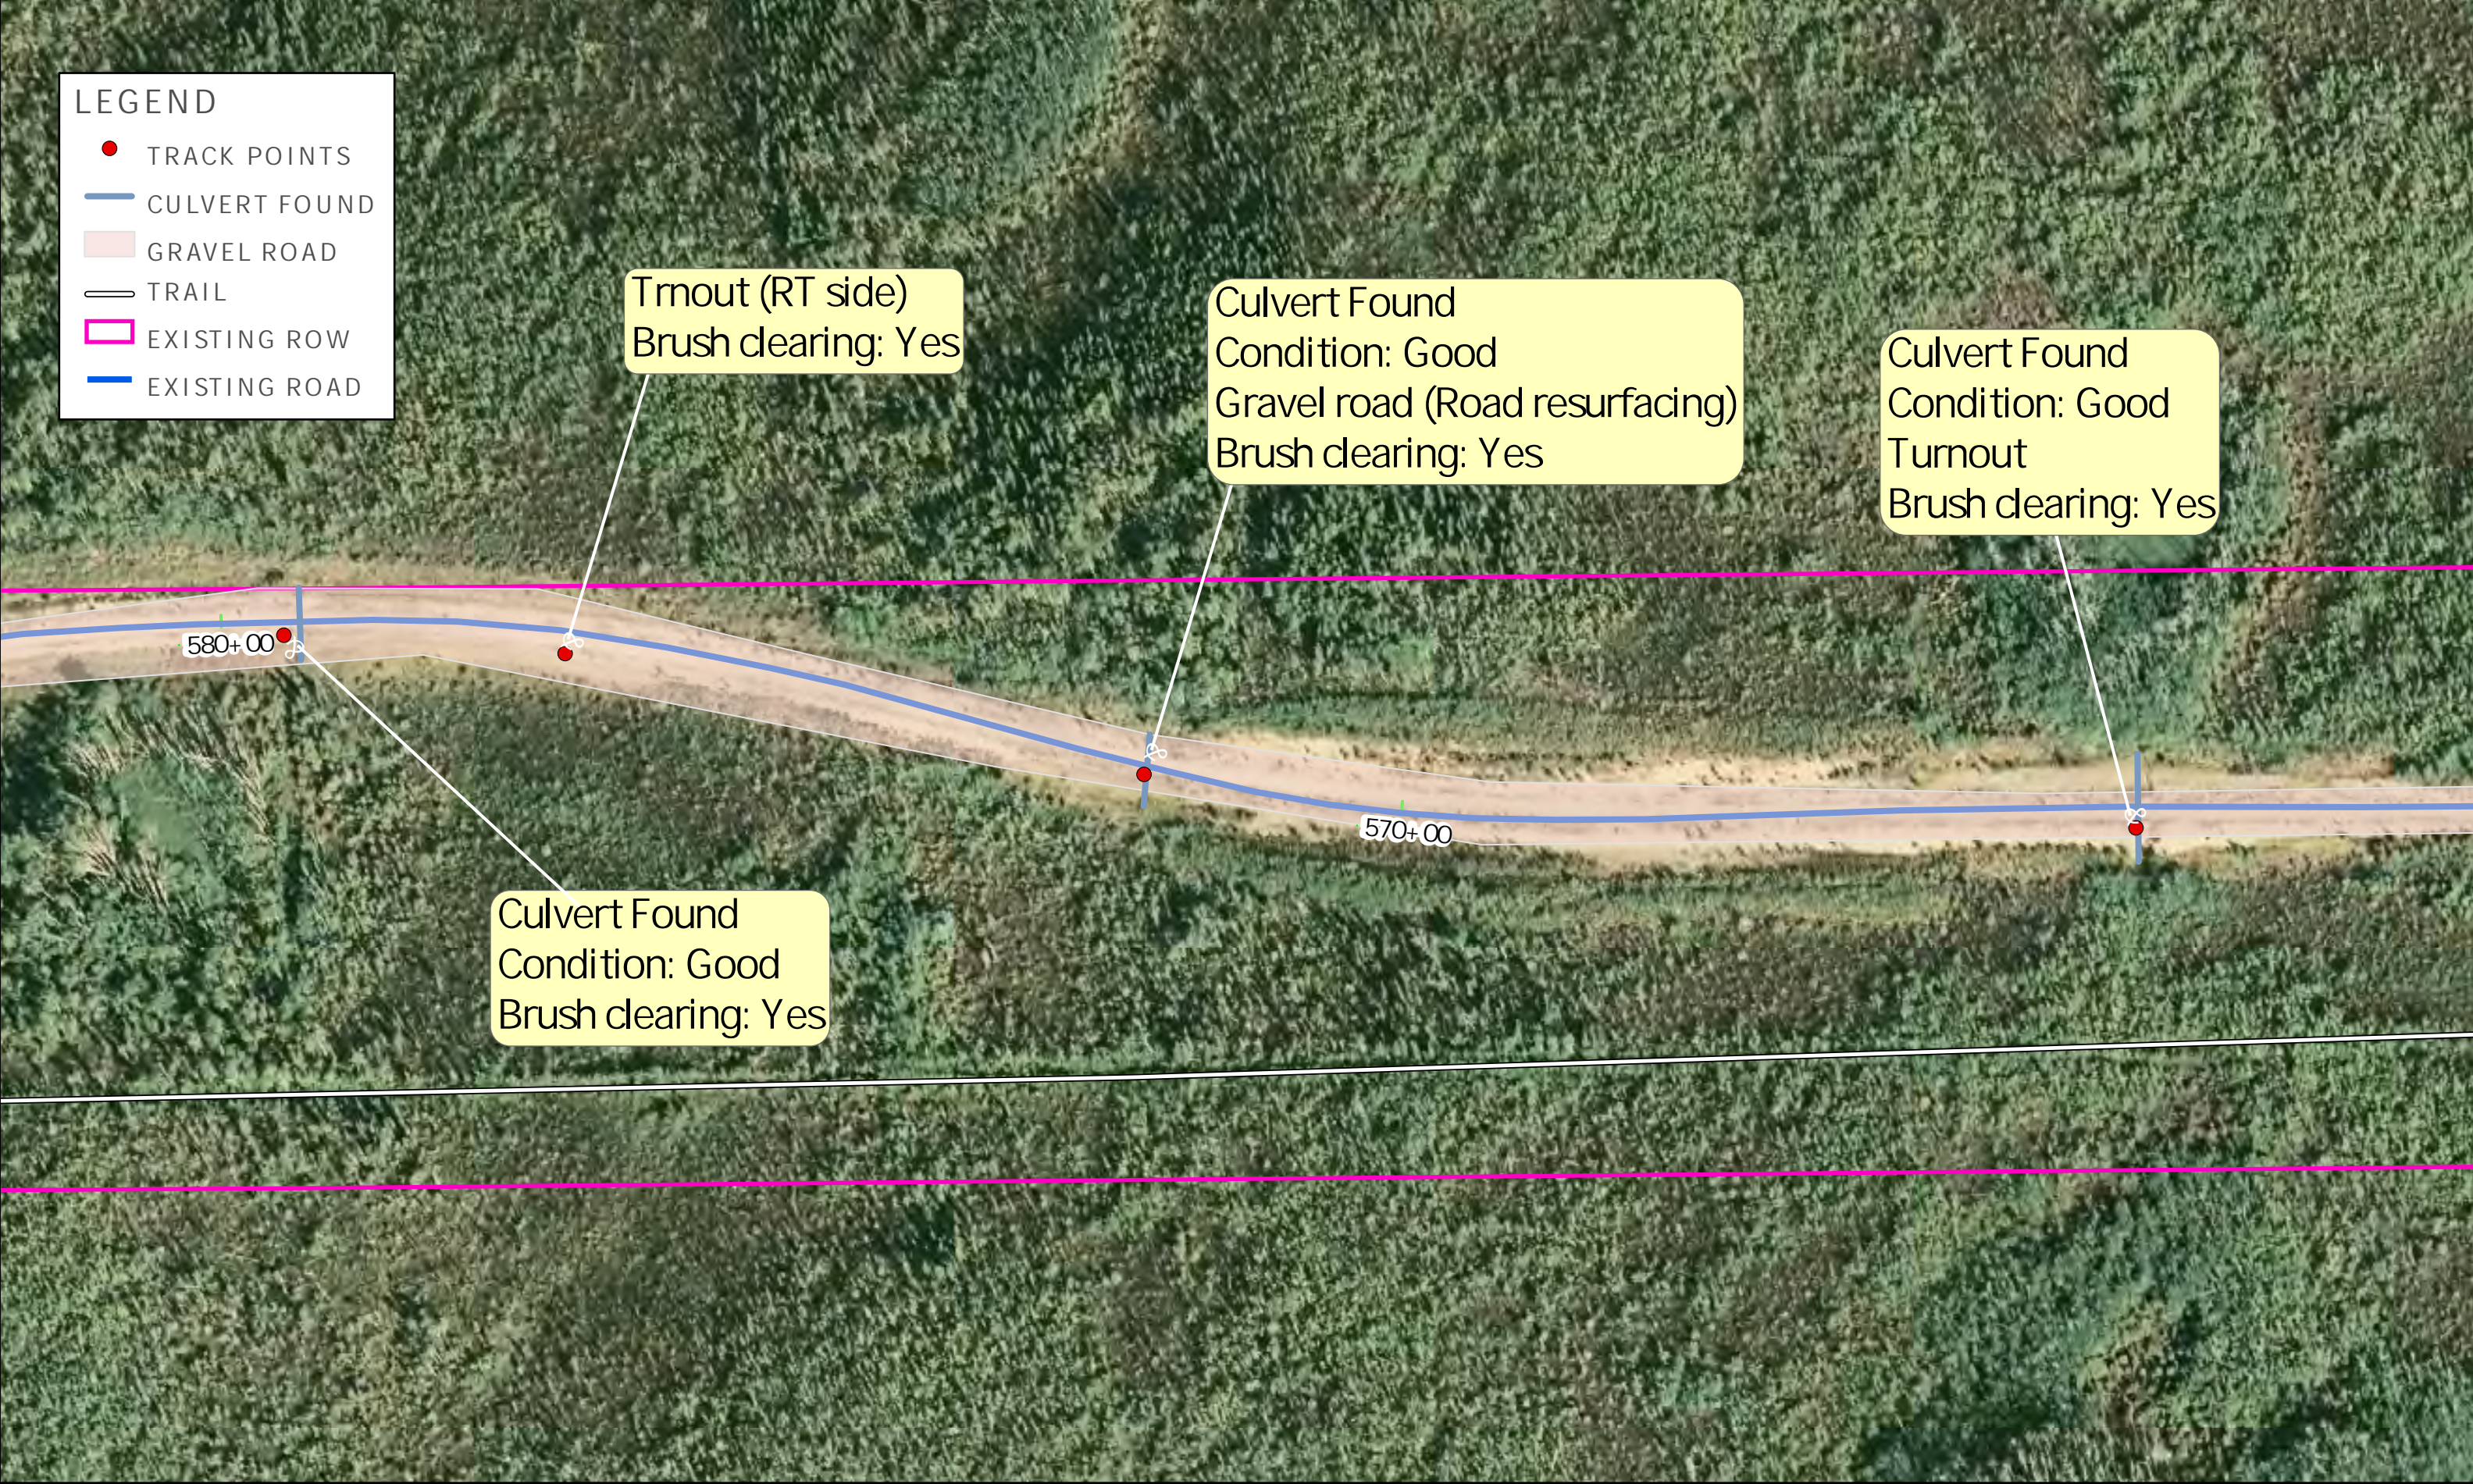
Turnout (RT side)
Brush clearing: Yes

Culvert Found
Condition: Good
Gravel road (Road resurfacing)
Brush clearing: Yes

Culvert Found
Condition: Good
Turnout
Brush clearing: Yes

Culvert Found
Condition: Good
Brush clearing: Yes

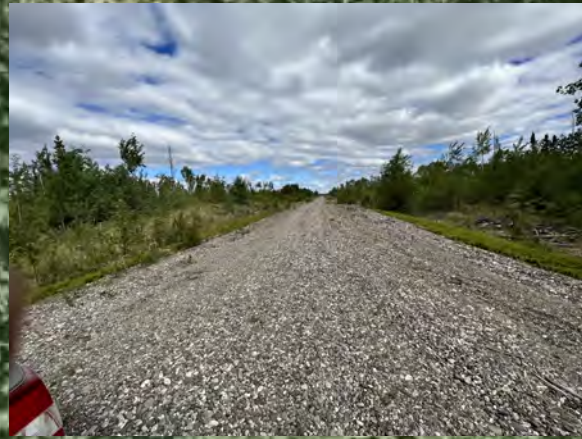
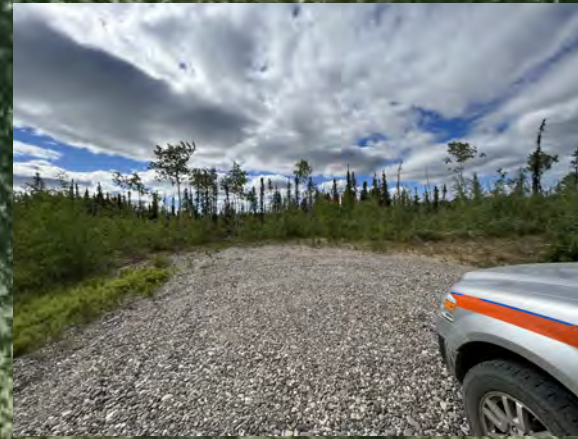
Road end
Gravel and sand road (Road resurfacing)
Brush clearing: Yes
