Asphalt Summit 2003

SE Region Update

Efforts to Make a Rut Resistant Pavement

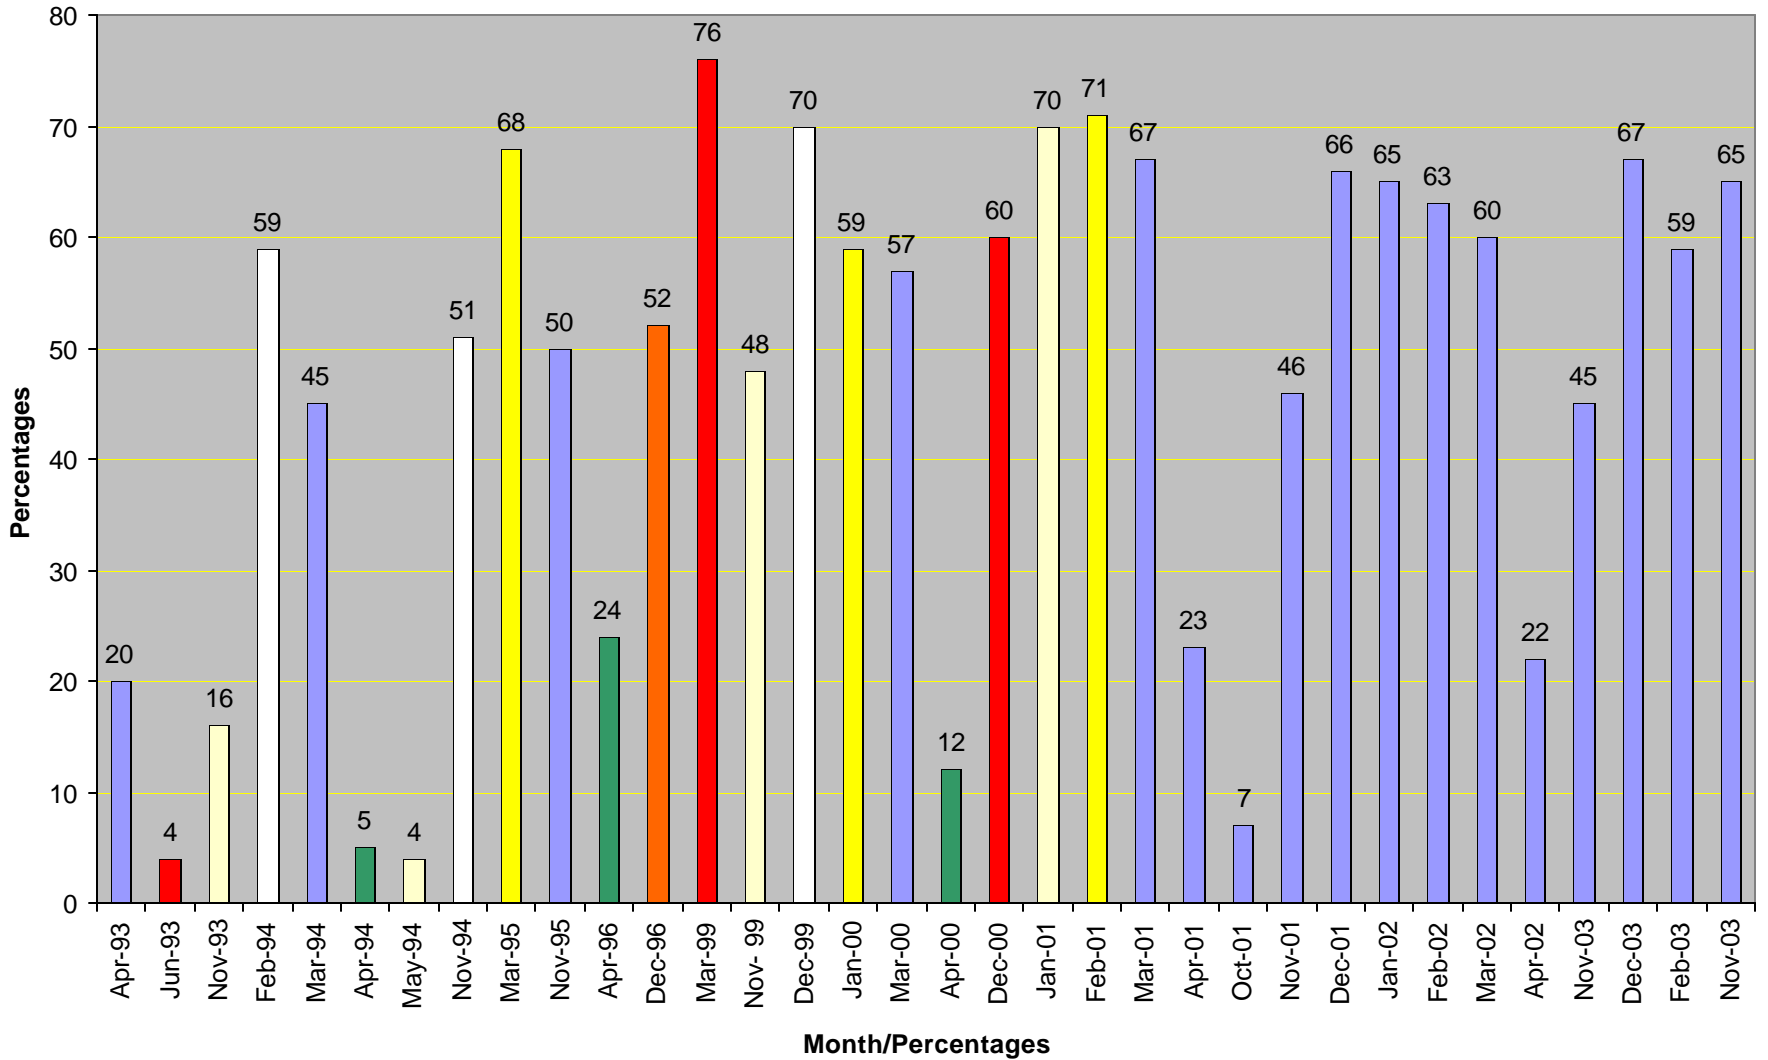
Effective Studded Tire Use Rate In Juneau vs Time

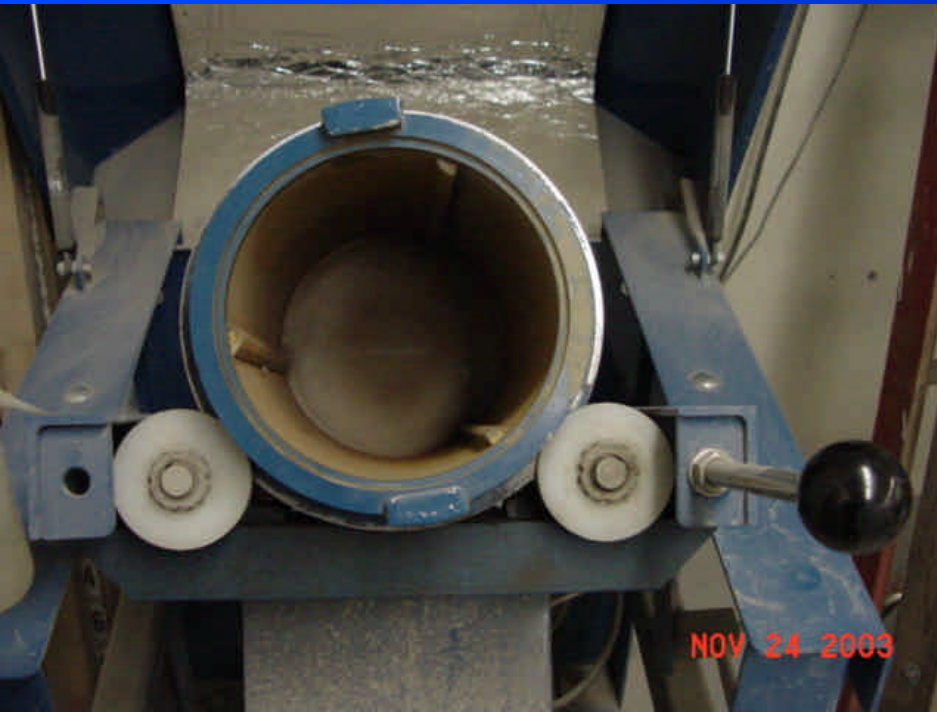
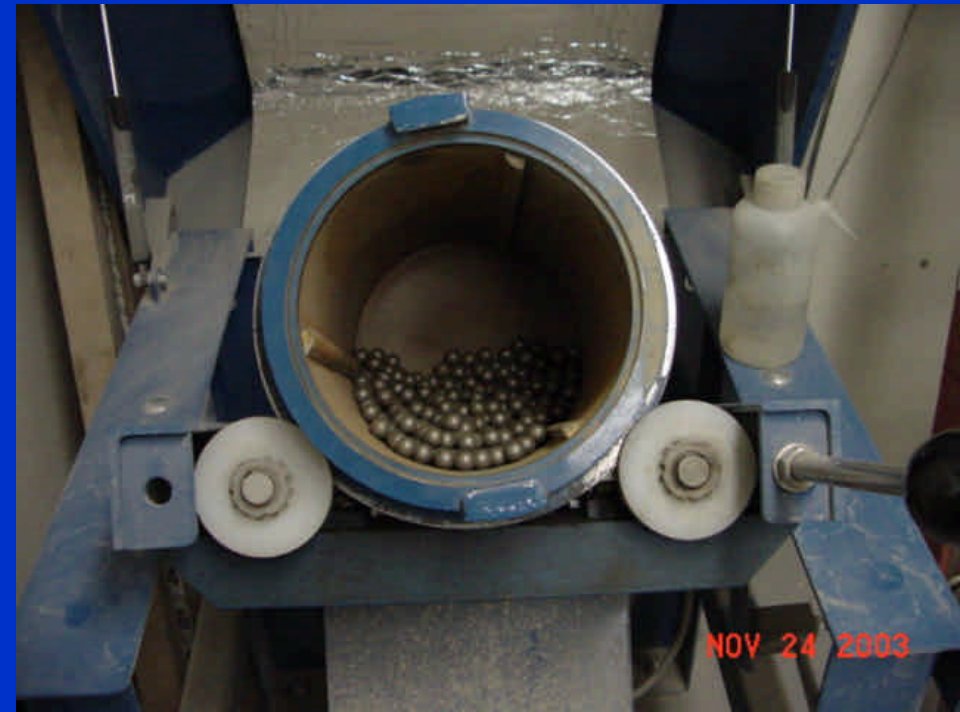
Nordic Abrasion Ball Mill

- Ribbed Test Chamber
- Wet Test
- 5400 Revolutions
- More Rigorous than Micro Duvall

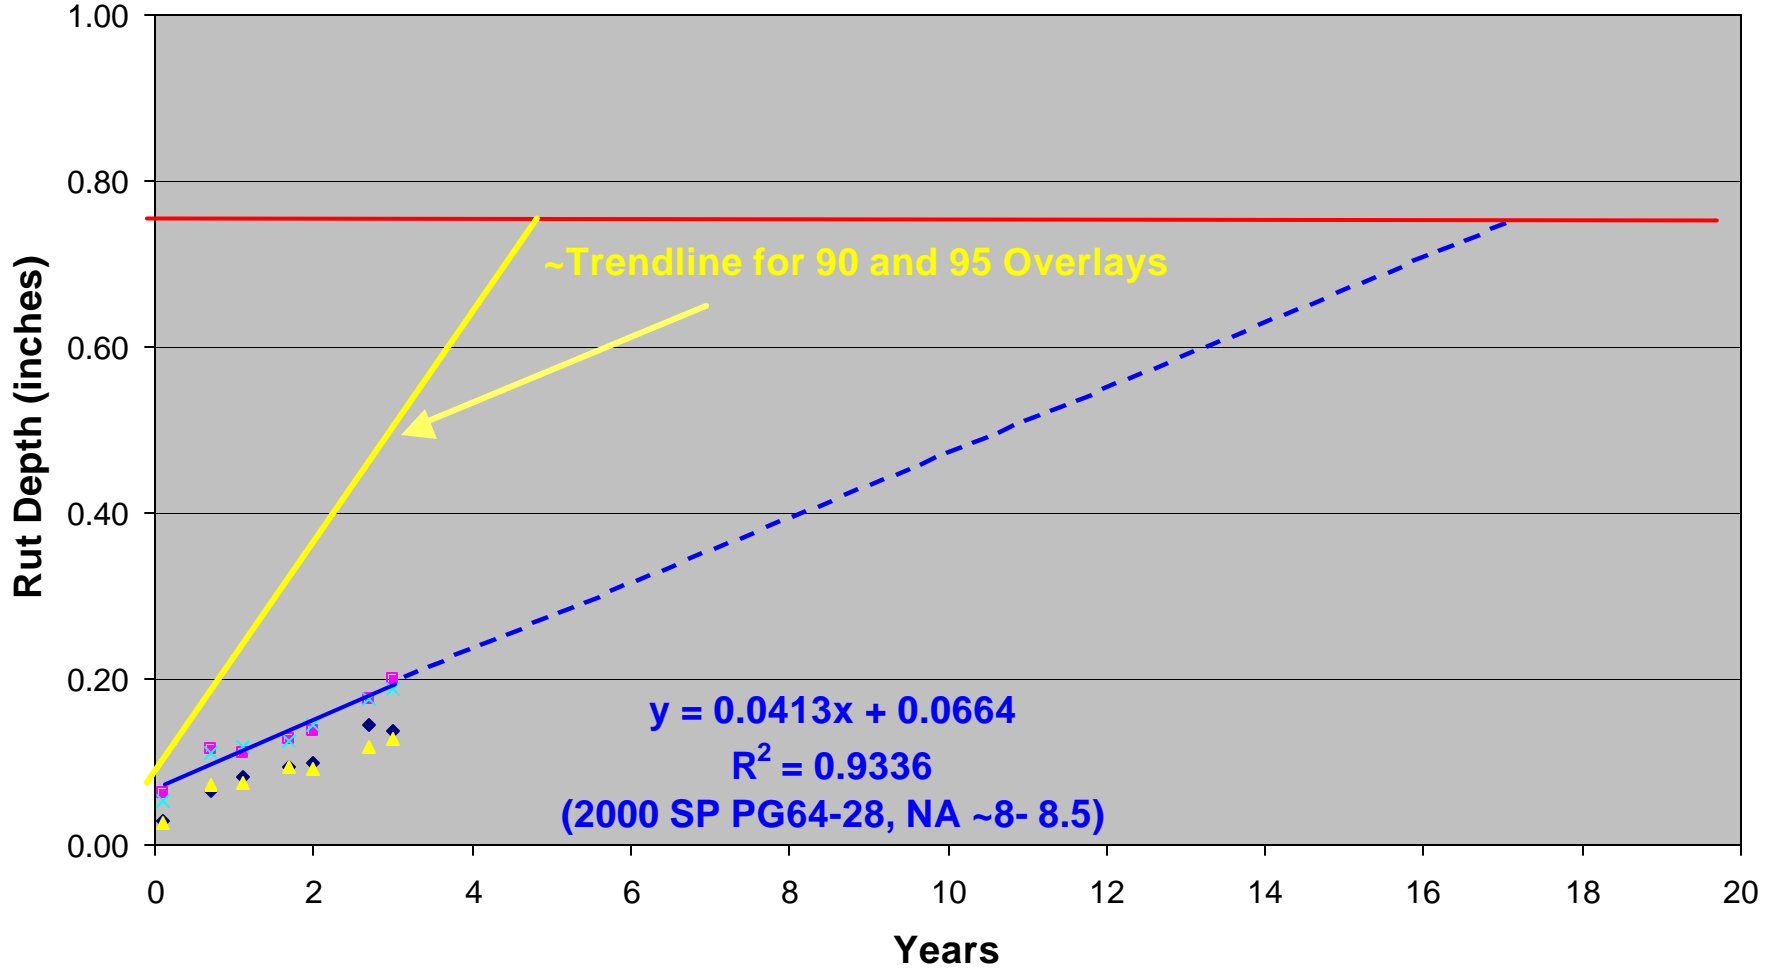
Egan Wear Model Average Rut Depth vs Age

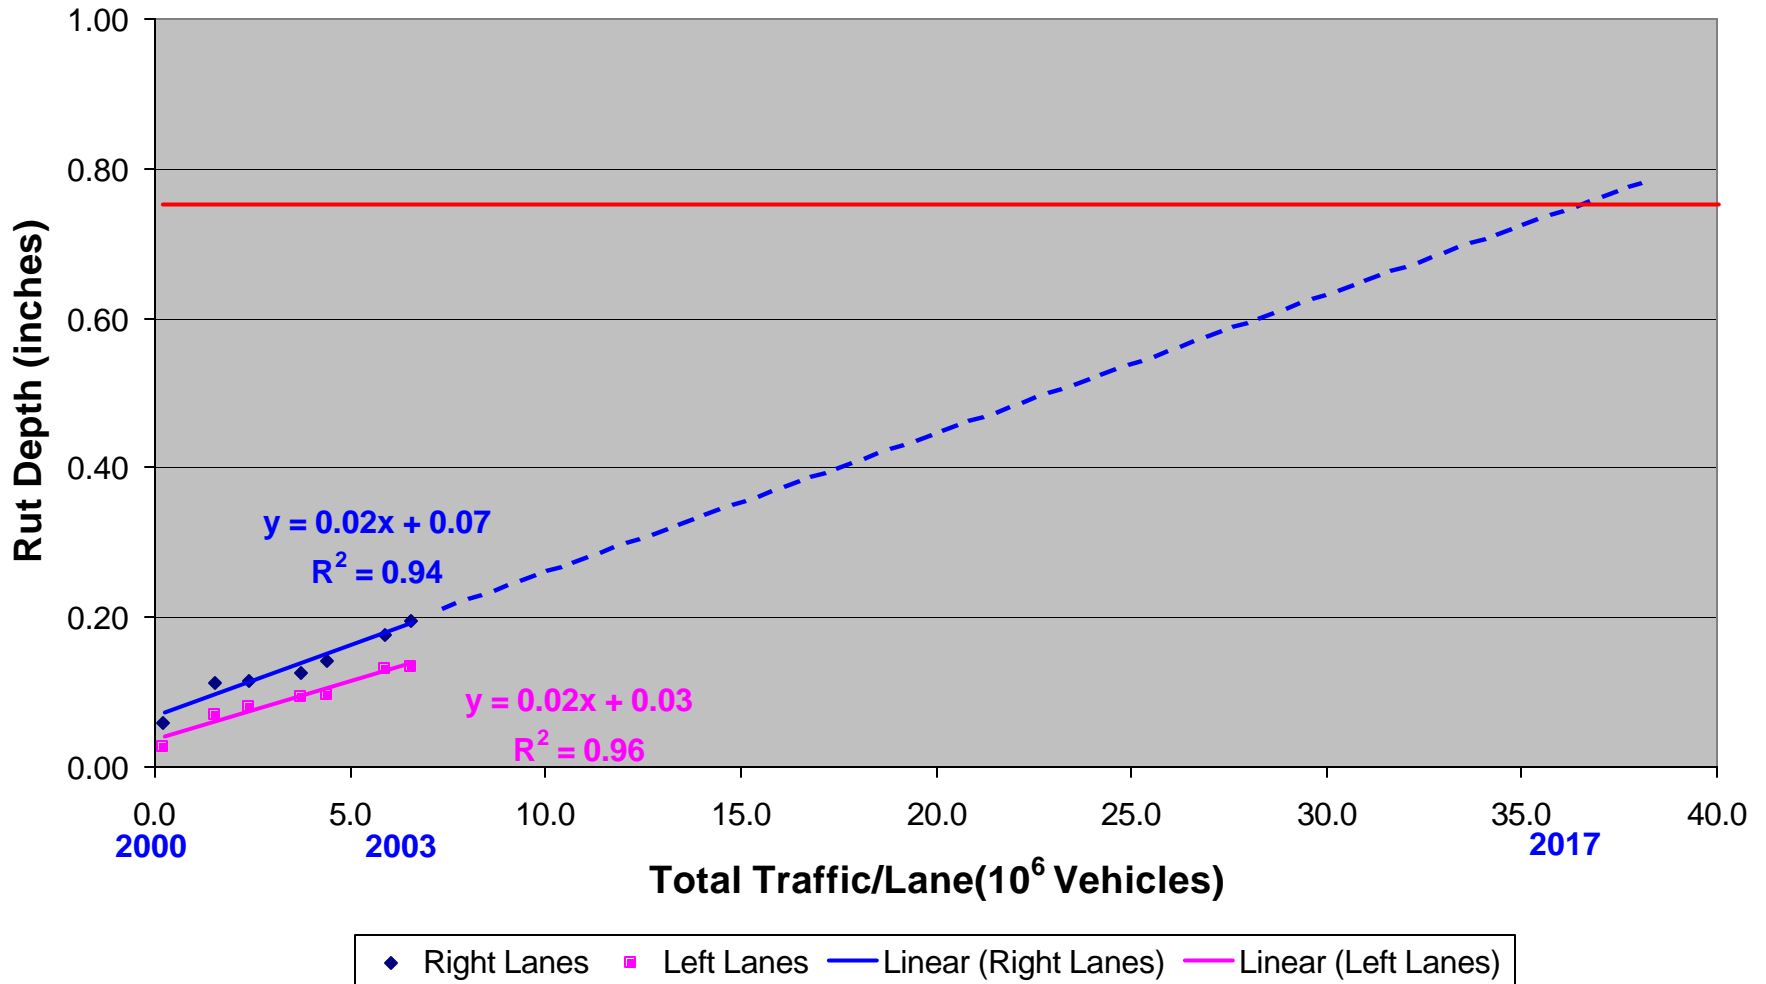
Egan Wear Model

Rut Depth vs Total Traffic

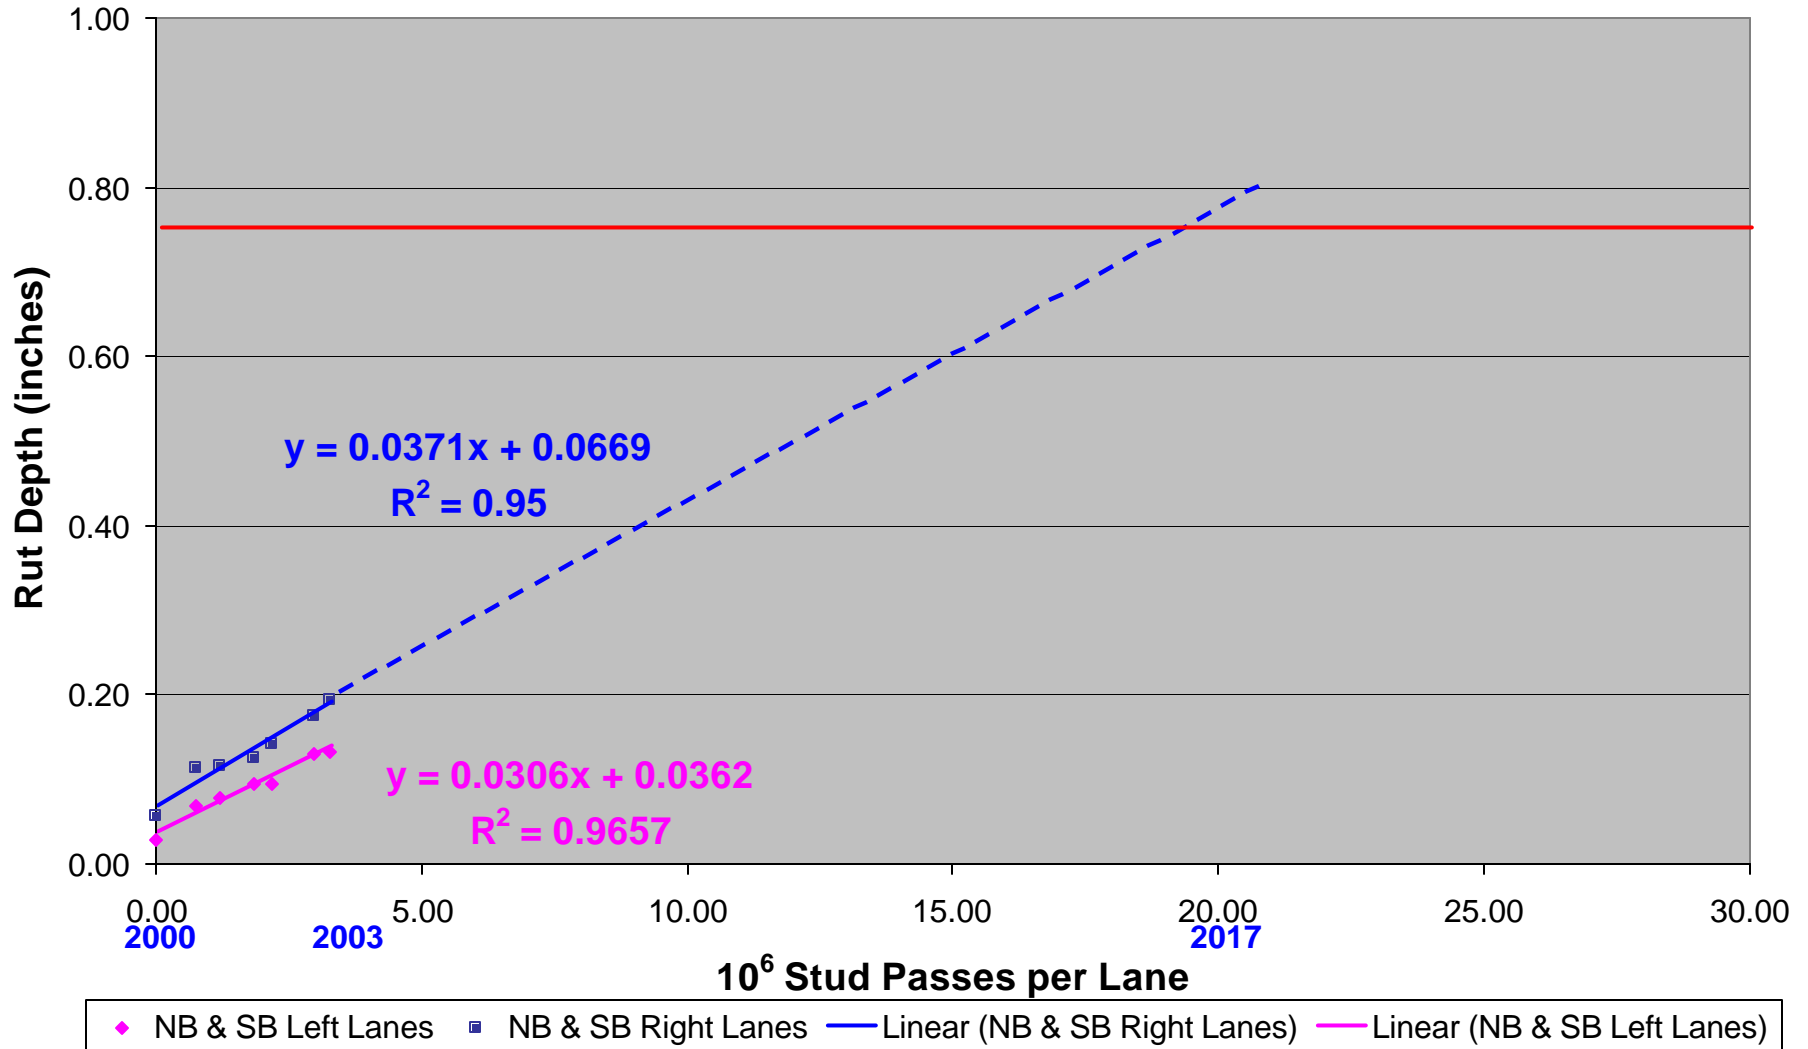
Egan Rut Depth vs Studded Tire Traffic

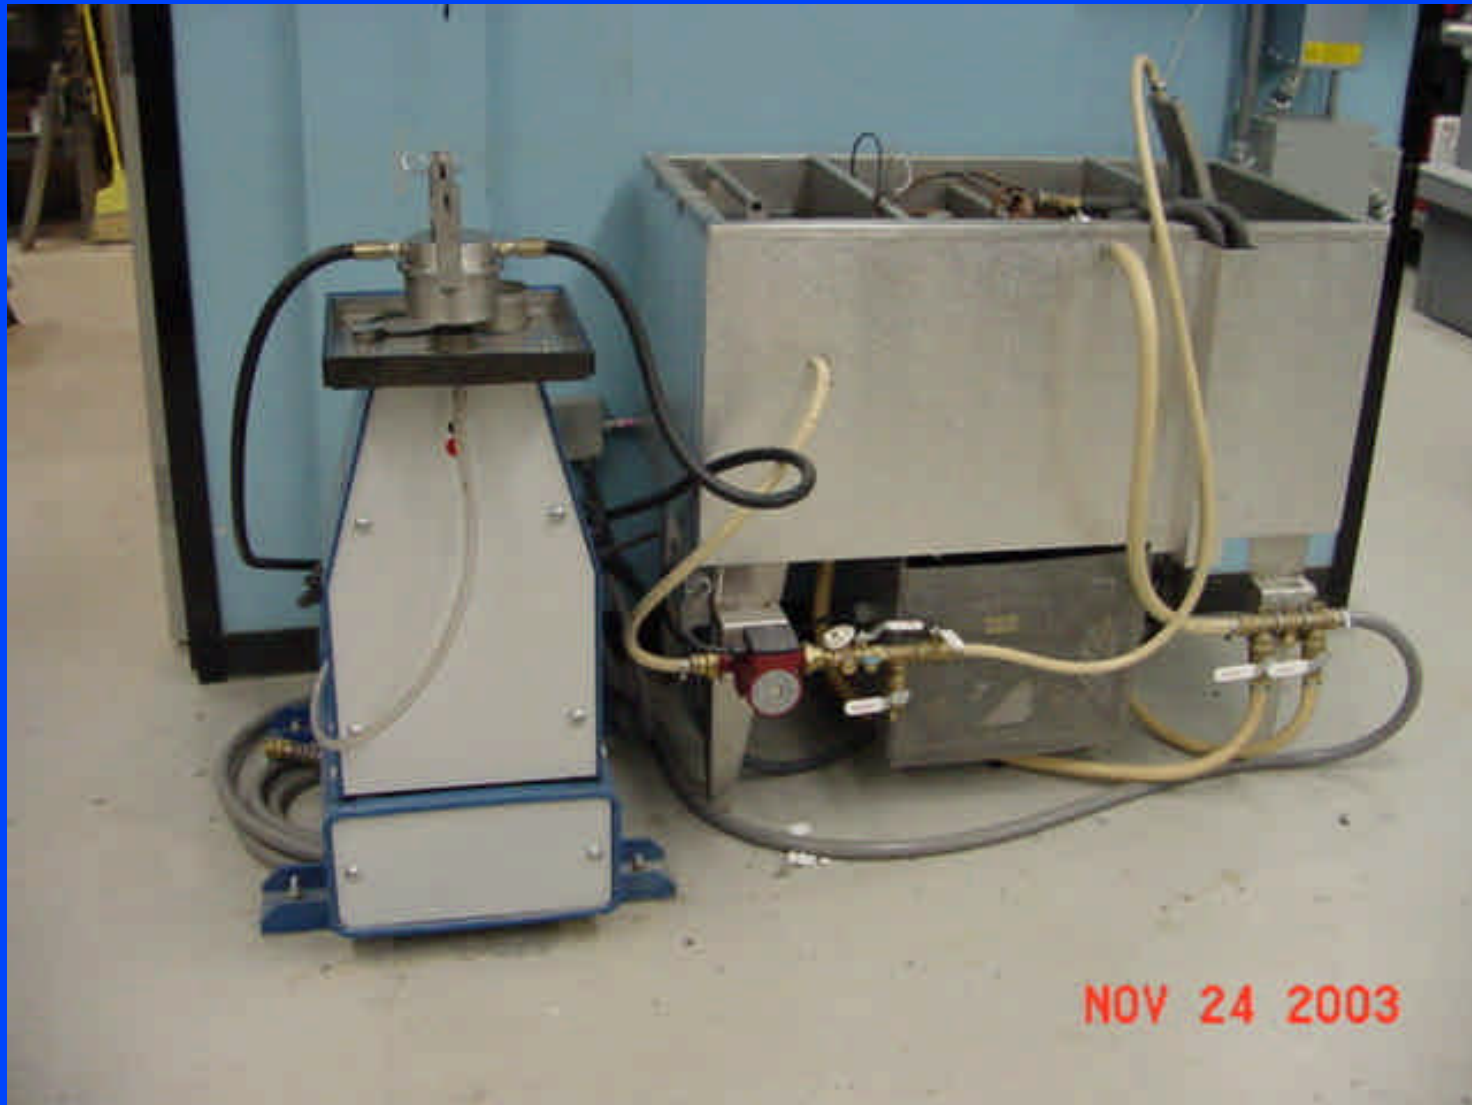
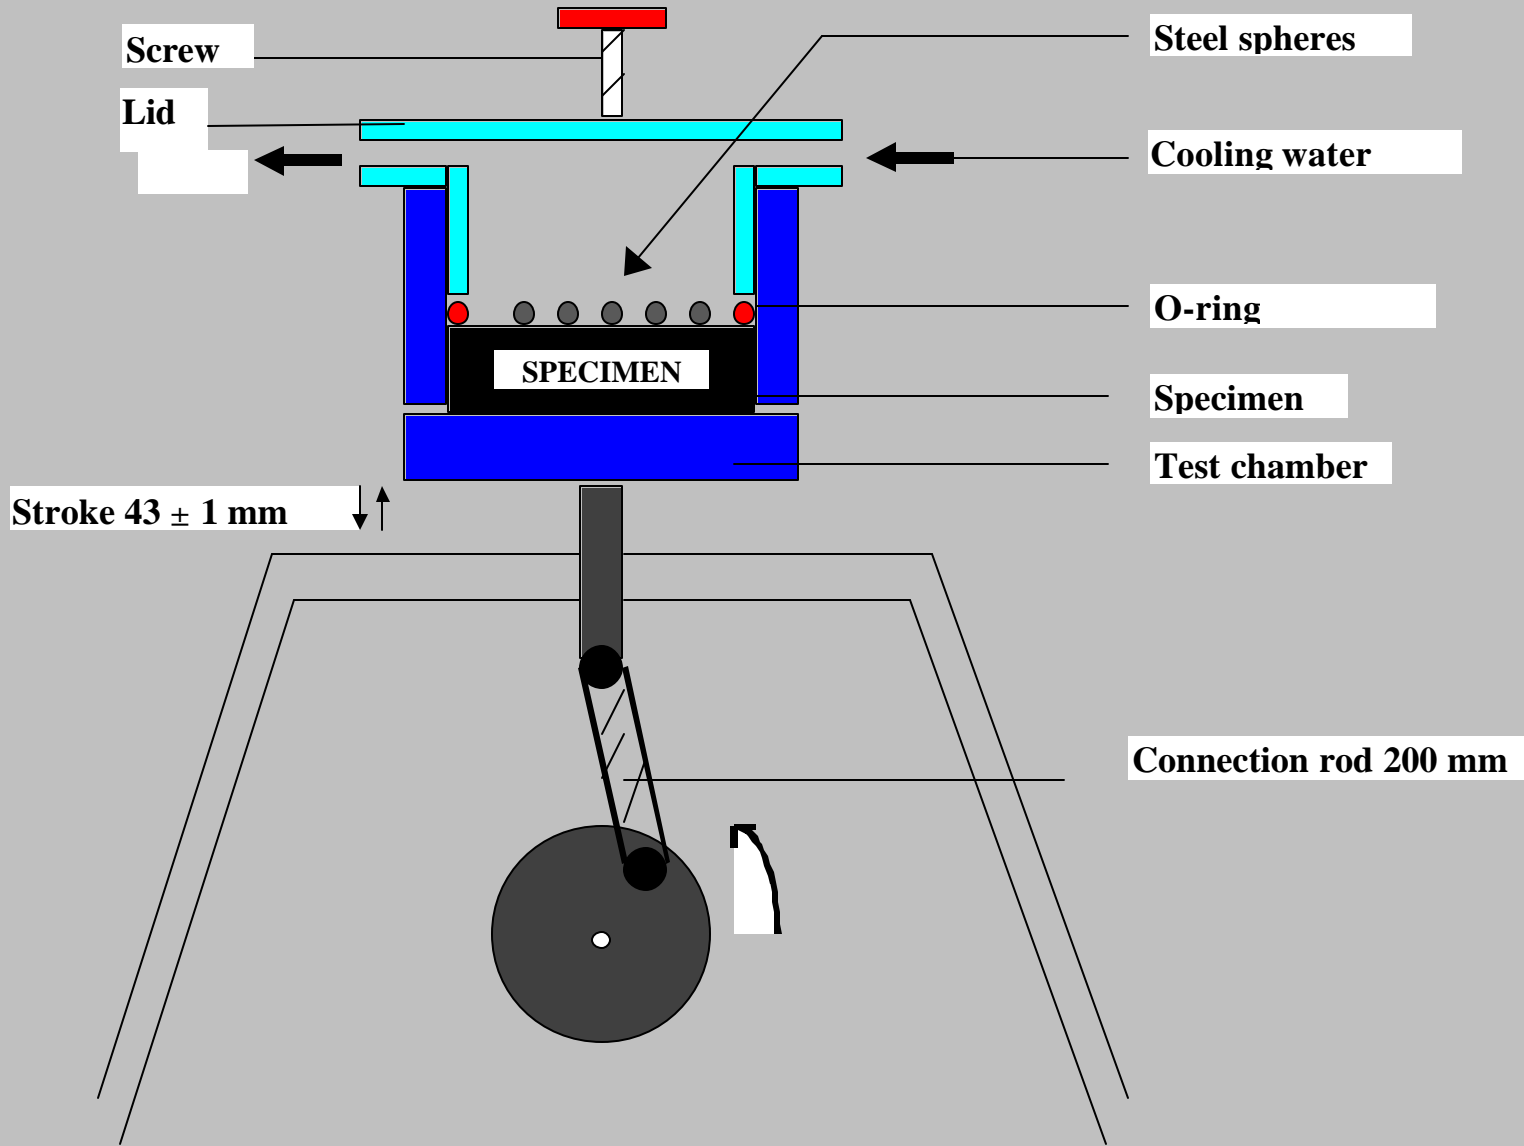
Prall Test Equipment

Method A the *Prall-method*, but improved by comprehensive research work to meet an adequate design. Swedish research correlates with abrasion in the field.

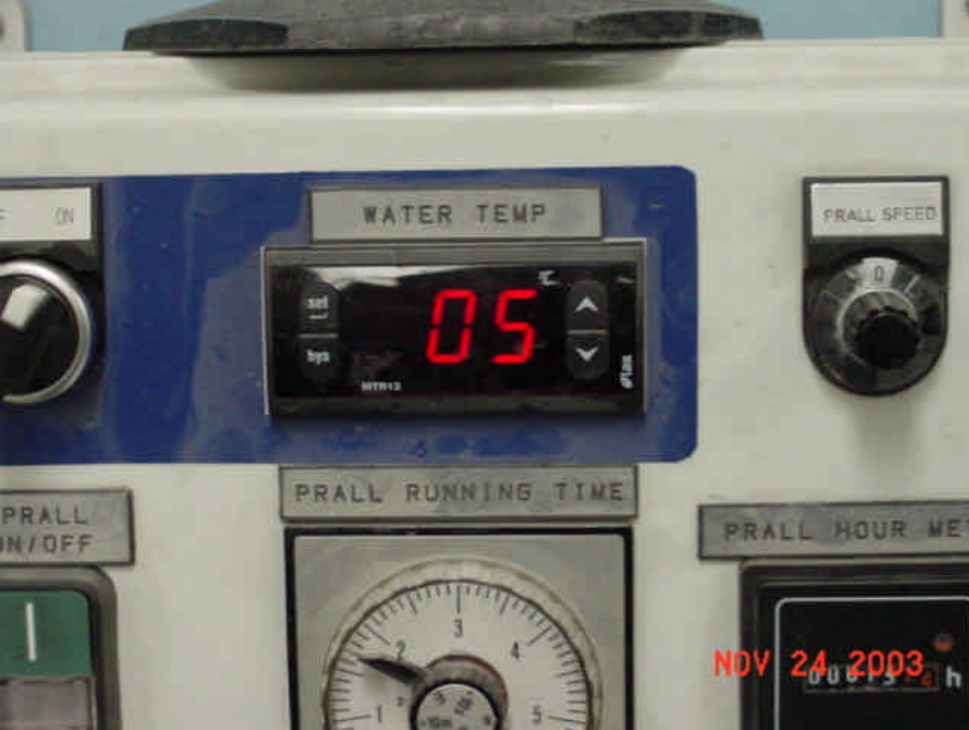
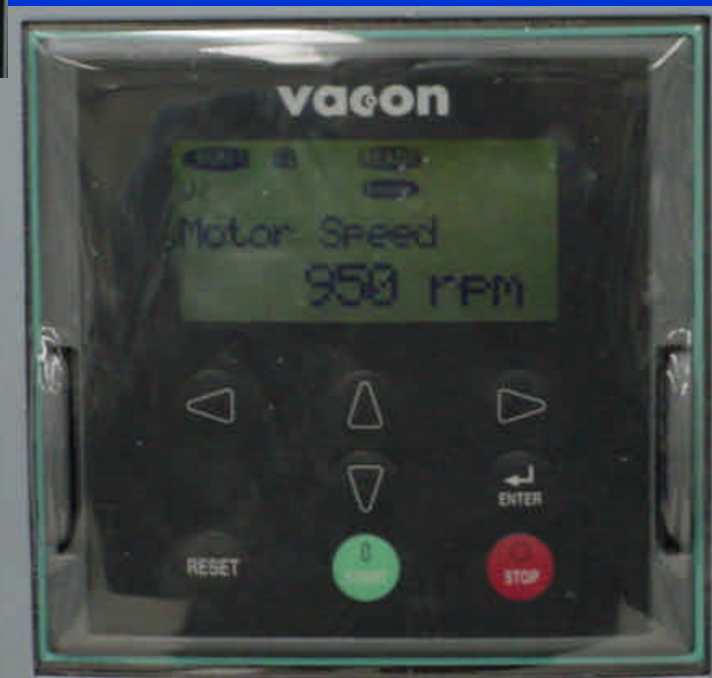
Motor Speed Control

Temperature Controls
For
Conditioning/Chilling
Sample

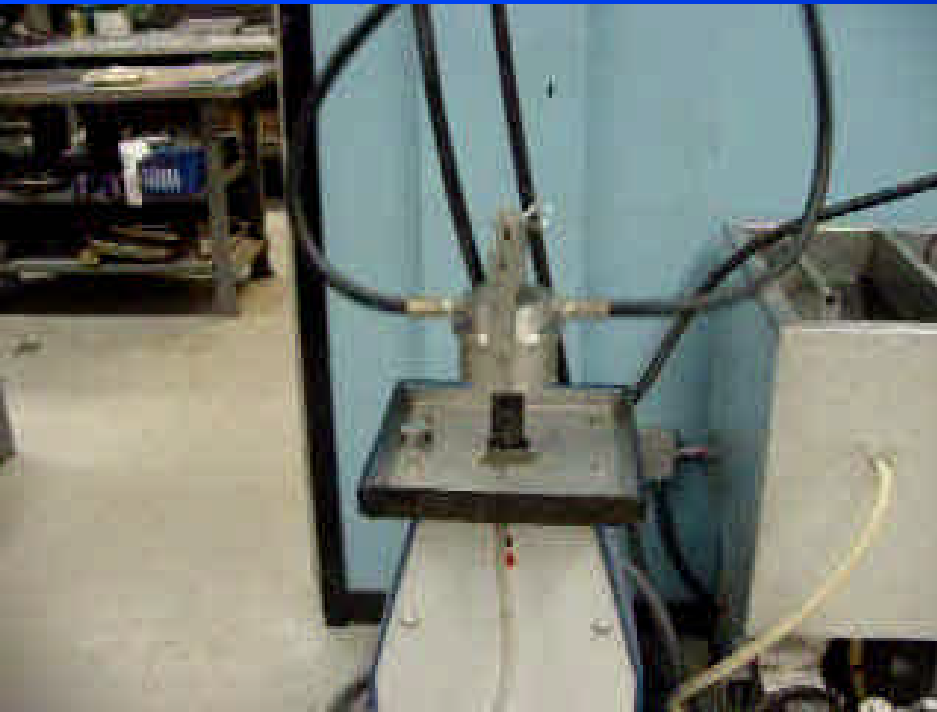
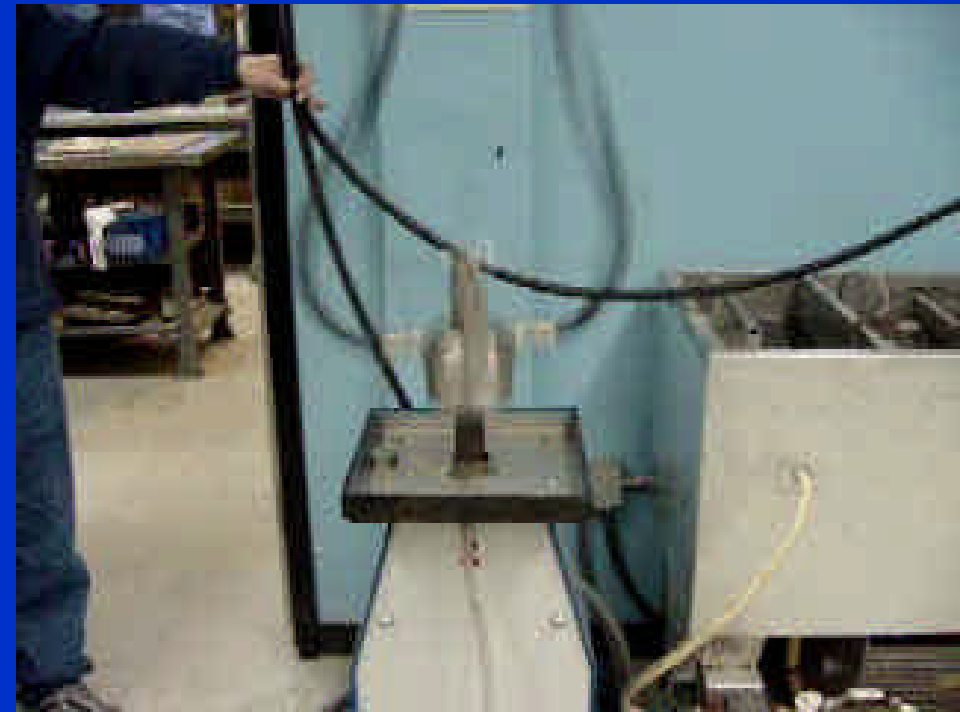
Prall Test

- Core Samples Conditioned 20hrs @ 20°C
- Exposed to Impact of 40 Steel Bearings for 15 minutes @ 950 rpm
- Cooling Water (5°C) Flows over Sample During Testing
- Results are Reported in Volume Loss (cm³)

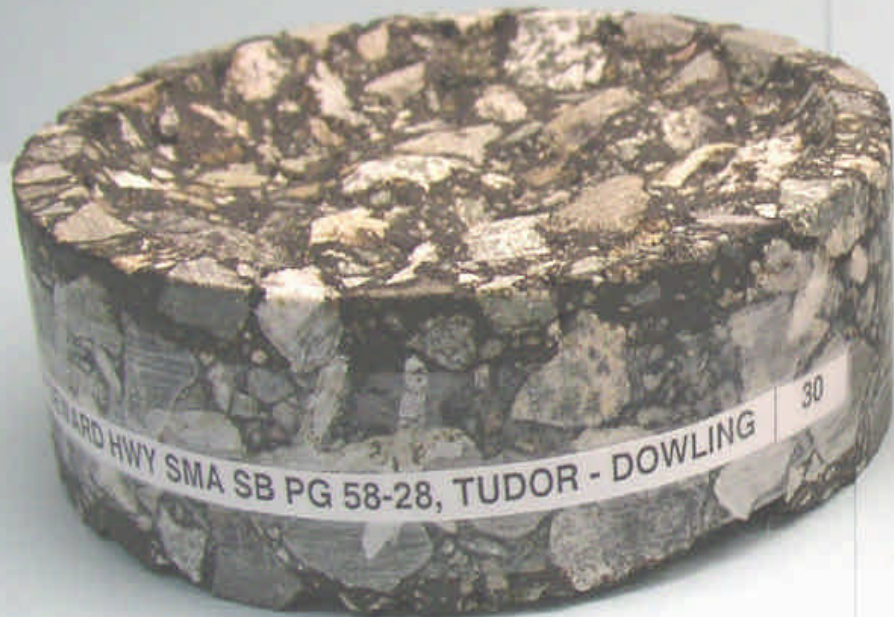
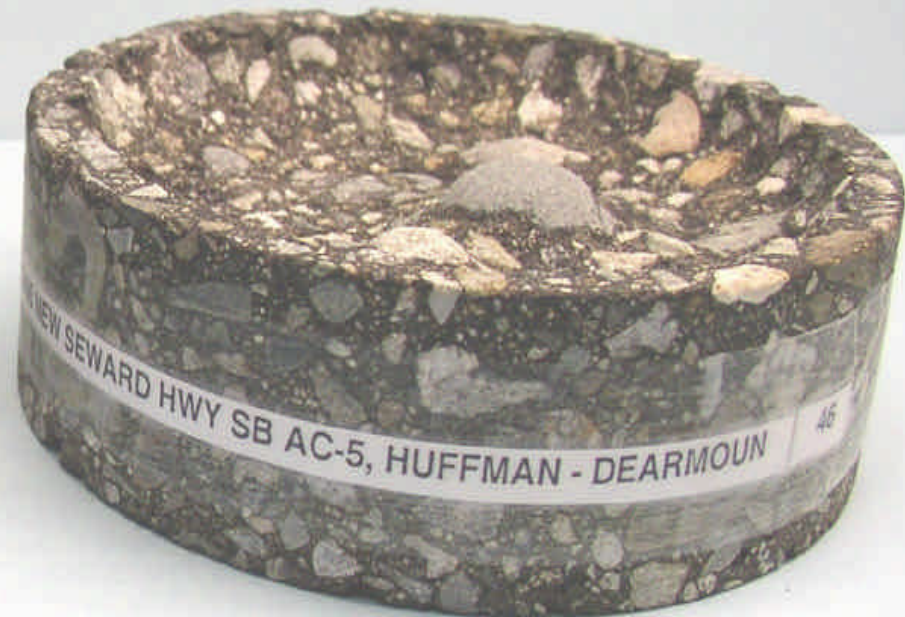
Prall Results

SMA Old (46) vs New (30)

Anchorage Cores:	Prall Loss cm³	Aggregate Source
1993 Muldoon Rd SMA AC-5	50	Mat-Su
2003 New Seward SMA 64-28 (Fireweed to Benson)	23	Mat-Su Mat-Su
2003 New Seward SMA 64-28 (36th to Benson)	32	Mat-Su Mat-Su
2003 New Seward SMA 58-28 (Tudor to Dowling)	30	Mat-Su Mat-Su
2003 New Seward SP 58-28	26	Mat-Su
1996 New Seward AC-5	46	Mat-Su
1982 New Seward AC-5	45	Mat-Su
1985 A St. Plus Ride	14	Mat-Su
1985 A St. Plus Ride	16	Mat-Su

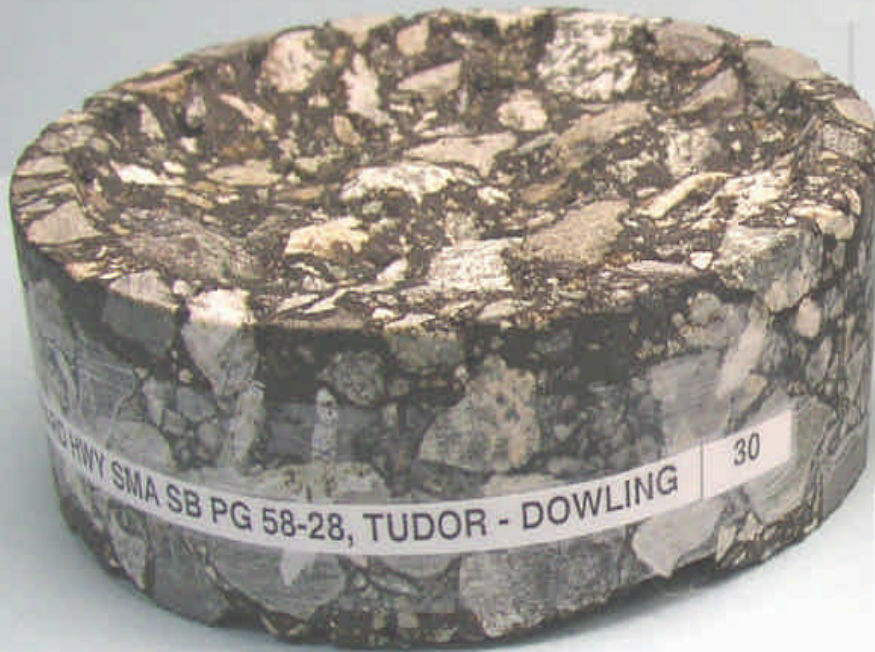
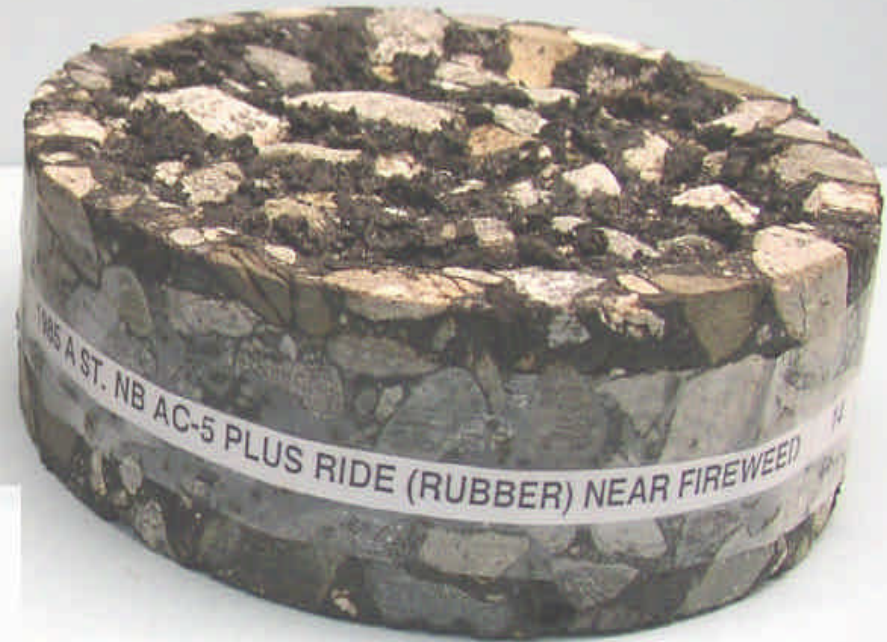
Prall Results

SMA (30) vs Plus Ride (14)

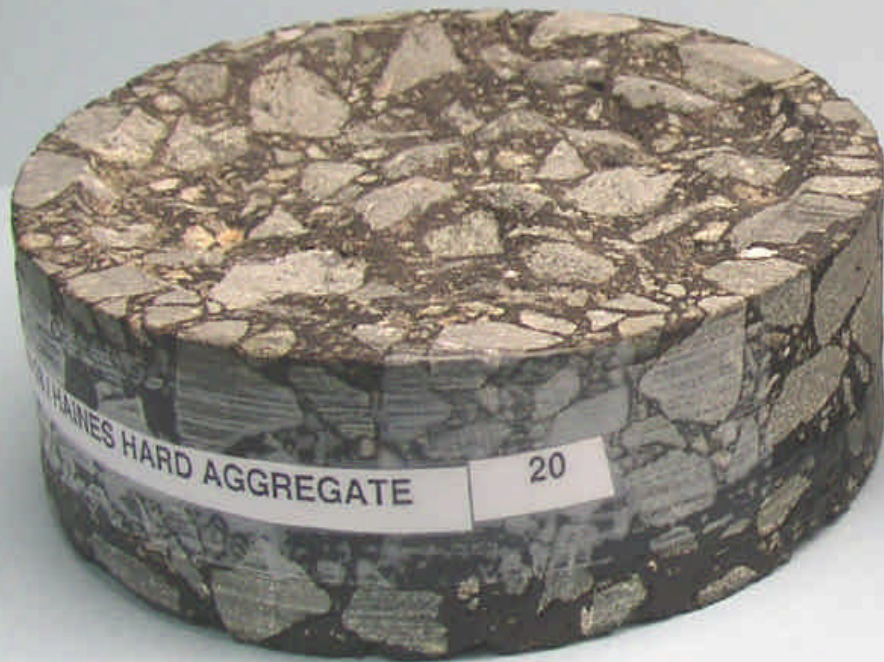
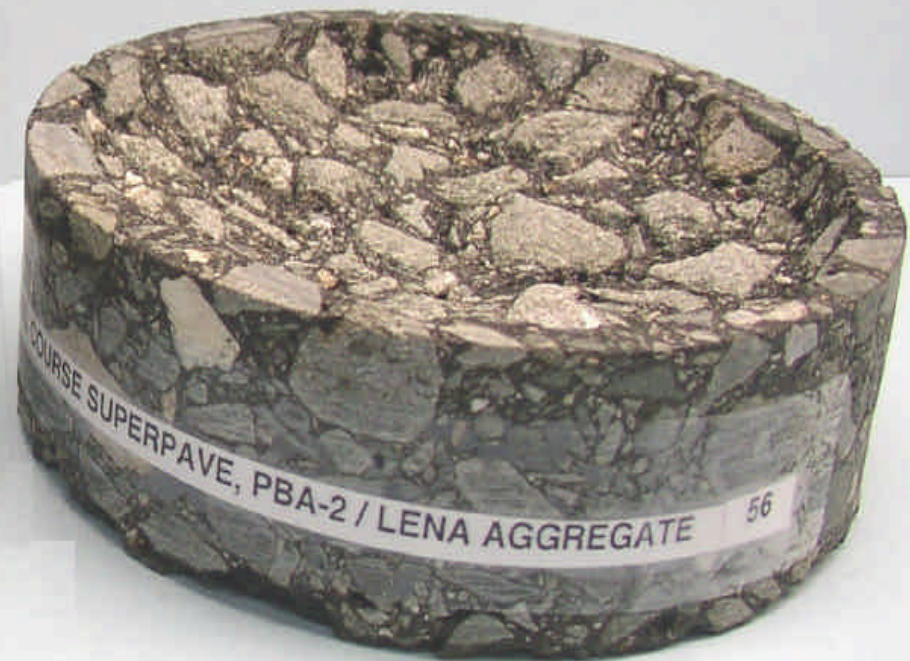
Pral Results

New Egan (20) vs Old Egan (56)

Juneau Cores:	Prall Loss cm ³	Aggregate Source
2000 Egan Dr. SP 64-28	20	Haines
2000 Leveling Mix PBA 2 (Similar to 95 Egan Mix)	56	Lena Pt.
2001 Lemon Rd SP 64-28	20	Haines
2002 N. Tongass SP 64-28		Glacier NW
2001 Glacier Hwy SP 64-28		Glacier NW

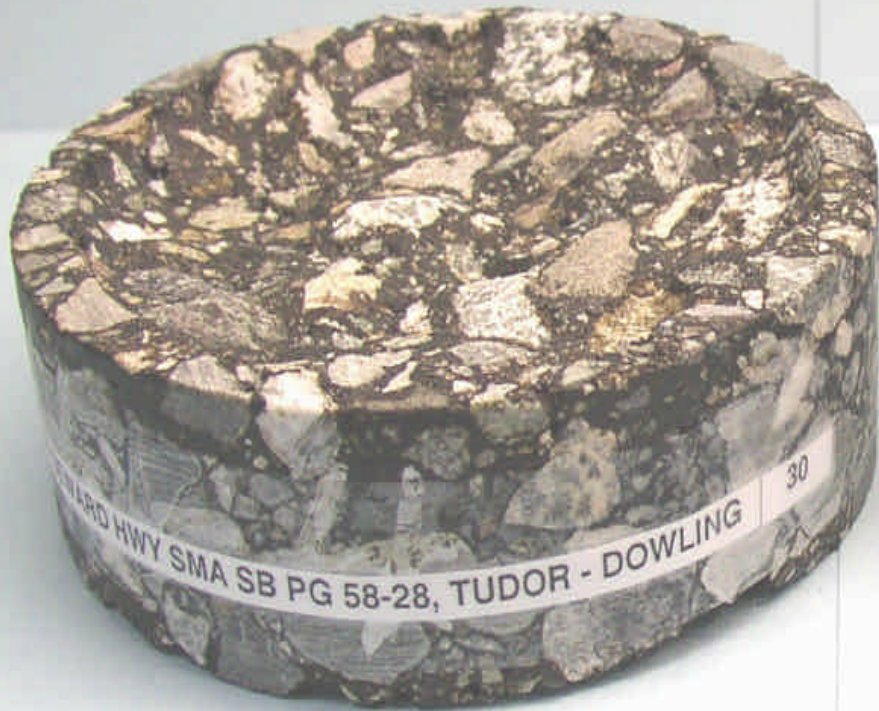
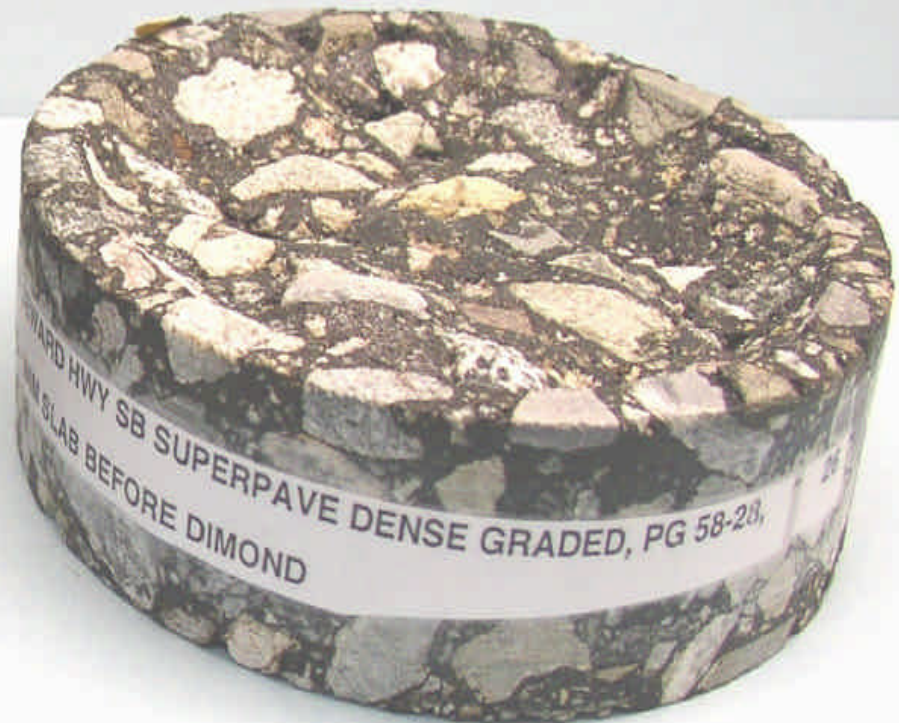
Prall Results

SMA (30) vs SP (26)

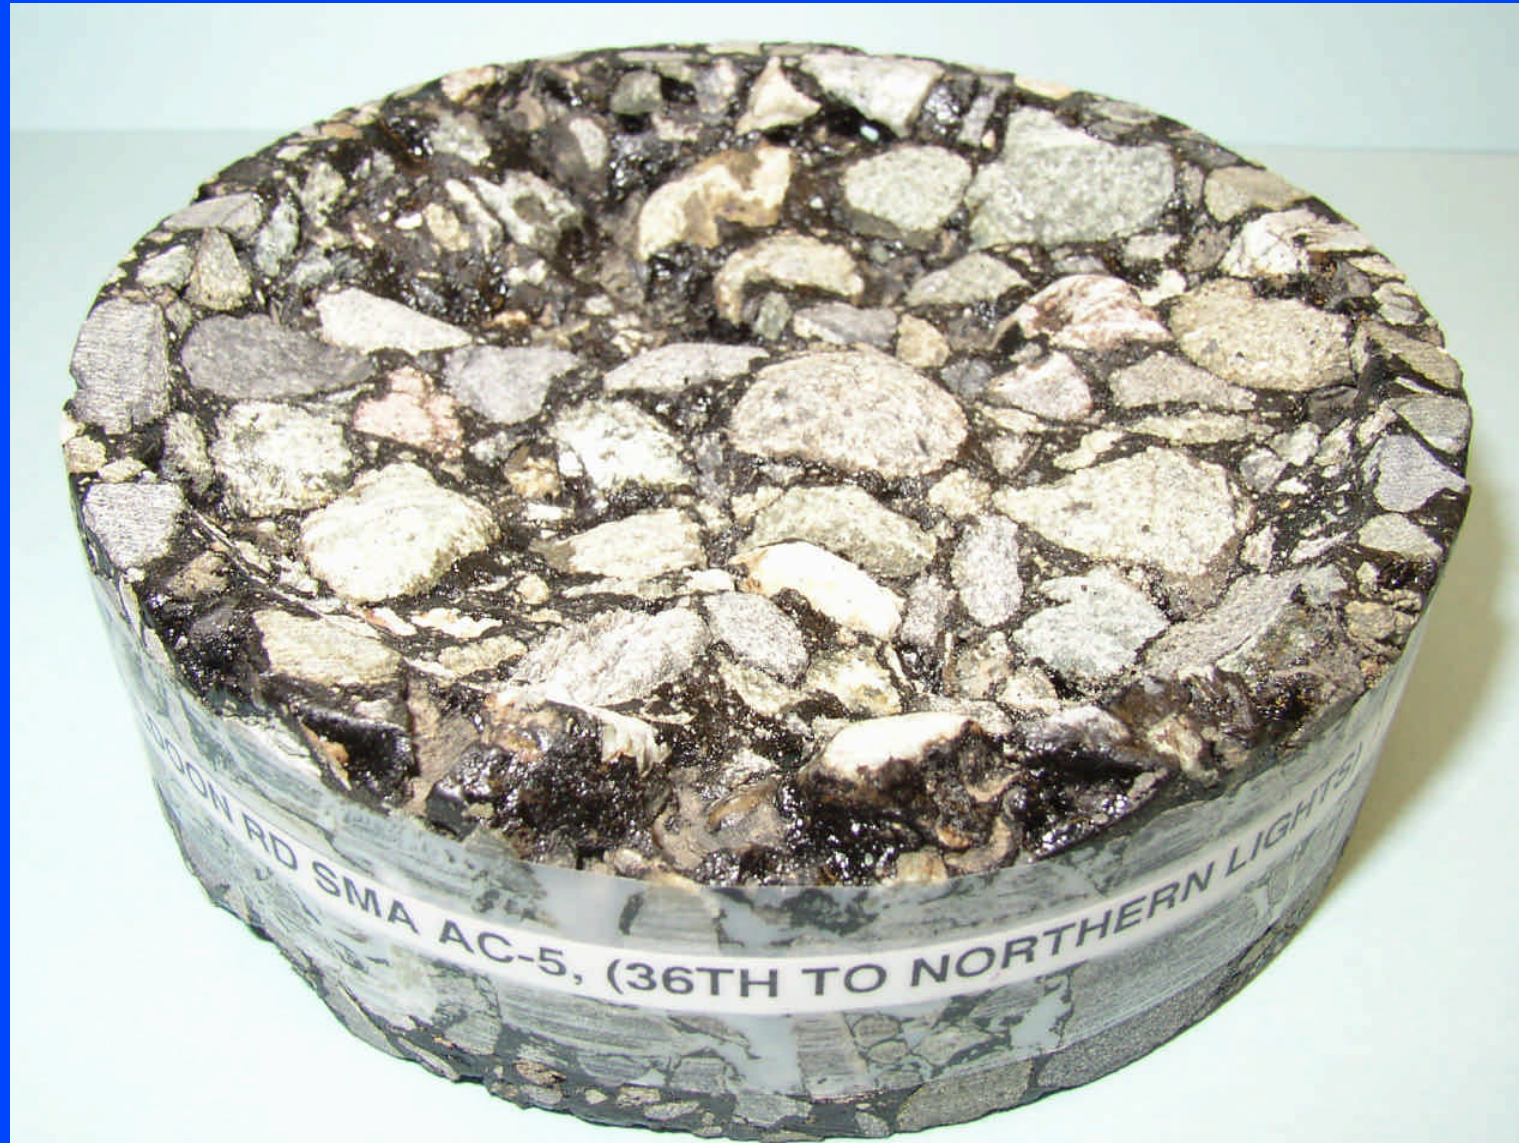
Prall Sensitive to Mix Voids

(50)

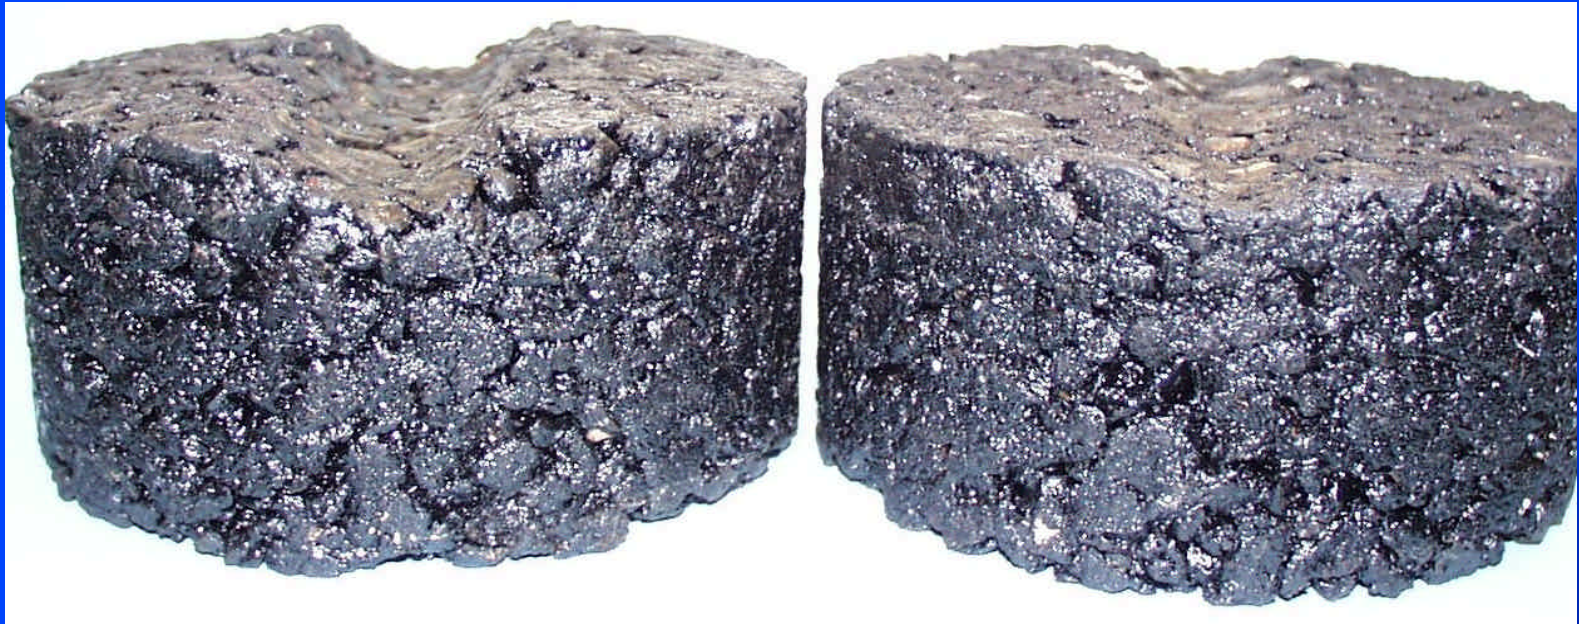
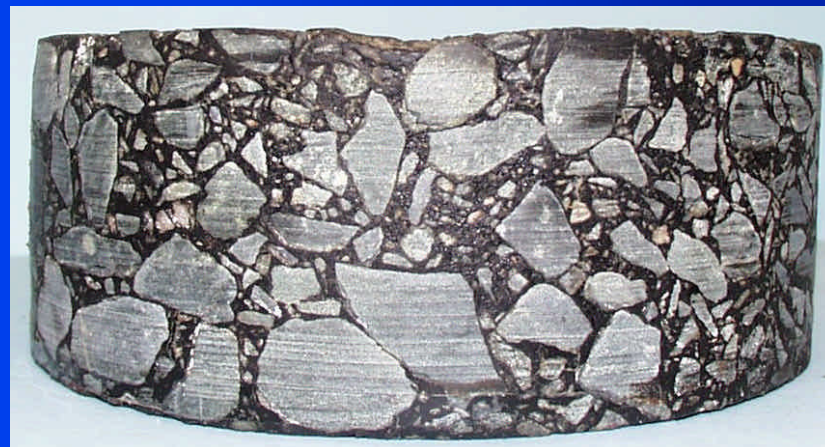
PG 52-28
Rut Index = 10.7

PG 58-28
Rut Index = 4.7

PG 64-28
Rut Index = 1
