Spring 2006  
 Volume 31, Number 1

## Raising the Million Dollar Bridge

# Nordic Abrasion Test Equipment Made Right Here in Fox, Alaska

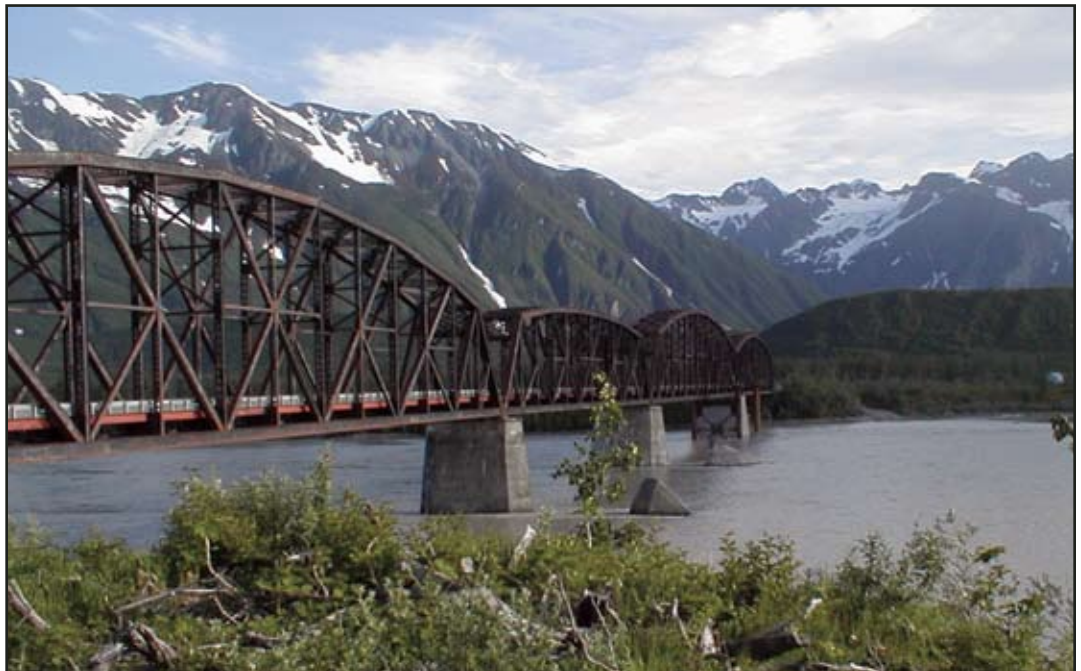
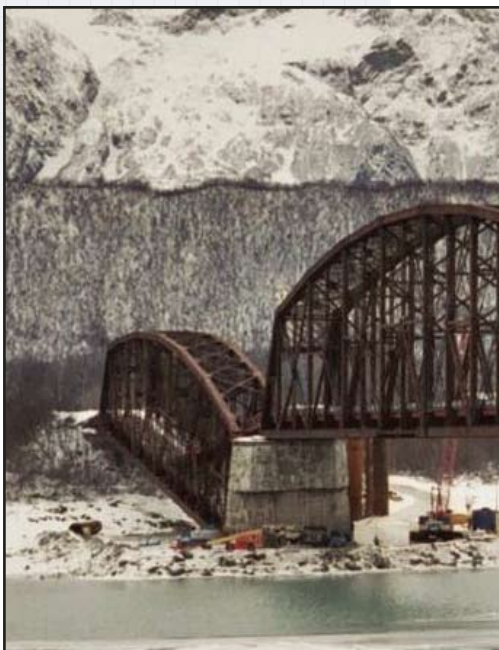
*The profile of the Million Dollar bridge is restored 41 years after the 1964 earthquake dropped the north span off its pier (below).*

March 27, 1964, when the 9.2 magnitude Good Friday Earthquake, knocked the northernmost span from its concrete piling, where it remained for forty-one years, slumped into the Copper River.

Before demolishing the old pier, four temporary steel pilings were erected, two on each side of the existing pier. Each piling was fitted with a 660-ton hydraulic jack. The jacks lifted a block attached to steel rods connected to a lifting beam under the fallen span (see figure below). The span was then lifted a little at a time, limited by the stroke of the jack. The jacks successfully lifted both spans above the level of the damaged bridge pier.

The old pier was then demolished and the new pier built upon the new pad. The bridge sections were then lowered and slid into place on the new pier. The contractor used newly fabricated parts to replace dam-

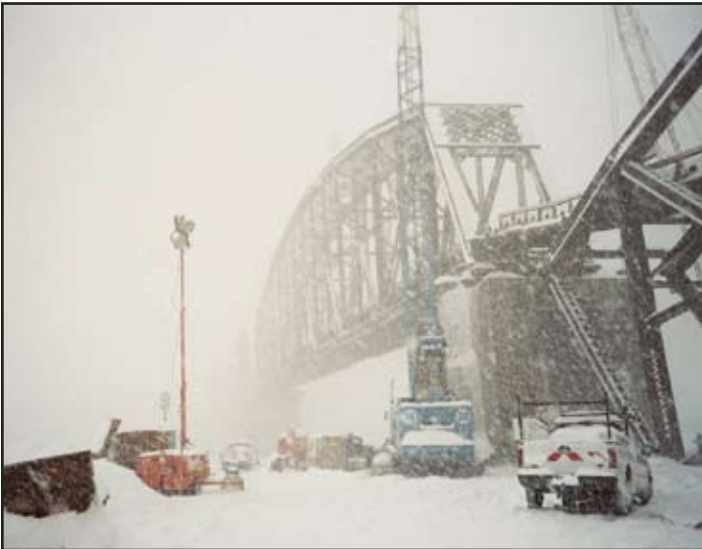
*Weather conditions during the repair were not always good.*

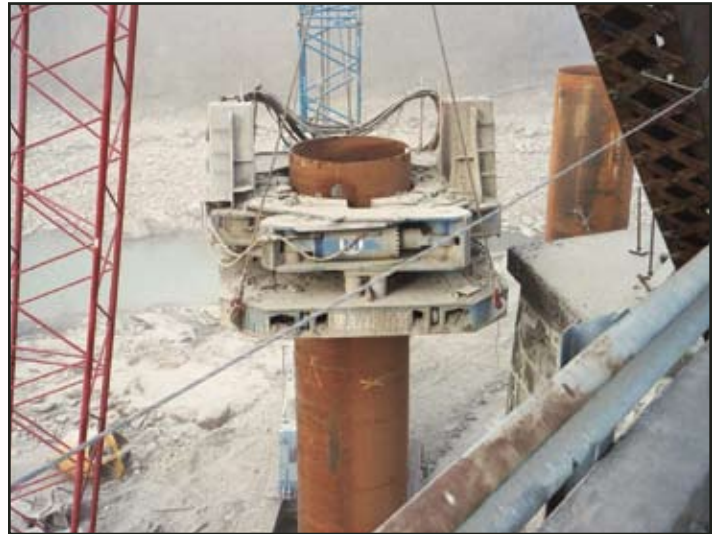
*Temporary piling being driven with a hydraulic casing oscillator. Existing material is excavated out of the piling as installed. These piers, four in all, were used to lift both the fallen and intact span, so a replacement pier could be constructed.*

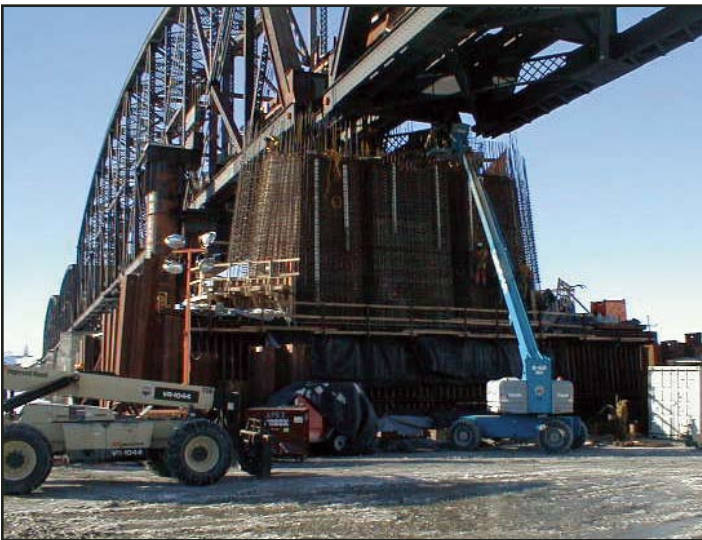
*Steel rebar is placed during construction of the replacement pier. Less concrete is used than in original pier due to advances in materials.*

The earthquake-damaged pier needed replacement. Five 6-foot-diameter steel pilings were driven 150 feet and filled with concrete, cut, capped, and topped by a concrete slab to create the new base for the replacement pier. The old pier would later be demolished and a pier constructed on the new pad. Throughout the project, the historic appearance of the bridge was preserved.

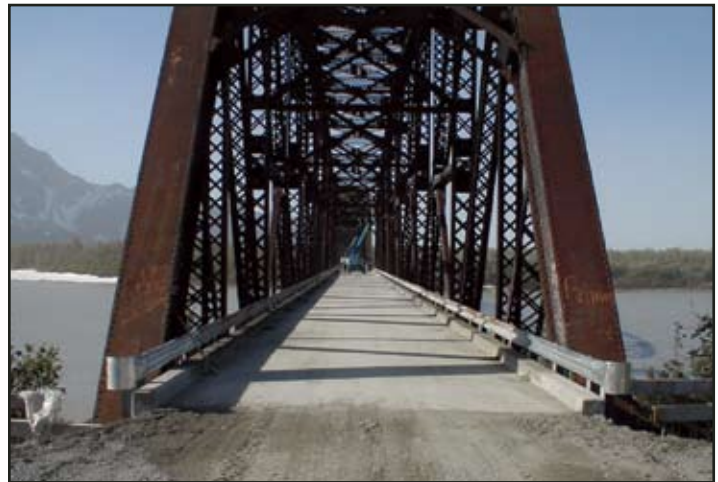
*A new concrete deck was poured to replace the old deck.*

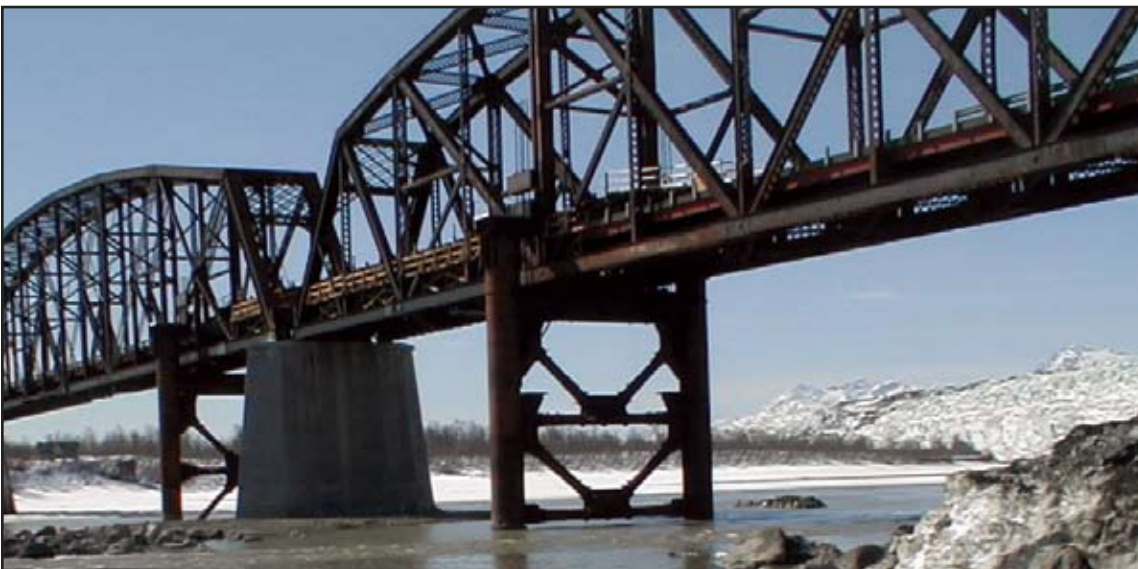
*The bridge structure is intact once again with a newly constructed pier. The four pilings used to lift the spans will be removed under phase two of the project.*

Phase two of the project will include removing the four steel pilings, straightening an offset between spans three and four, and installing isolation bearings on the other two piers

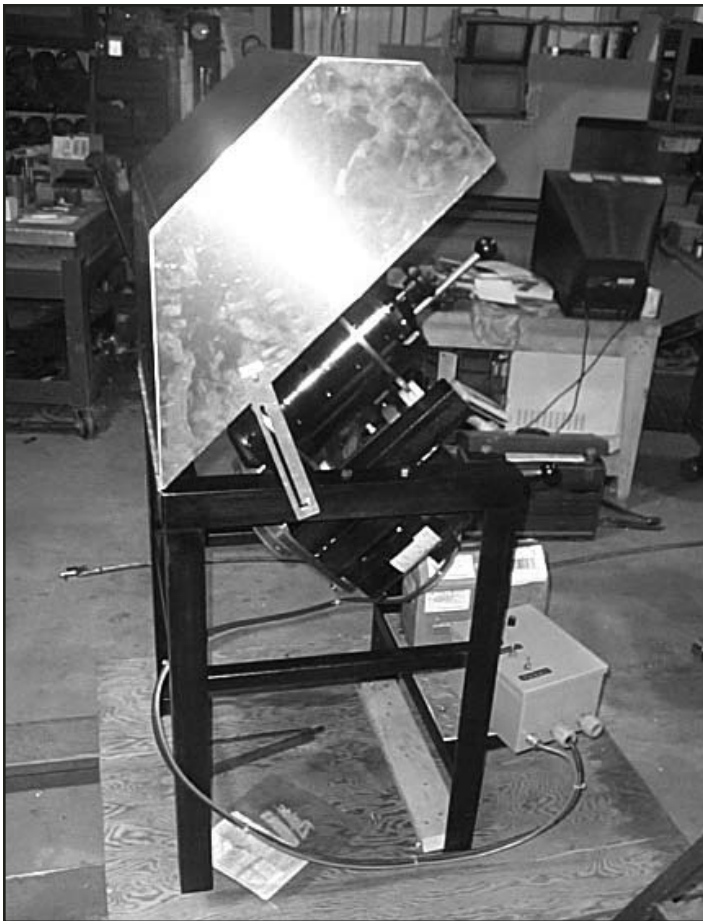
*A new Nordic abrasion tester is fitted with a safety hood and is almost ready for delivery. You can see the drum is tilted in this picture. It can tip up for loading and down for unloading the sample charge.*

The testers work similarly to hobby rock tumblers. Seven kilograms of chrome-steel ball bearings are tumbled with three and a half kilograms of 7/16 to 5/8 inch aggregate sample and two liters of water in the revolving drum for about one hour at 90 rpm. The drum is then stopped automatically at the 5,400th revolution. At the end of this run, the drum is tipped and the sample charge dumped out to be dried, sieved, and weighed to evaluate degradation. Control of the test is achieved with an inductive pickup sensor connected to a programmable revolution counter and a variable frequency drive.

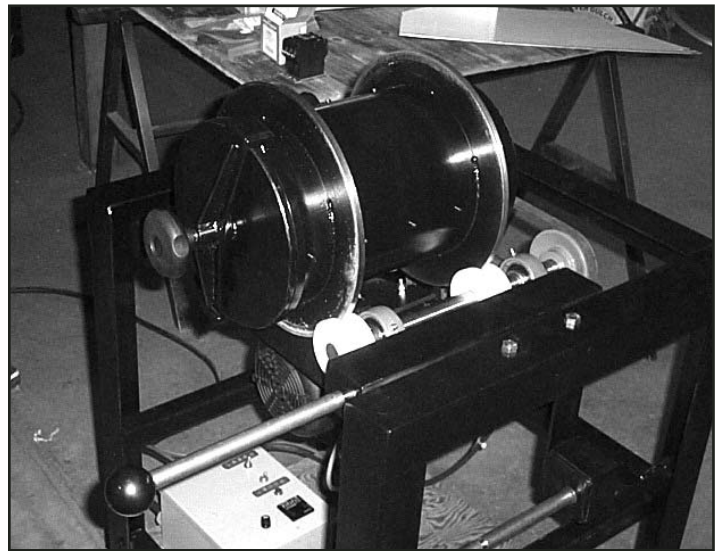
*These photos of the tester shows the concept of the revolving drum that tumbles the sample. The drum rests on Delrin wheels machined in the shop.*

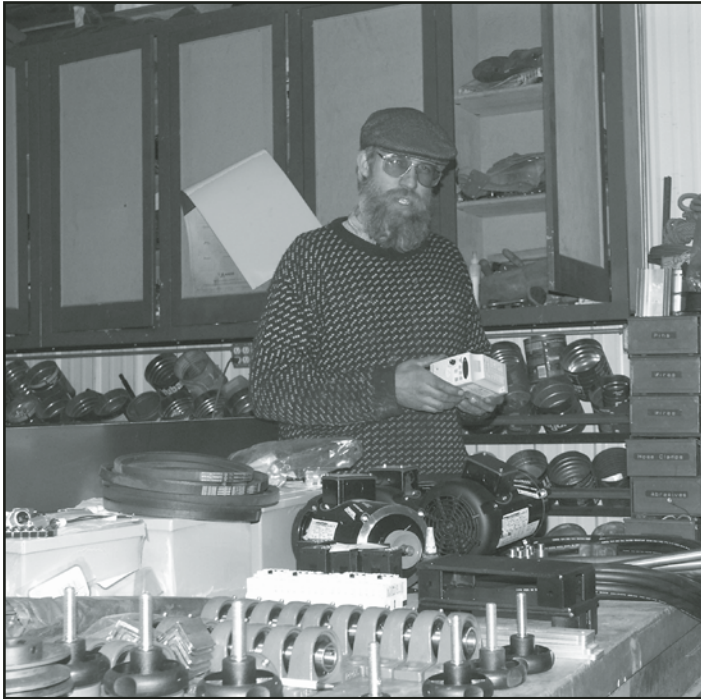
*Jon Holmgren prepares a control unit for the Nordic abrasion testers. Parts for the testers are organized on the table in the foreground*

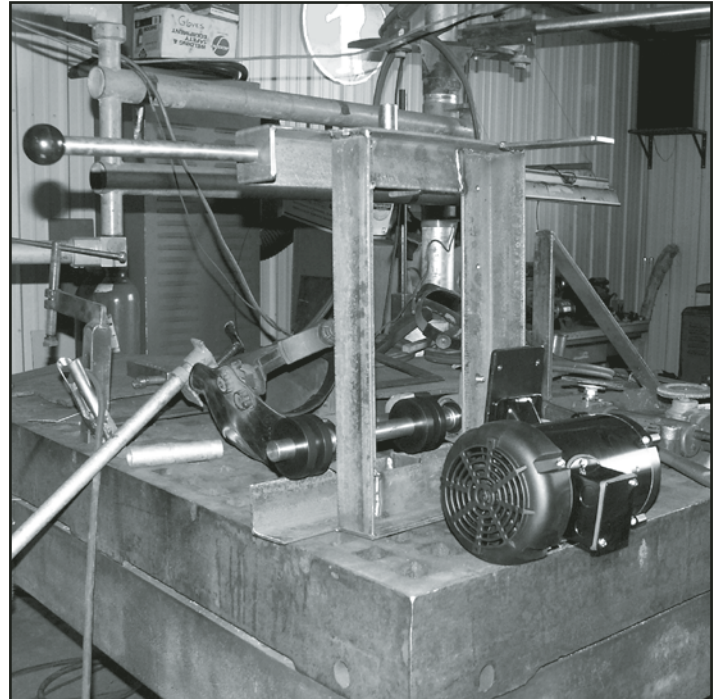
*The chassis for the drum and drive wheels and bearings is being test-fitted here with the drive motor.*

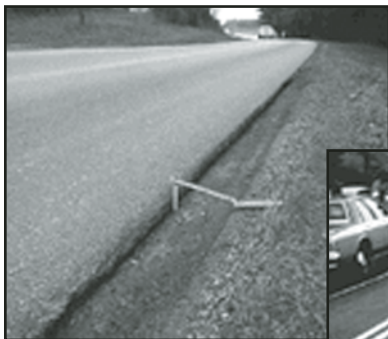
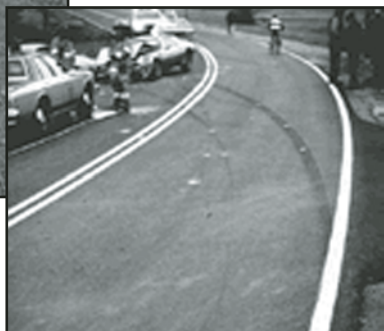
Drivers who slip off a resurfaced road onto an unimproved shoulder are likely to lose control as they attempt to climb back onto the roadway. The pavement edge creates a “scrubbing” condition that a driver must overcome by oversteering. As drivers oversteer to re-enter the roadway, they are prone to lose control of the vehicle. Compounding the dan-

ger, the rear wheel may catch the edge of the shoulder, swinging the car around. This may cause the car to veer into the adjacent lane, where it may collide or sideswipe oncoming cars, overturn, or run off the road and crash.

The solution to the pavement edge drop-off hazard is two-fold: Require a “Safety Edge,” an angled asphalt edge, or fillet, that slopes 30 to 35° from the pavement surface to the shoulder, as a contract specification in all pavement construction and resurfacing projects. Routinely resurface shoulders when roadways are resurfaced. The angled asphalt edge, or fillet, provides a safer roadway edge and a stronger interface between the roadway and the shoulder. The cost of providing an asphalt fillet is minimal in comparison to the total amount of the resurfacing contract and pays back in countless dollars saved from reduction of fatalities, injuries, property damage, and lawsuits. The fillet ties the existing shoulder into the resurfaced roadway and allows a vehicle to reenter the roadway safely. Highway agencies are able to restore the shoulder after the resurfacing project is completed.

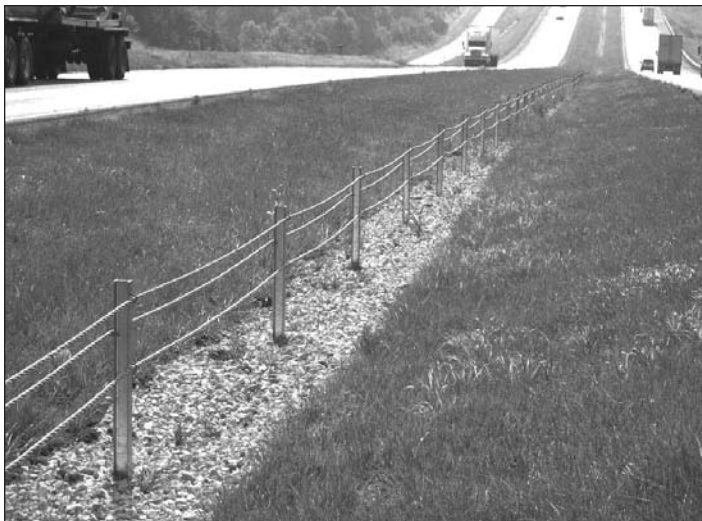
*Above: A standard three-strand cable median barrier.*

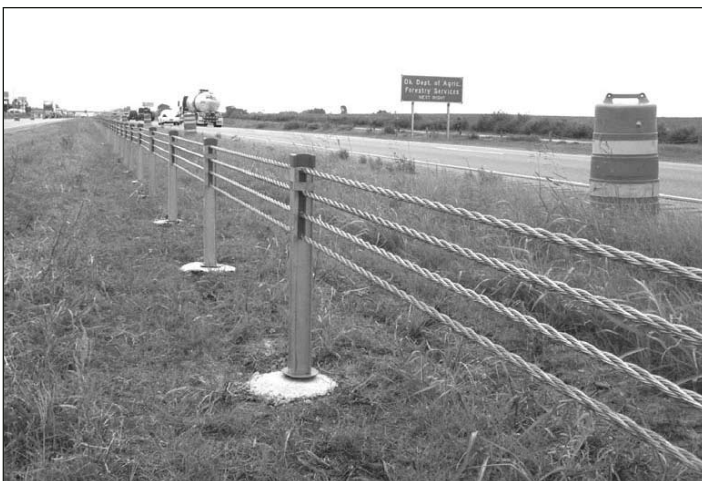
*Below: A high-tension four-strand cable median barrier.*

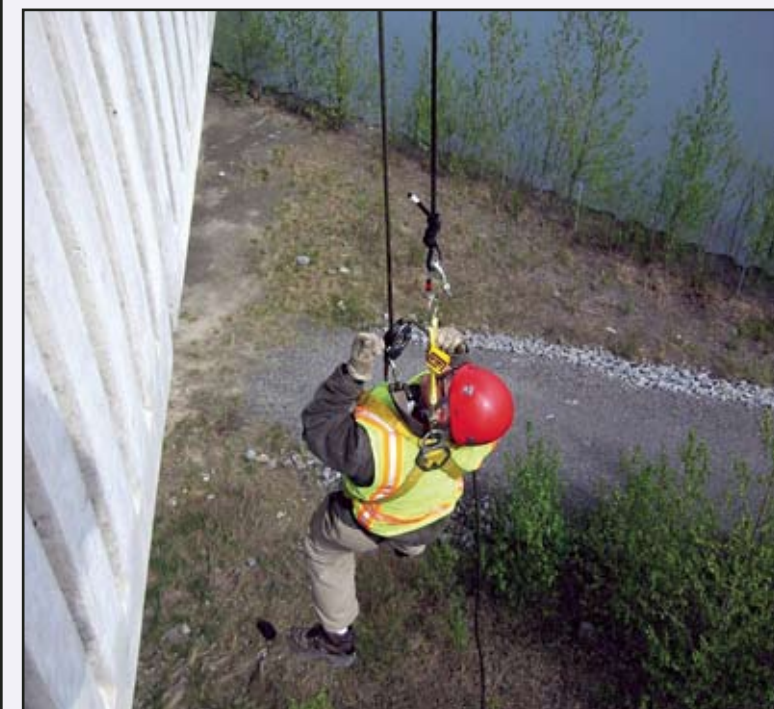
Personal fall-protection systems include a body harness (safety belts for fall arrest are no longer allowed by OSHA) and a lanyard that connects you to a substantial anchorage.
