**SUBGRADE INSULATION FOR FROST HEAVE CONTROL
CONSTRUCTION, INSTRUMENTATION,
AND
FIRST YEAR SUMMARY**

State of Alaska, Department of Highways
Materials Division

*Prepared by David C. Esch
June, 1969*

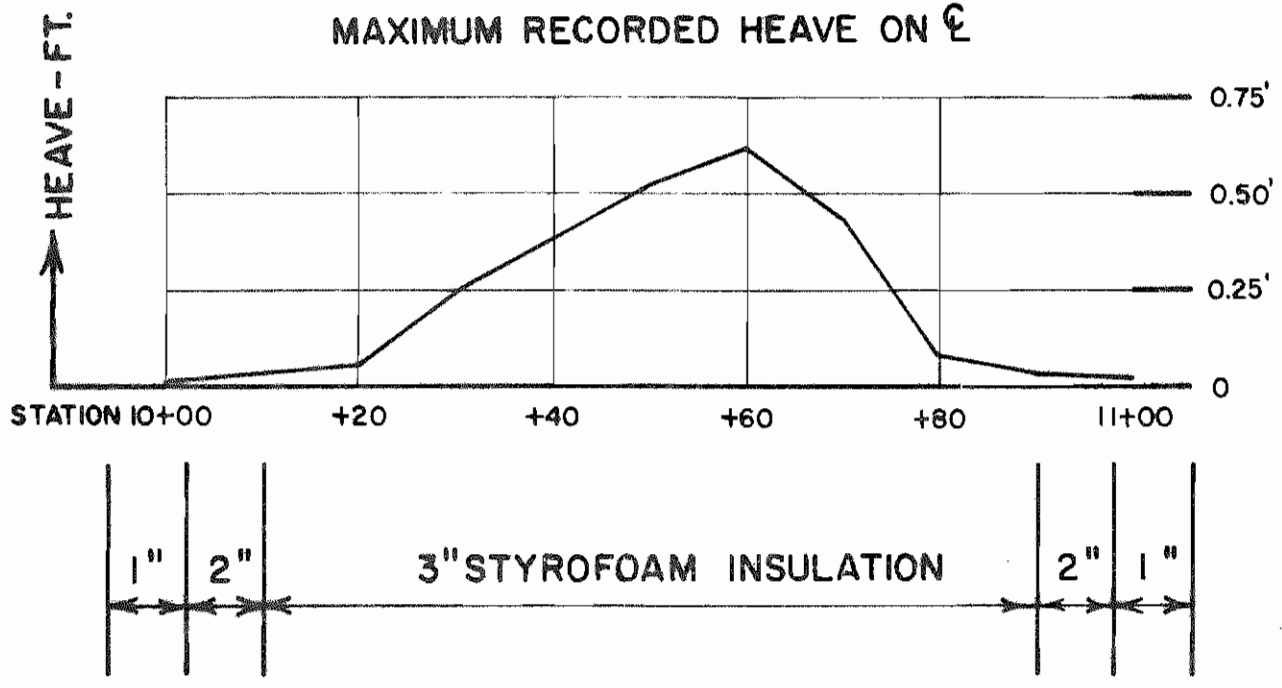
FIGURE 2(b)

TEST SECTION 1B
WINTER OF 1967-68

MAXIMUM RECORDED HEAVE ON \mathcal{C}

The two heave sections selected for the insulation test sections showed maximum heave differentials of from zero to 0.32 and 0.60 ft., within distances of 20 feet, as shown by Figures 2(a) and 2(b). These sections were located 900 feet apart, which presented the chance to compare the performance of two separate installations presenting very similar conditions as to climatological environment and terrain. Both sections were provided with decreased insulation thicknesses at the ends, to provide thermal transitions from uninsulated to fully insulated areas. Selection of the starting and ending points was done on the basis of the heave profiles. Insulation widths were designed to provide coverage for a distance of four feet beyond the edge of the pavement, for a total width of 32 feet. A minimum total overlay of base plus pavement of 18 inches was provided above the insulation.

Maximum heave recorded during the 67-68 winter, before the insulation was installed, was 0.62 feet. The insulation resulted in a general reduction in heave, as compared to the previous season, of about 0.4 feet, which completely eliminated the safety hazard and discomfort involved in traversing the test section.

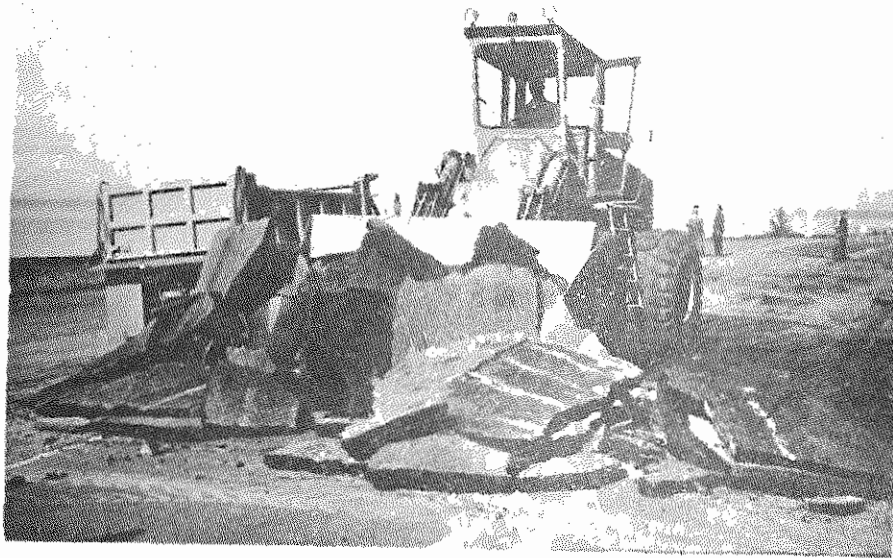
Photo 1A-1

Excavation of pavement and base with loader.

Excavation of the roadway pavement and base layers to a depth of 21 inches was done on August 28, 1968, by means of a front end loader. After leveling, the surface was rolled with a vibratory steel wheel roller, which resulted in a satisfactory surface for insulation placement. Borings were made for placement of two thermocouple strings beneath the insulated area and one thermocouple string located beneath the adjacent uninsulated roadway at Station 0+80.

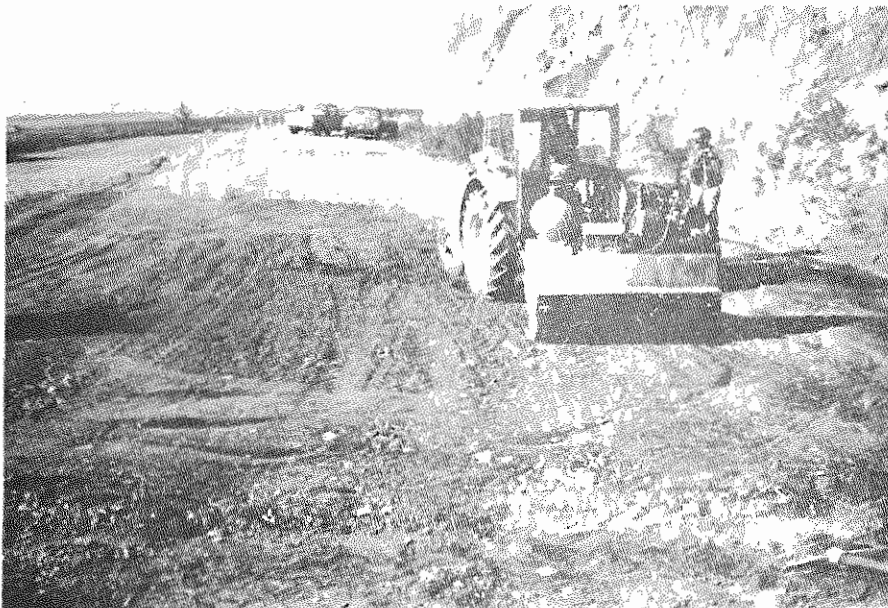
Photo 1A-2

Excavation and leveling completed. Vibratory roller used to compact and smooth surface prior to foam placement.

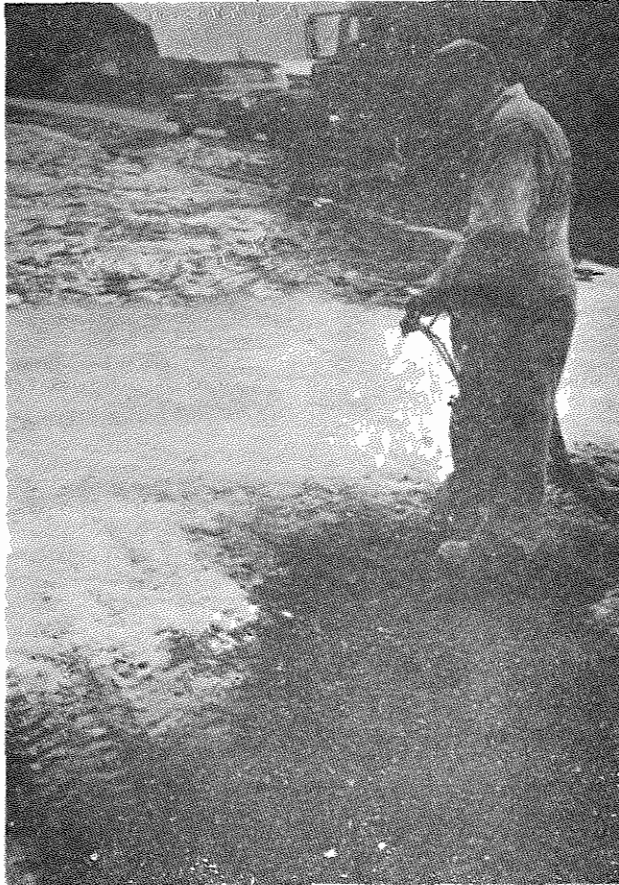
Photo 1A-3

Polyurethane foam placement in operation. Two components are heated, mixed at the nozzle, and sprayed on the roadway subgrade. The surface beneath the insulation has been given a preparatory coating of asphalt to prevent the foam from absorbing moisture. The asphalt coating applied to the top of the foam is visible in the background.

Application of the urethane insulation started on August 29. Because a rain shower during the night had saturated the previously prepared surface, it was necessary to delay operations and permit the roadway to dry prior to application of the preliminary asphalt coating. The asphalt, a 200-300 penetration grade, was heated to 350 degrees F. and applied at an average rate of about 0.2 gallon per square yard. Due to minor equipment problems, foam application was not completed until 2:00 P.M. on August 30. The urethane foam results from mixing two pre-heated components and spraying the resultant fluid. Average production rate for the single gun-type foaming apparatus used was 500 board feet per hour. Width of the insulation averaged 34 feet. Transition sections received one inch of foam, while two inches were placed on the center section. The foam surface is naturally somewhat irregular and the actual thickness of the foam is dependent upon the skill of the operator. Repeated checks on the foam thickness, made by penetrating it with a knife blade, showed the thickness to average quite close to the two and one inch thicknesses specified. After foaming, the insulation could support the weight of a man in about one minute. The strength increases for a number of hours after foaming, according to the manufacturer. Next, a second asphalt coating was applied at the same rate and temperature as the initial coat. The hot asphalt had no detrimental effect on the foam as far as could be determined.

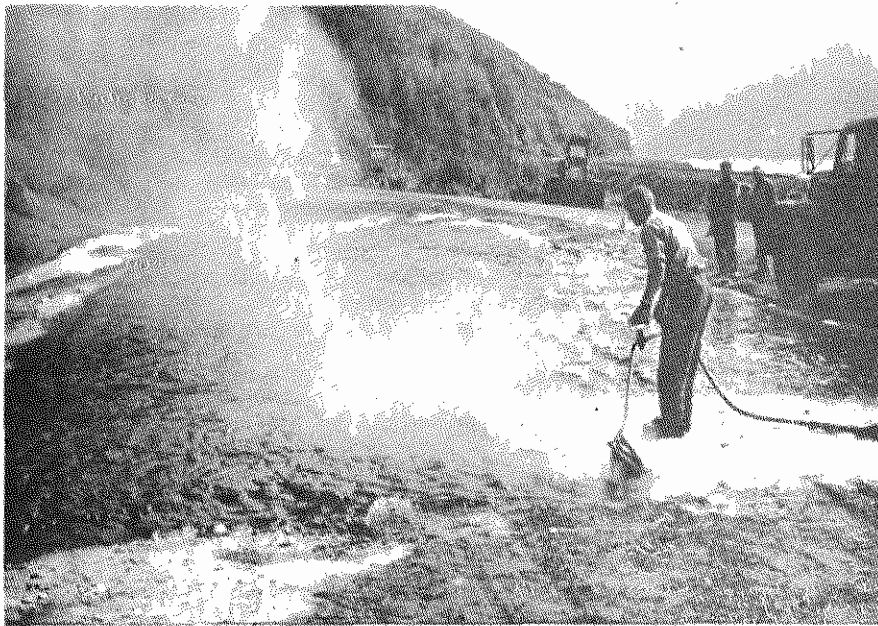
Photo 1A-4

Foaming operation completed. Spraying of final coating of hot asphalt over polyurethane foam is in progress.

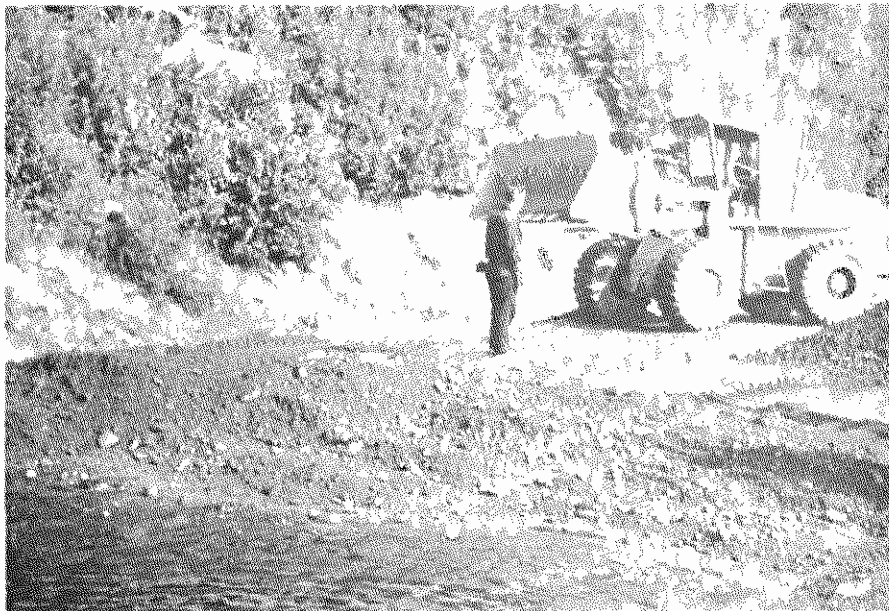
Photo 1A-5

Placement of initial lift of backfill over the urethane foam. Note cobbles up to 6 inch size in the sandy gravel backfill.

Backfilling started immediately after completion of the foaming operation. The initial 9 in. thick layer was spread with the loader, leveled with a motor grader, and compacted with several passes of a steel-wheel vibratory roller. The backfill material was a sandy gravel with some cobbles. In two areas the first lift was accidentally spread too thin, resulting in less than 4 inches of gravel beneath the wheels of the loader. In both instances, excavation showed negligible damage or crushing of the foam. A second lift of gravel was placed and compacted. Following this, the section was brought to grade with a crushed aggregate base material, and opened to traffic on the evening of August 30.

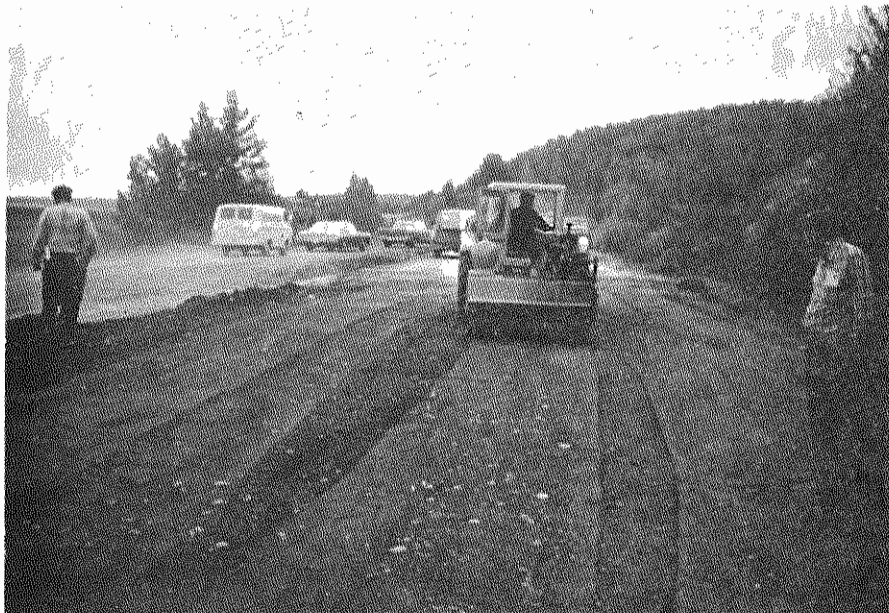
Photo 1B-5

Compaction of backfill above insulation.

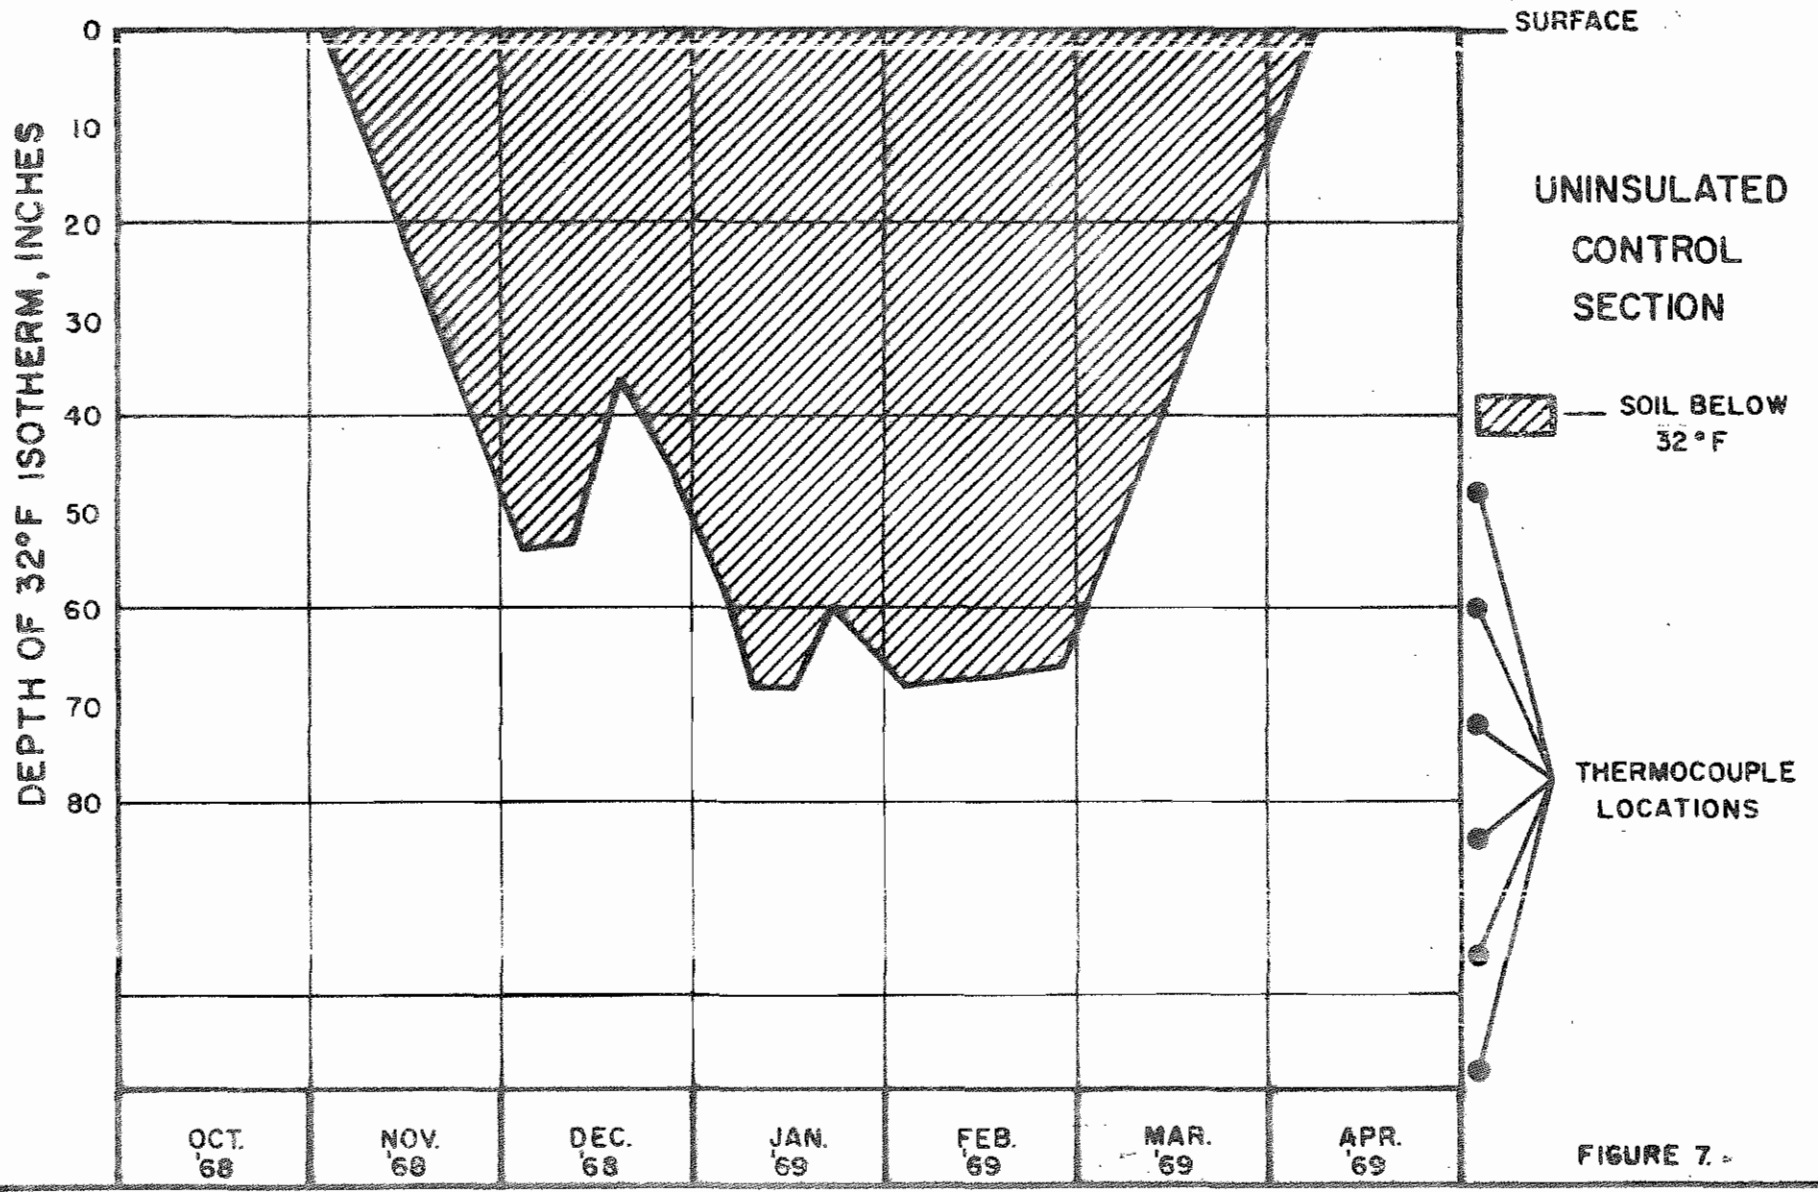
FIGURE 7.

SECTION 1A, LOCATION TC-8, ON E

The control thermocouple string for this section, located on centerline 20 feet away from the end of the insulation, showed increasing frost penetration up until mid-January. At that time the total penetration was nearly six feet. For the remainder of the winter, frost penetration did not increase significantly.

Figures 6 and 7 show the depth of the 32 degree F. isotherm plotted versus time at the thermocouple locations related to Section 1A. It should be noted that no thermocouples were located above the upper surface of the insulation and that the advances of the freezing and thawing planes through the materials above the insulation were not defined.

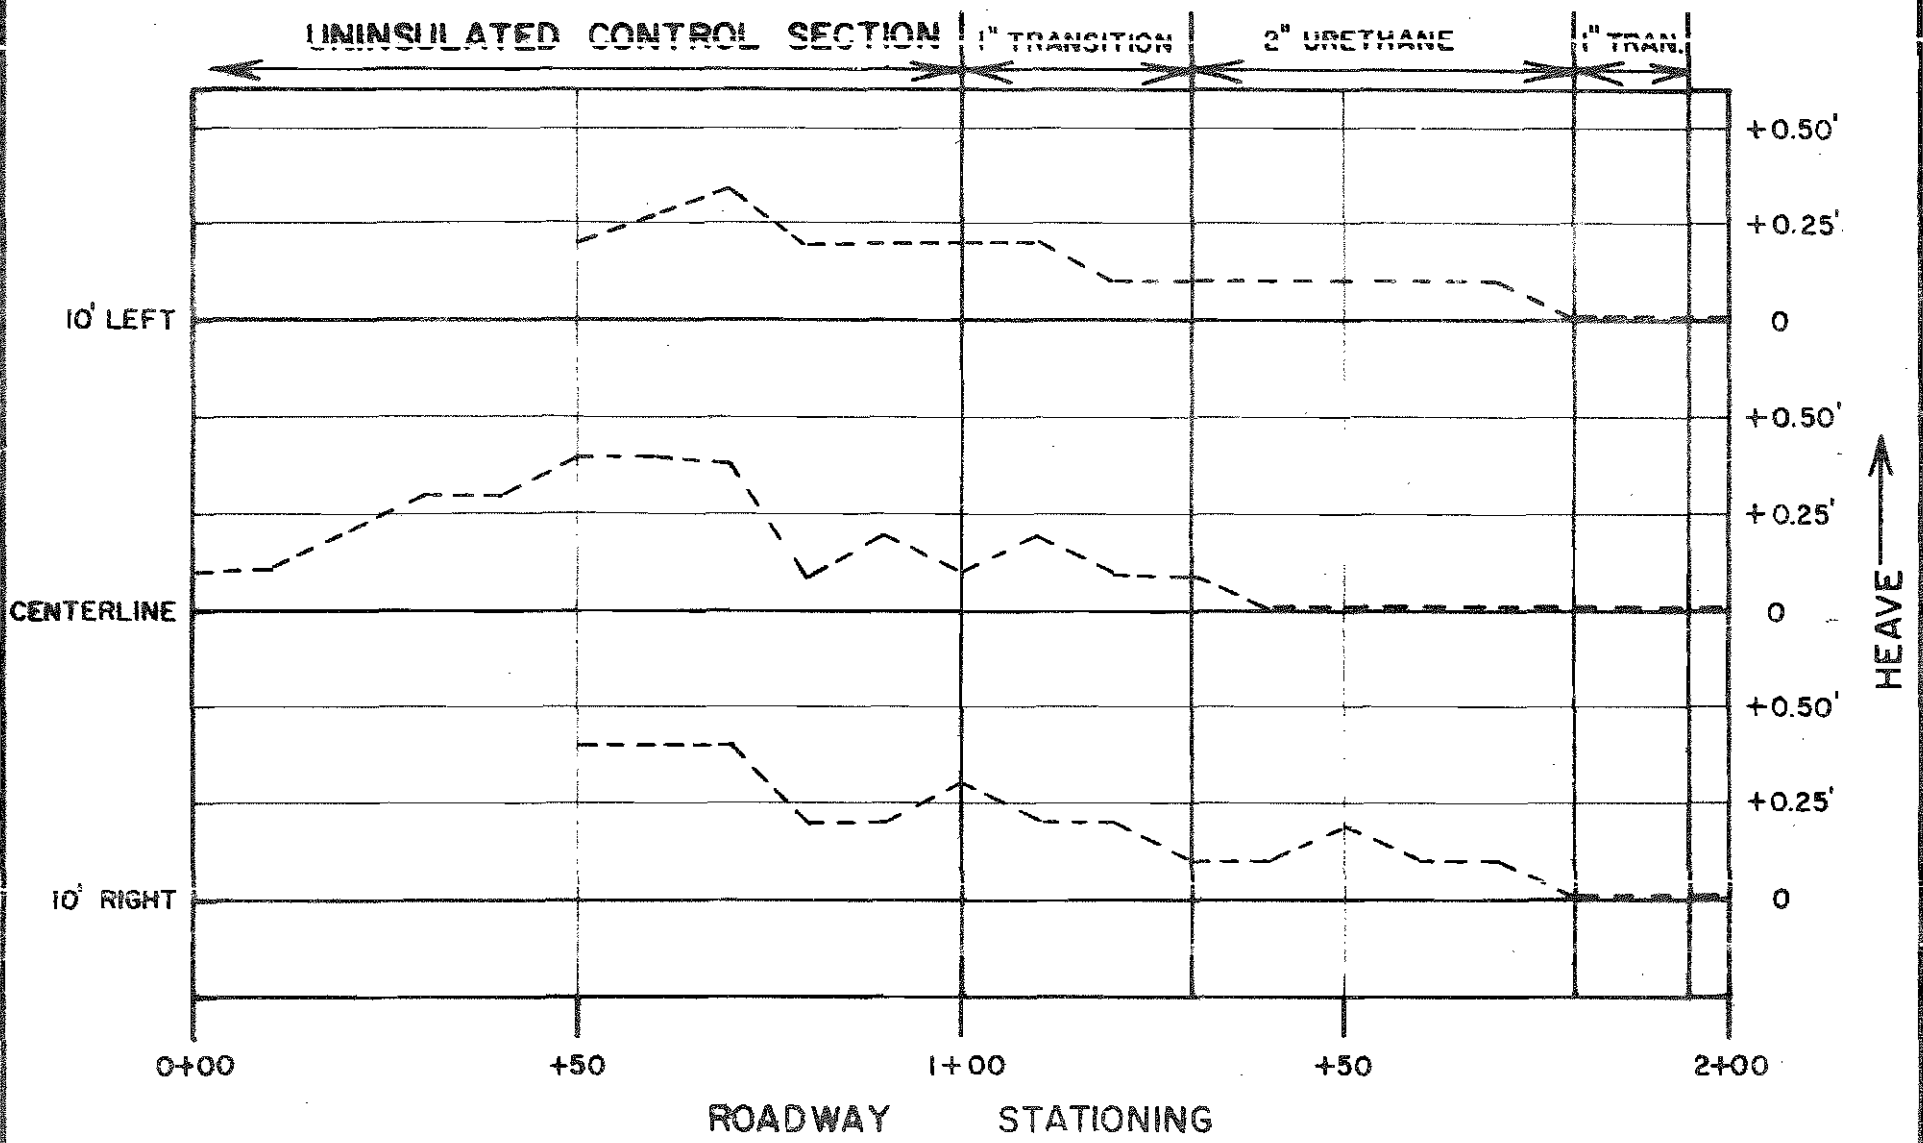
FIGURE 8.

MAXIMUM ROADWAY HEAVE PROFILE

TEST SECTION 1A, 1968-69 WINTER

The heave profiles for Section 1A showed that minor heaving of the fully insulated area had occurred by January 14, 1969. By mid-February, the heave was at its maximum for the winter in most areas. Heave elevation checks showed only one point, out of the thirty within the fully insulated area, at which the heave exceeded 0.10 feet. The heave magnitude increased through the southern transition section to 0.20 to 0.30 feet at the uninsulated end of the transition. Beyond the control thermocouple location, Station 0+80, the heave increased to a maximum of 0.4 to 0.5 feet, creating a rather severe bump. The bump was some 30 feet beyond the insulated section and does not appear to have been created by the test section. This heave was not noticeable during the winter of 1967-1968, and elevation checks run in the preliminary study of frost heave magnitudes did not extend far enough to cover the area. The maximum heave magnitudes recorded during the 1968-69 winter on centerline and on lines located 10 ft. right and left of centerline are plotted on Figure 8. This should be compared with Figure 2(a) showing heaving prior to insulation placement.

Heave profiles for the previous winter showed a uniform heave of about 0.15 feet at the point where the southern insulation transition section was ended. Because of limited funds, lack of an adequate detour route, and lack of information of the southern end of the heave area, the test section was provided with a long transition section, rather than extended further to the south.

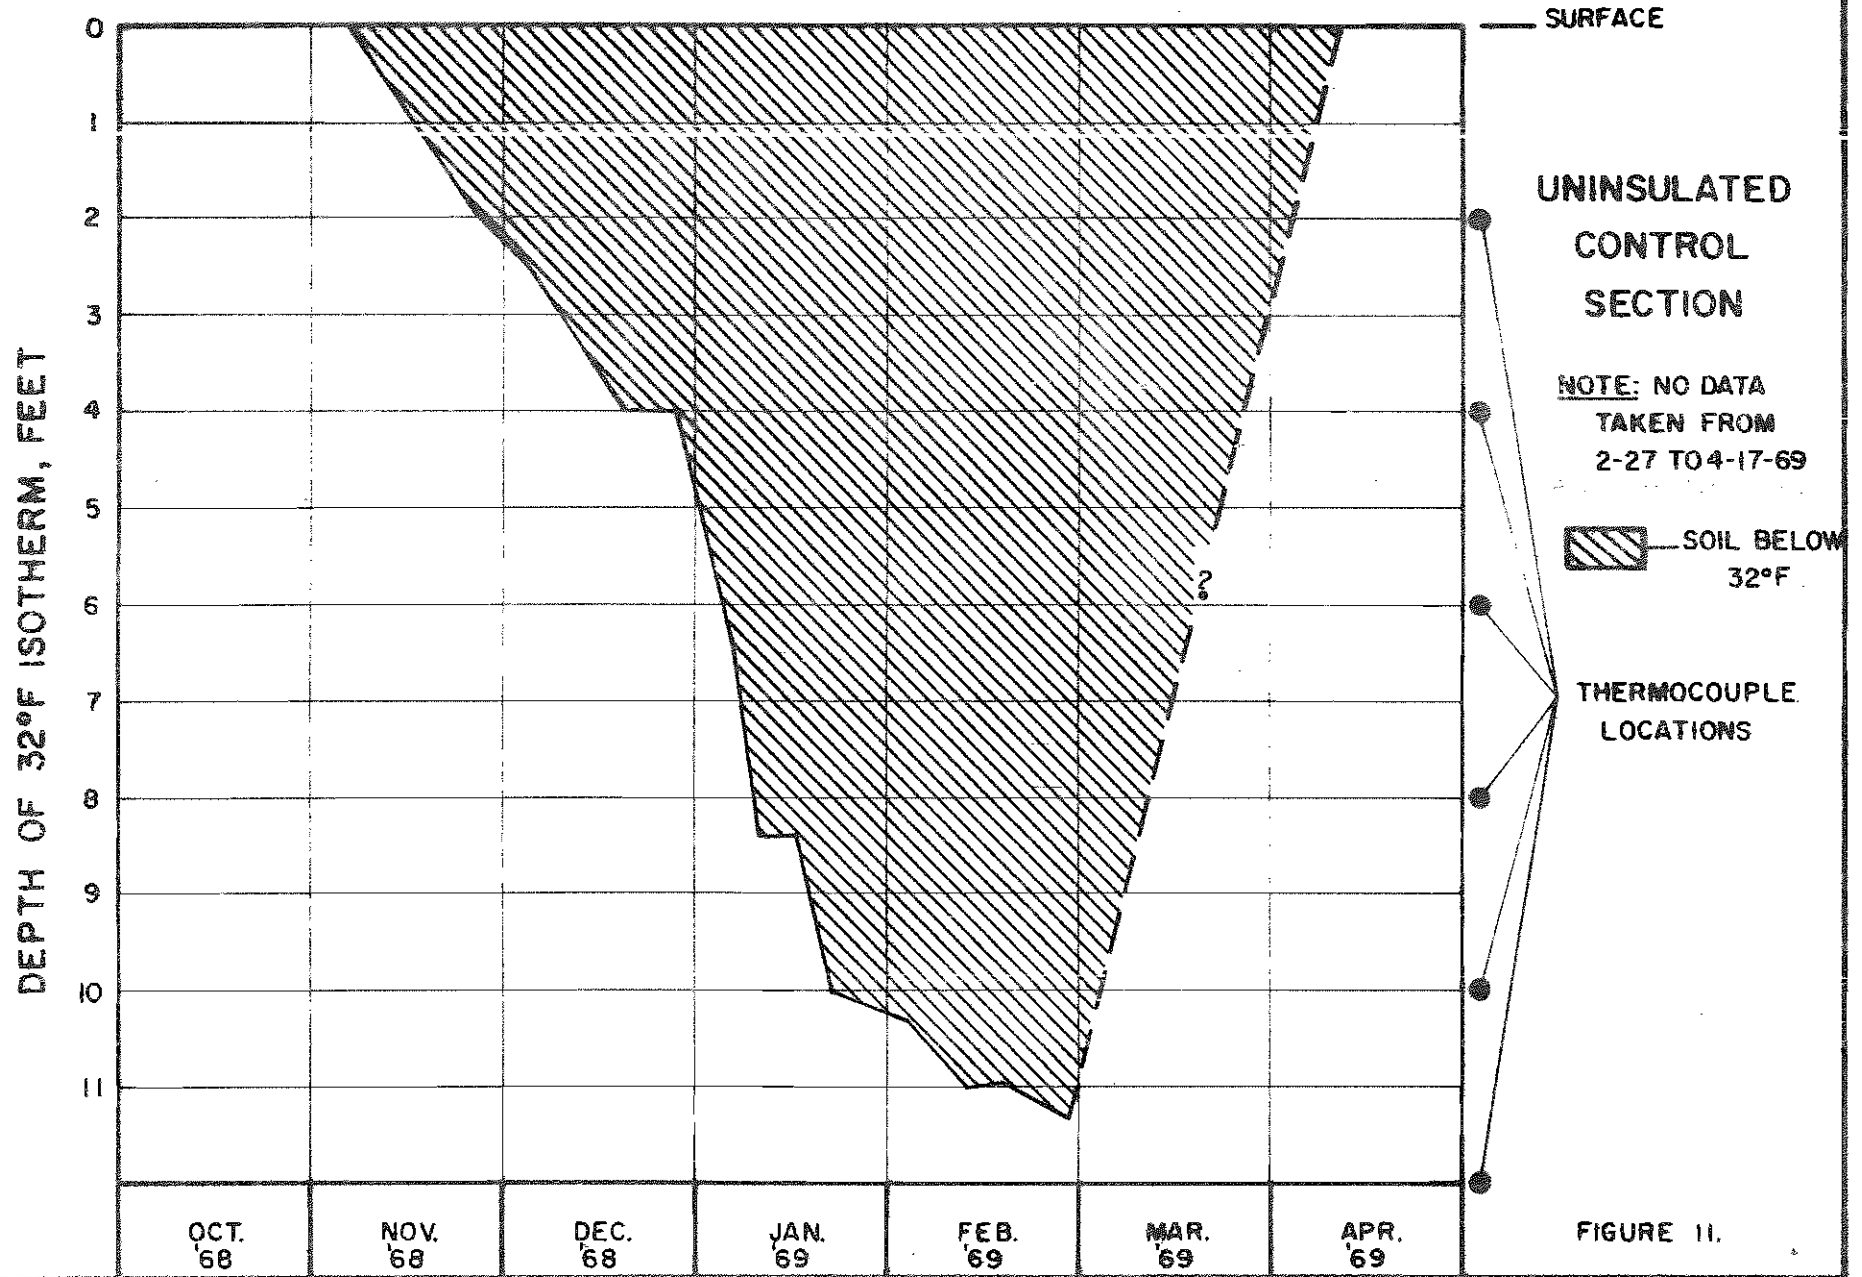
FIGURE 11.

SECTION 1B, LOCATION TC-4, ON E

Thermocouple readings taken on February 3, 1969 indicated that all soils beneath the insulation had thawed. Frost penetration in the control area, at thermocouple location TC-4, continued to increase through February, 1969, reaching a maximum depth of 11½ feet.
