Evaluation of MEMS-based In-place Inclinometers in Cold Regions

Margaret M. Darrow, Ph.D.
David. D. Jensen, E.I.T.

December 2012

INE/AUTC 12.38

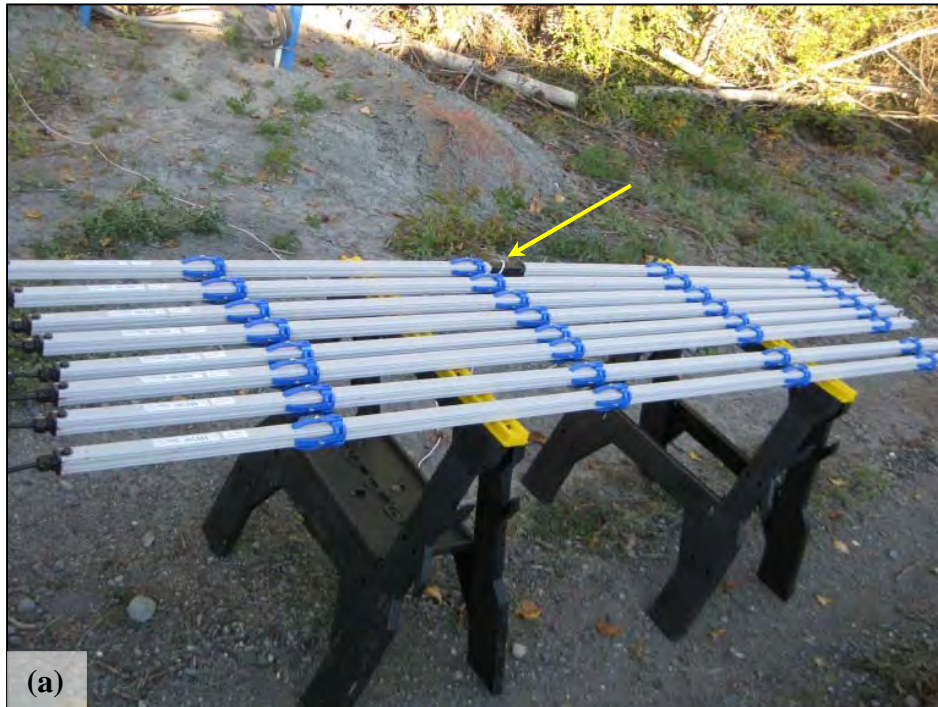
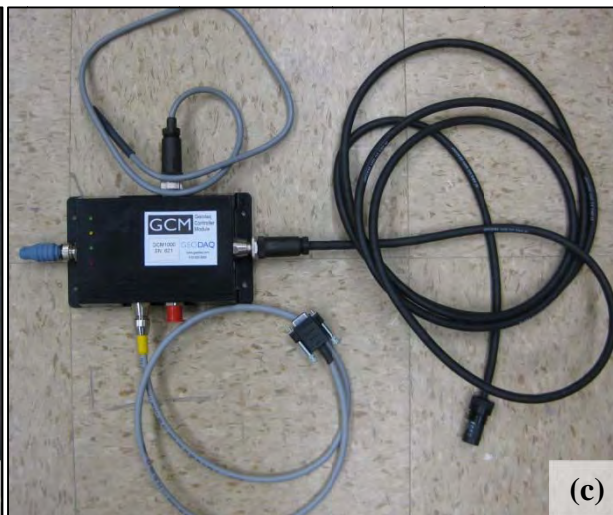
Figure 1. Components of the Geodaq INC500 device. (a) Modules prepared for installation; the yellow arrow indicates a safety line attached to the lowest module. The other components necessary to complete an installation are (b) coupler assemblies, centralizers, a slotted fork to hold the INC500 within the casing, and (c) the GCM controller module. (Photographs by M. Darrow)

The INC500 device consists of 8-ft long flexible modules that contain a series of MEMS-based accelerometer sensors, which measure tilt (see Figure 1). In a standard module, these biaxial sensors are located every 12 in., along with a temperature sensor that has a reported accuracy of $\pm 3^{\circ}\text{F}$ (GEODAQ, 2010) and is not calibrated unless specified by the customer. The modules are

joined by underwater electrical connectors, and the connections are stiffened by a coupler assembly, in order to give the entire instrument length a uniform rigidity. Additionally, three to four centralizers are mounted along the length of each module. Each centralizer contains four stainless steel wheels that are designed to guide and orient the device within a guide casing. Because of its modularity, an INC500 device can be lengthen or shortened to accommodate the geometry of a given installation. The order of the modules as installed within the casing must be recorded, as this order is an input parameter into a setup file for the software program to calculate displacement (see Figure A-6). The INC500 must be installed so as to rest on the bottom of the casing. Because of the potential difference in length between the joined modules and the total casing depth, the INC500 may rest slightly lower or higher than the ground surface within the casing (J. Lemke, pers. comm., March 2010). The INC500 instrument acquired for this research contained bi-axial sensors oriented only for a vertical installation. The manufacturer can make a model for both vertical and horizontal applications, which requires additional sensors (J. Lemke, pers. comm., March 2011).

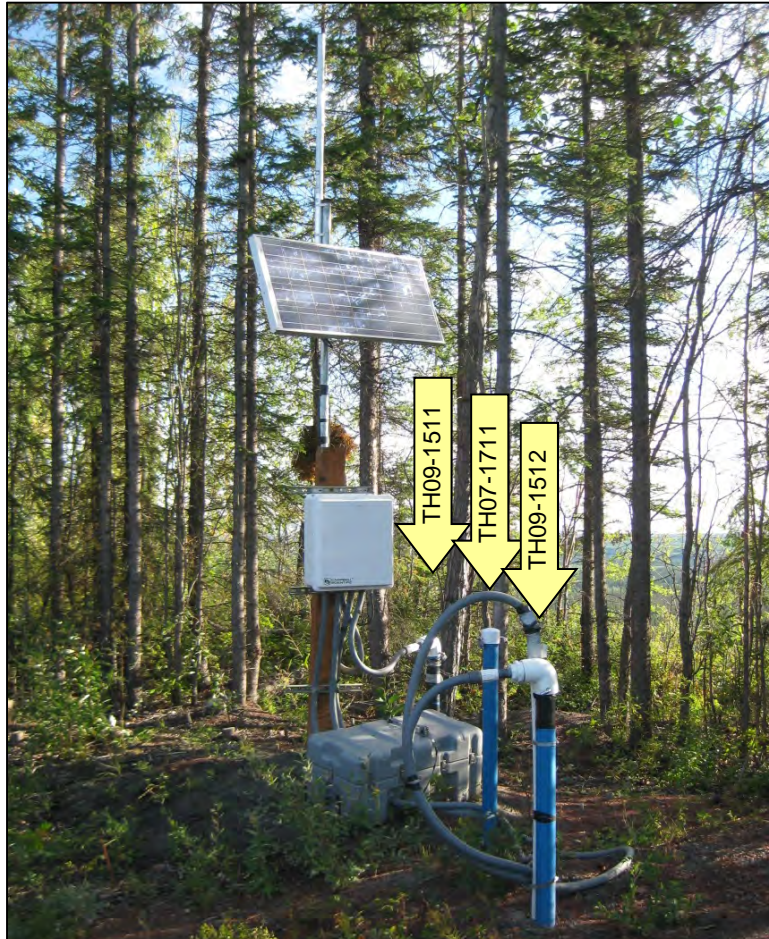
Figure 4. Relative locations of the measured casings at Rich113. Vertical arrows are labeled with the test hole identifiers. The edge of the bluff overlooking the Copper River is immediately beyond the spruce trees behind the installations, and the Richardson Highway is behind the photographer. (Photograph by M. Darrow)

For spatial reference of the measured locations, Figure 4 is a photograph of the casing locations relative to each other and the bluff edge. Figure 5a and b are plots of cumulative displacement obtained from the three instruments. The readings collected with the traditional inclinometer probe (shown as green diamonds and labeled with the prefix “SI” in each figure) indicate movement occurring at approximately 55 ft bgs, with between 0.5 and 0.6 in. of cumulative displacement within the analyzed time frame. Although small, this movement is consistent in depth and character with that previously recorded for this site.

We installed the INC500 inside a guide casing within the boring TH09-1511 (see Figure 4). When we extracted the M-IPI device, we measured the casing with the inclinometer probe for comparison. Thus, the cumulative displacements from the INC500 and the inclinometer probe shown in Figure 5a are directly comparable. Visual analysis indicates that the two sets of readings are very similar, with a maximum difference in readings of 6.89×10^{-2} in. Readings from equivalent depths for these two instruments are plotted in Figure 5c. The solid red line at 45° indicates a 1:1 relationship. For each pair of readings, the precision (or repeatability) of the inclinometer probe and INC500 is shown as horizontal or vertical whiskers, respectively. Examination of the measurement pairs indicates that each point lies within the precision of the inclinometer probe device; thus, the readings cannot be differentiated from each other.

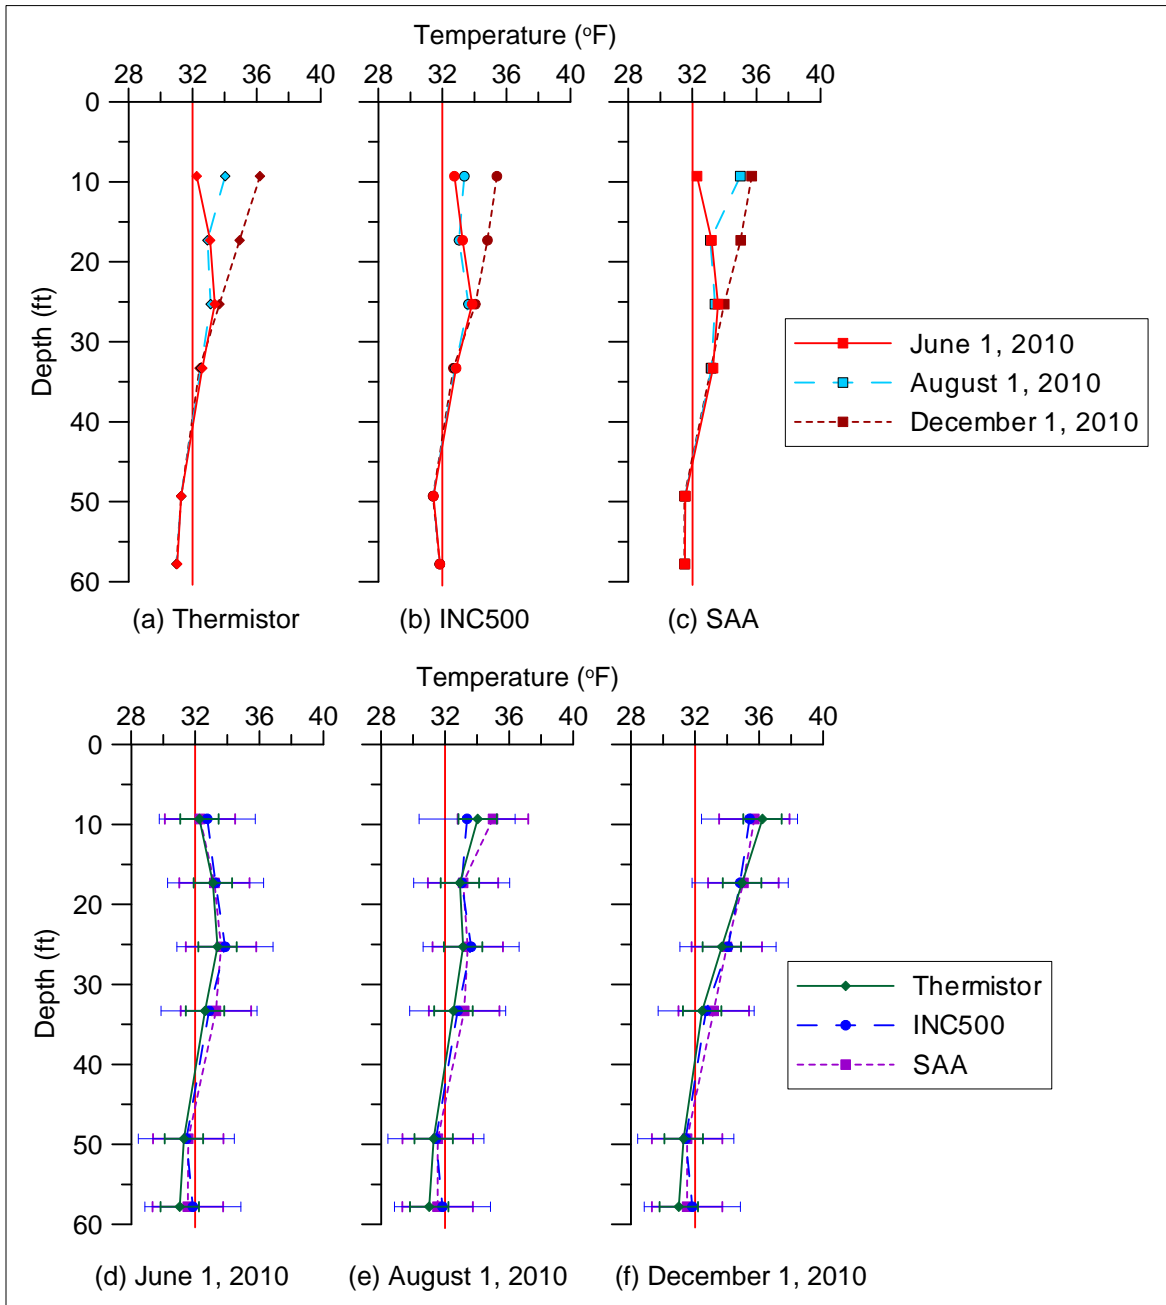
Figure 6. Comparison of measured temperatures. The graphs (a), (b), and (c) are measured temperatures from the thermistor string, INC500, and SAA devices, respectively. Data for three different days are shown for each device. The graphs in (d), (e), and (f) are comparisons of the measured data from all of the three instruments for June 1, 2010, August 1, 2010, and December 1, 2010, respectively.

The temperature measurements from the two M-IPI devices were compared against those collected from a thermistor string, which was installed in a second 1-in. dia. casing within TH09-1512. Each thermistor bead within the string has a reported accuracy of $\pm 0.2^{\circ}\text{F}$ (Measurement Specialties, 2008), and the entire string was calibrated in an ice bath. Thermistor measurements were recorded at 8-ft intervals along the length of the string, with the exception of the thermistor at 41.1 ft bgs, which ceased to report data after the installation (see Figure 6a). Since the temperature sensors in the INC500 and SAA were not positioned at the exact same depths as the thermistor beads, readings from the two nearest sensors above and below each thermistor bead were interpolated for the required thermistor depth. These are the values that are shown in Figure 6b for the INC500 and Figure 6c for the SAA. Data from three different days in 2010 are shown for each of the devices (see Figure 6a-c); each device measured the same temperature $\pm 0.02^{\circ}\text{F}$ for the lowest two depths, indicating a consistent temperature within the permafrost and stability of each measurement device throughout the six months presented.

Next, the INC500 and SAA data were compared to the thermistor string data. Figure 6d, Figure 6e, and Figure 6f are plots of all three devices for June 1, August 1, and December 1, 2010, respectively. Each data point is plotted with horizontal whiskers indicating the reported accuracy of the sensor. Each cluster of measured temperatures falls within the ranges of accuracy for both instruments. On average for these three days, the INC500 and SAA sensors were within 0.41°F and 0.39°F of the thermistor measurements, respectively. While temperatures plotted with these devices are able to demonstrate the general trend of temperature with depth, this $\sim 0.4^{\circ}\text{F}$ offset would make analysis of activity in the active layer or identification of the permafrost table problematic. This issue may be addressed by using an M-IPI device with calibrated temperature sensors.

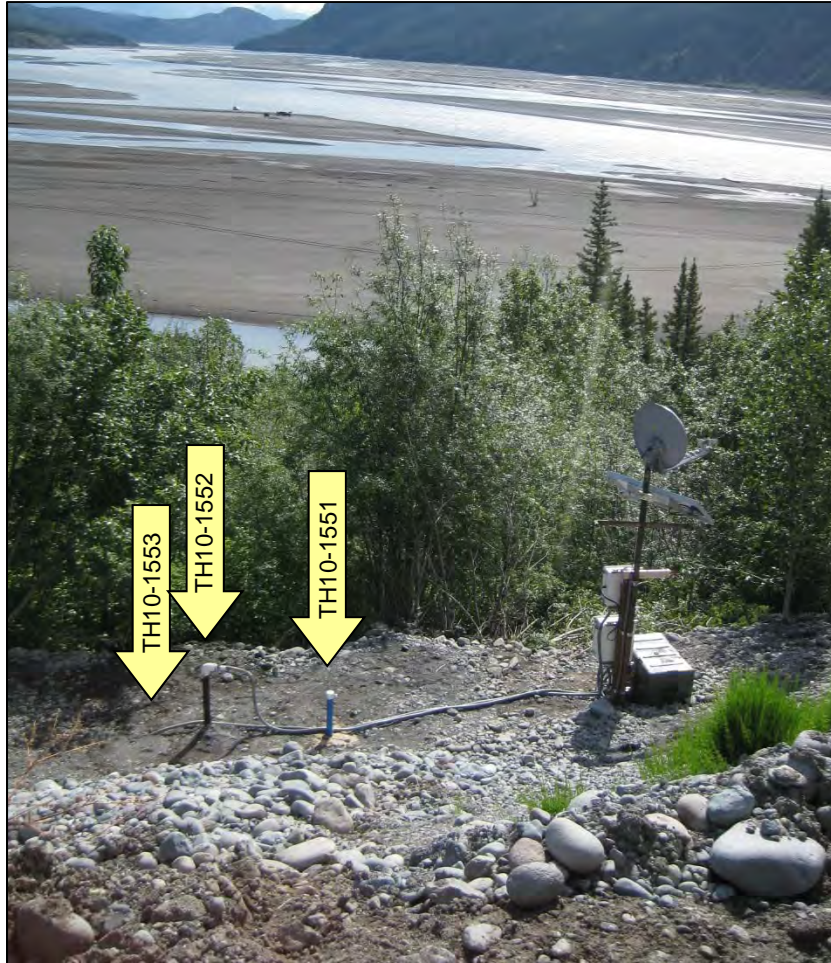
Figure 8. Relative locations of the measured casings and piezometer installation at the Chitina Dump Slide. Vertical arrows are labeled with the test hole identifiers; the installations were located on a drill bench downhill of the roadway embankment. This photograph was taken from the McCarthy Road embankment looking east towards the Copper River. (Photograph by M. Darrow)

For spatial reference of the measured locations, Figure 8 is a photograph of the casing locations relative to each other. As a first step in analysis, inclinometer probe measurements were used to evaluate the effectiveness of tamping the sand backfill around the casing within the boring. Voids created by bridging within the loosely poured sand into the annular space in a boring often are evident in sagging of the casing within a few weeks after the initial installation. The data collected during the summer of 2010 was evaluated by assigning two different initial dates, June 17 (date of installation) and June 25 (one week later). Below the shear zone, these sets of readings differed by 0.03 in. at the most; thus, we considered any sagging of the casing as minor, and used June 17 as the initial reading for the rest of the analysis. Figure 9b contains all of the cumulative displacement measurements from 2010, which indicate a shear zone between 14.3 and 18.3 ft bgs and about 1.7 in. of movement over the three month measurement period.

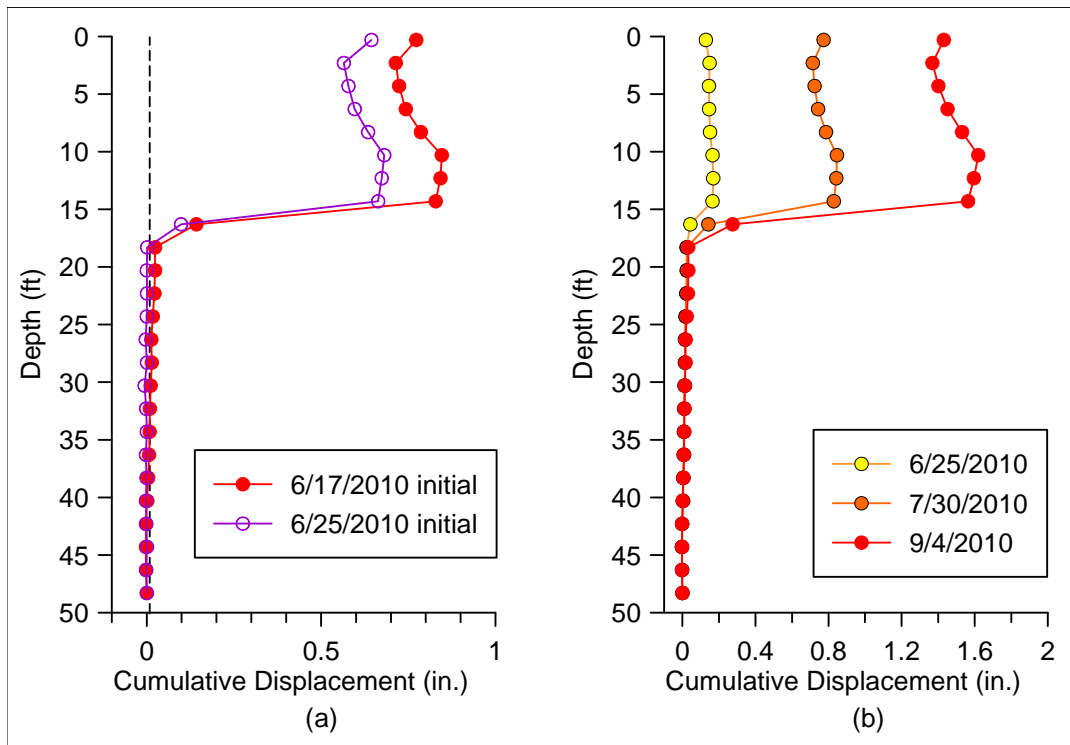
Figure 9. Cumulative displacement measurements from the inclinometer probe for TH10-1551. (a) Evaluation of slump of the casing within the tamped sand backfill using two different start dates (note the enlarged horizontal scale for better resolution); (b) all cumulative displacement measurements from 2010.

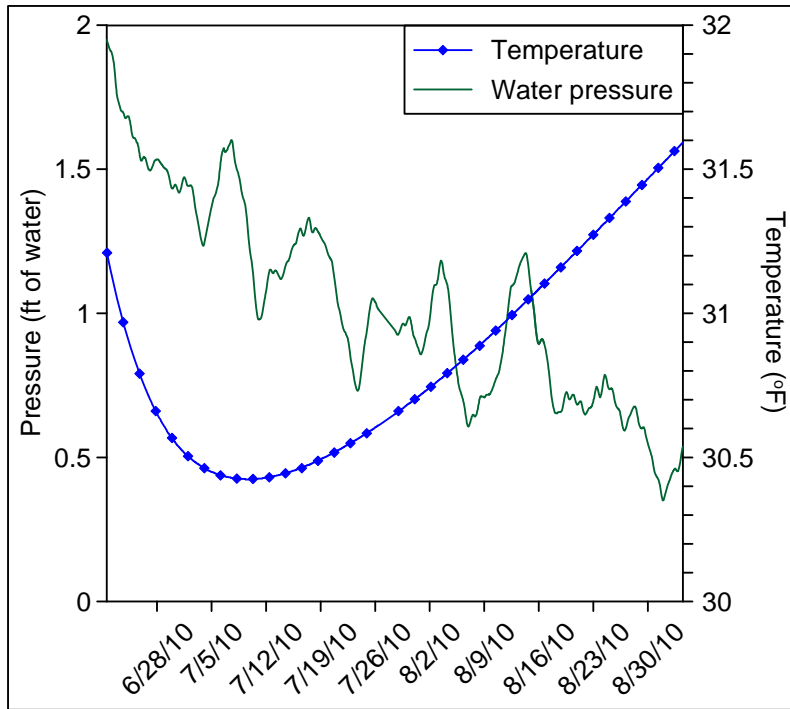
Figure 12. Data from the vibrating wire piezometer. In addition to water pressure, the device reports temperature with a thermistor that has $\pm 0.9^{\circ}\text{F}$ accuracy.

The data collected from the VW piezometer at 15.8 ft bgs in TH10-1553 is presented in Figure 12. In addition to water pressure, the device recorded temperature via a thermistor that had an accuracy of $\pm 0.9^{\circ}\text{F}$. The VW piezometer indicated a steady decrease in water pressure over the measurement period. This trend may reflect the loss of water from the cement-bentonite grout. The measured temperatures demonstrated an unusual trend, with an initial decrease in temperature followed by a steady rise. Additionally, all of the reported temperatures were below freezing, which is not supported by the observations made during drilling. The reasons for this trend are not known at this time. A longer data set, which may have helped to explain the observations, was not possible given the removal of the ADAS in September 2010.

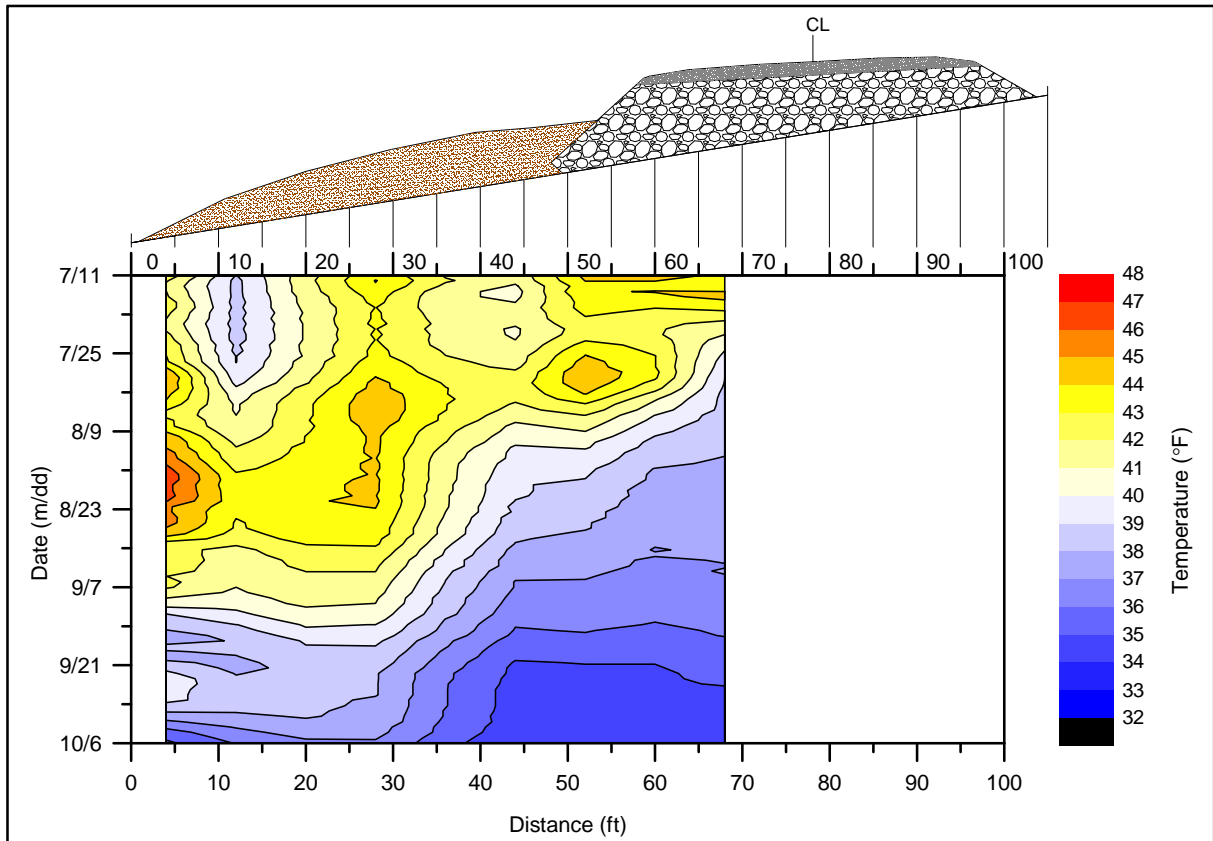
Figure 22. 2-Dimensional plot of temperatures versus time measured by the SAA device. Data presented is from July 11 to October 6, and a schematic of the final placement of thermal berm (left) and ACE (right) is provide for reference.

Figure 22, another 2-dimensional plot, represents the temperatures versus time measured by the SAA device. For the SAA, temperature sensors are located every 8 ft between 4 and 68 ft from the downslope toe, a spacing which provides greater resolution of temperature measurements. Temperatures were recorded once every 24 hours with this device. Finally, Figure 23 is a 2-dimensional plot of temperature versus time as measured by the TAC device. This device has a temperature sensor located every foot from 0 to 100 ft, which provides exceptional resolution of temperature measurements. Temperatures were recorded every 12 hours with the TAC device. As a function of the instrument spacing and overall length, the TAC device produced the highest resolution temperature plot and the most spatial coverage; however, where these different strings of sensors overlap, all three data sets demonstrate similar trends. There was a distinct difference in the rate of cooling between the thermal berm and the ACE during the measurement period. On October 6, the temperature beneath the thermal berm was approximately 37-38°F, whereas the temperature beneath the ACE was approximately 34-35 °F. Very apparent in Figure 23, and to a lesser extent in Figure 22, is the noticeable temperature fluctuation present near the embankment toes. These sensors are experiencing a greater impact from short term variations in air temperature due to less material covering the casings.

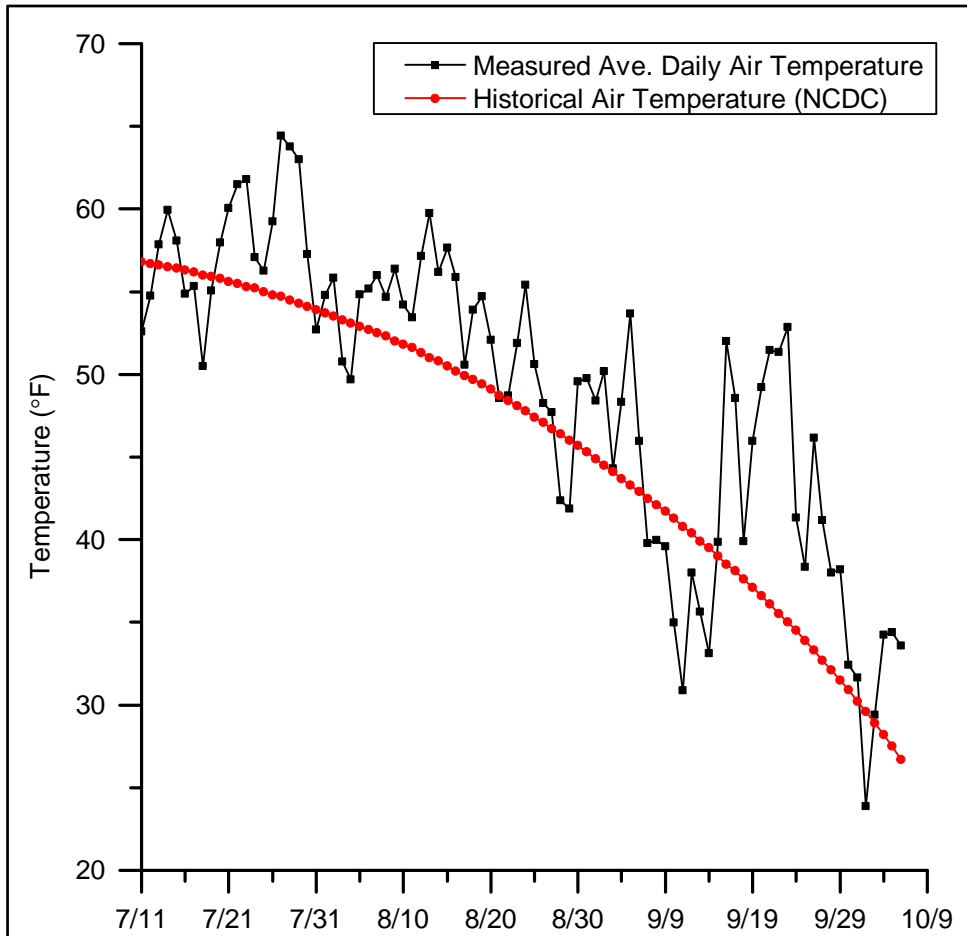
Figure 24. Comparison of measured average daily air temperature and historical average daily air temperature obtained from NCDC.

Figure 24 is a comparison of the measured average daily air temperature at the Lost Chicken location and the historical average daily air temperature from the National Climatic Data Center (NCDC). The historical climate data measured at nearby Chicken were obtained online from Golden Gate Weather Services (http://ggweather.com/normals/daily_AK.html). The dataset covers the period from 1981 to 2010. The measured temperatures at the site follow the same trend as the historical temperatures. In addition to air temperature sensors, we placed several CS109 temperature sensors on different surfaces to measure surface temperatures throughout the year. One sensor was placed just at the surface of the moss in an undisturbed area. Another sensor was placed at the toe of the thermal berm and left exposed at the surface, and the final sensor was installed level with the ground surface on the top of the thermal berm near the toe of the ACE. Figure 25 contains plots from each of these sensors, indicating that the measured surface temperatures and air temperatures are similar throughout the summer. The plots begin to differ after the first snowfall around September 30, when the ground surface temperatures remain fairly constant at 31.9°F, while the air temperature continues to fluctuate. These data will be used in future thermal modeling of the Lost Chicken embankment.

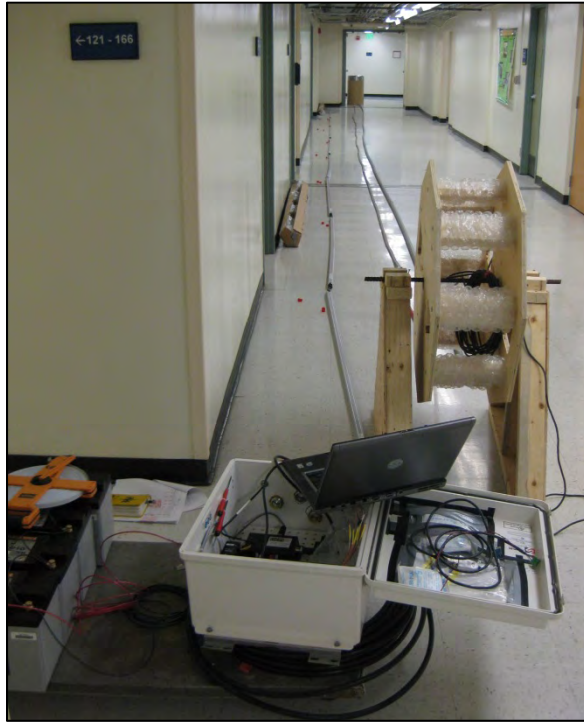
Figure A-3. Conducting a “hallway” test with the INC500 and SAA devices wired into the ADAS enclosure. (Photograph by M. Darrow, March 2010)

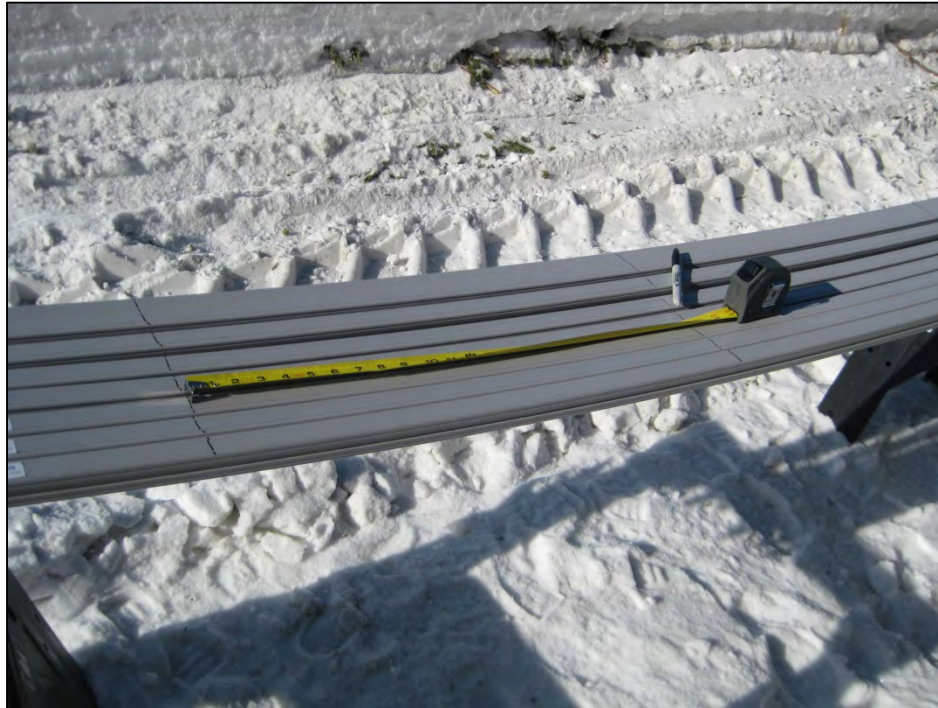
Figure A-5. Marking the INC500 for placement of centralizers. (Photograph by M. Darrow, March 2010)

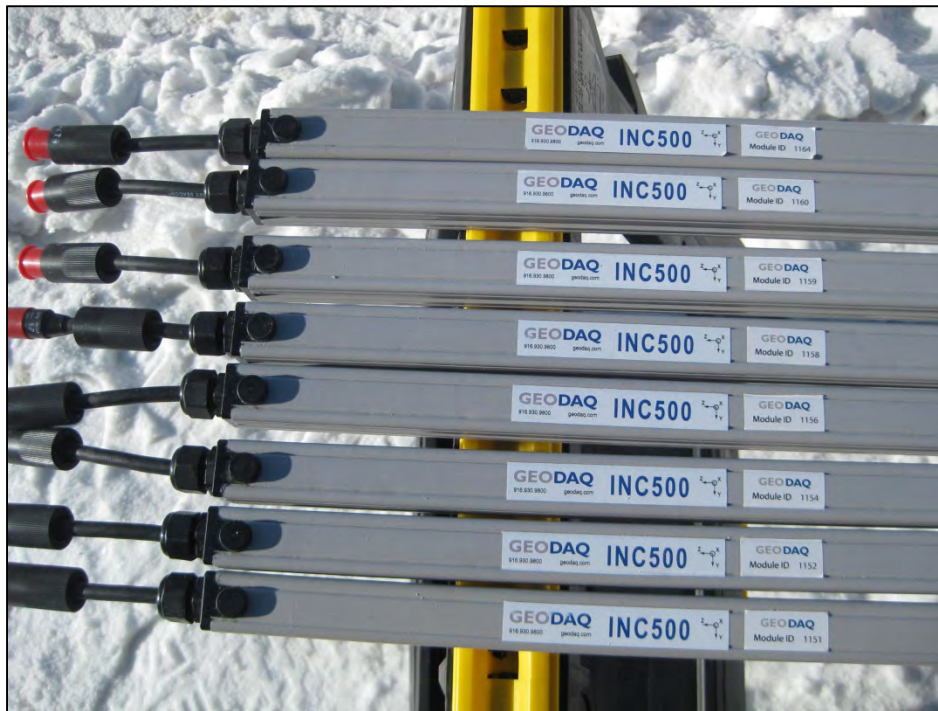
Figure A-6. Order of INC500 module serial numbers before installation. It is good practice to record this order both in a field book and through photographs. (Photograph by M. Darrow, March 2010)

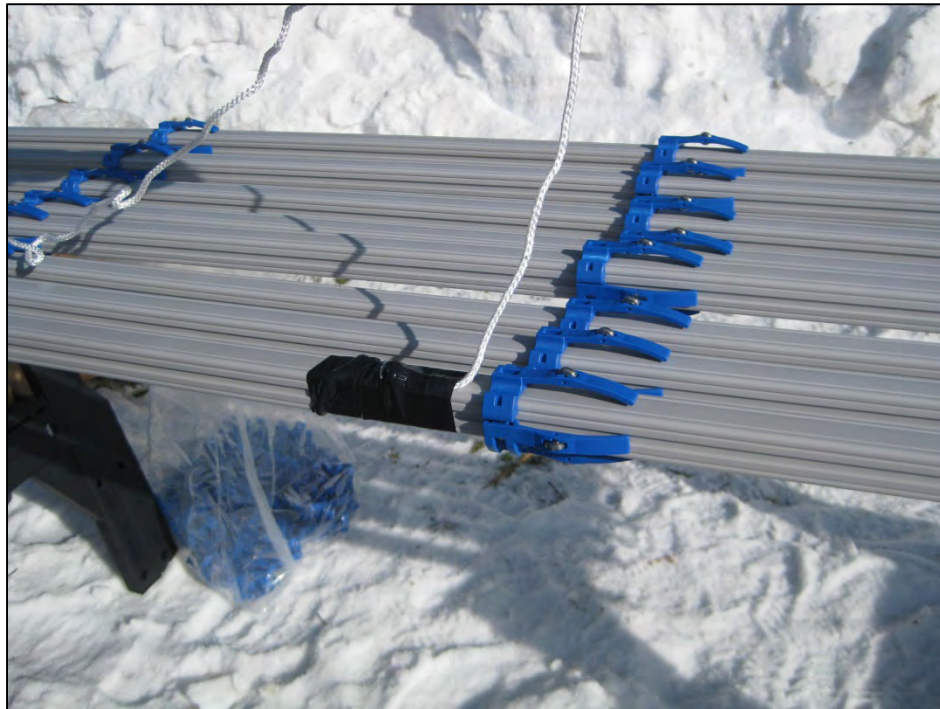
Figure A-8. Attaching the safety line to the lowest module. (Photograph by M. Darrow, March 2010)

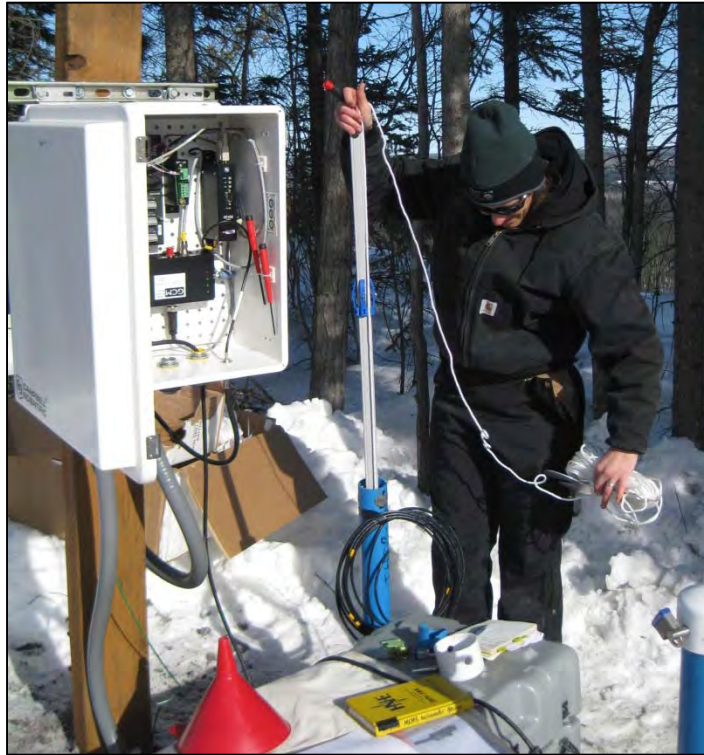
Figure A-9. Lowering the first INC500 module down the guide casing. (Photograph courtesy of A. Parsons, March 2010)

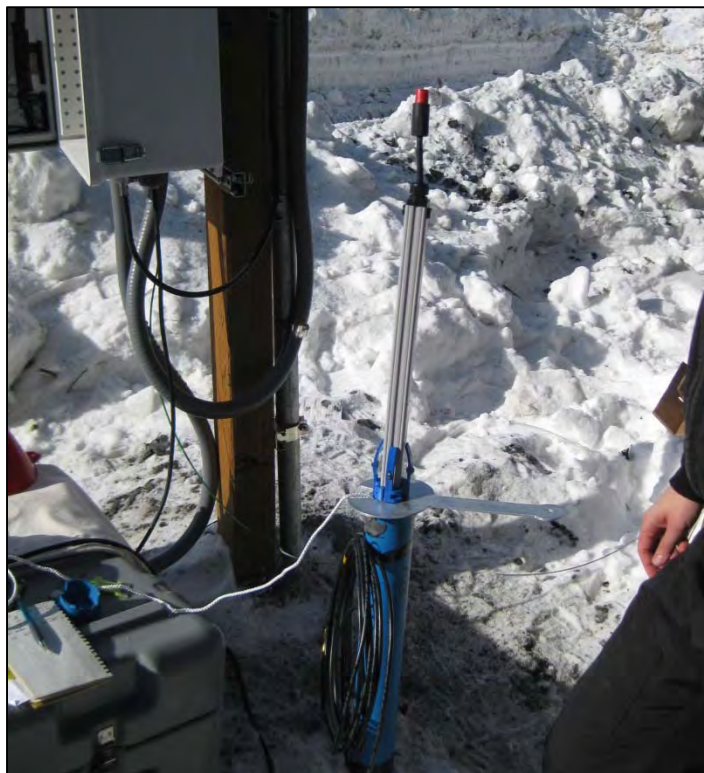
Figure A-10. First INC500 module resting on fork. (Photograph courtesy of A. Parsons, March 2010)

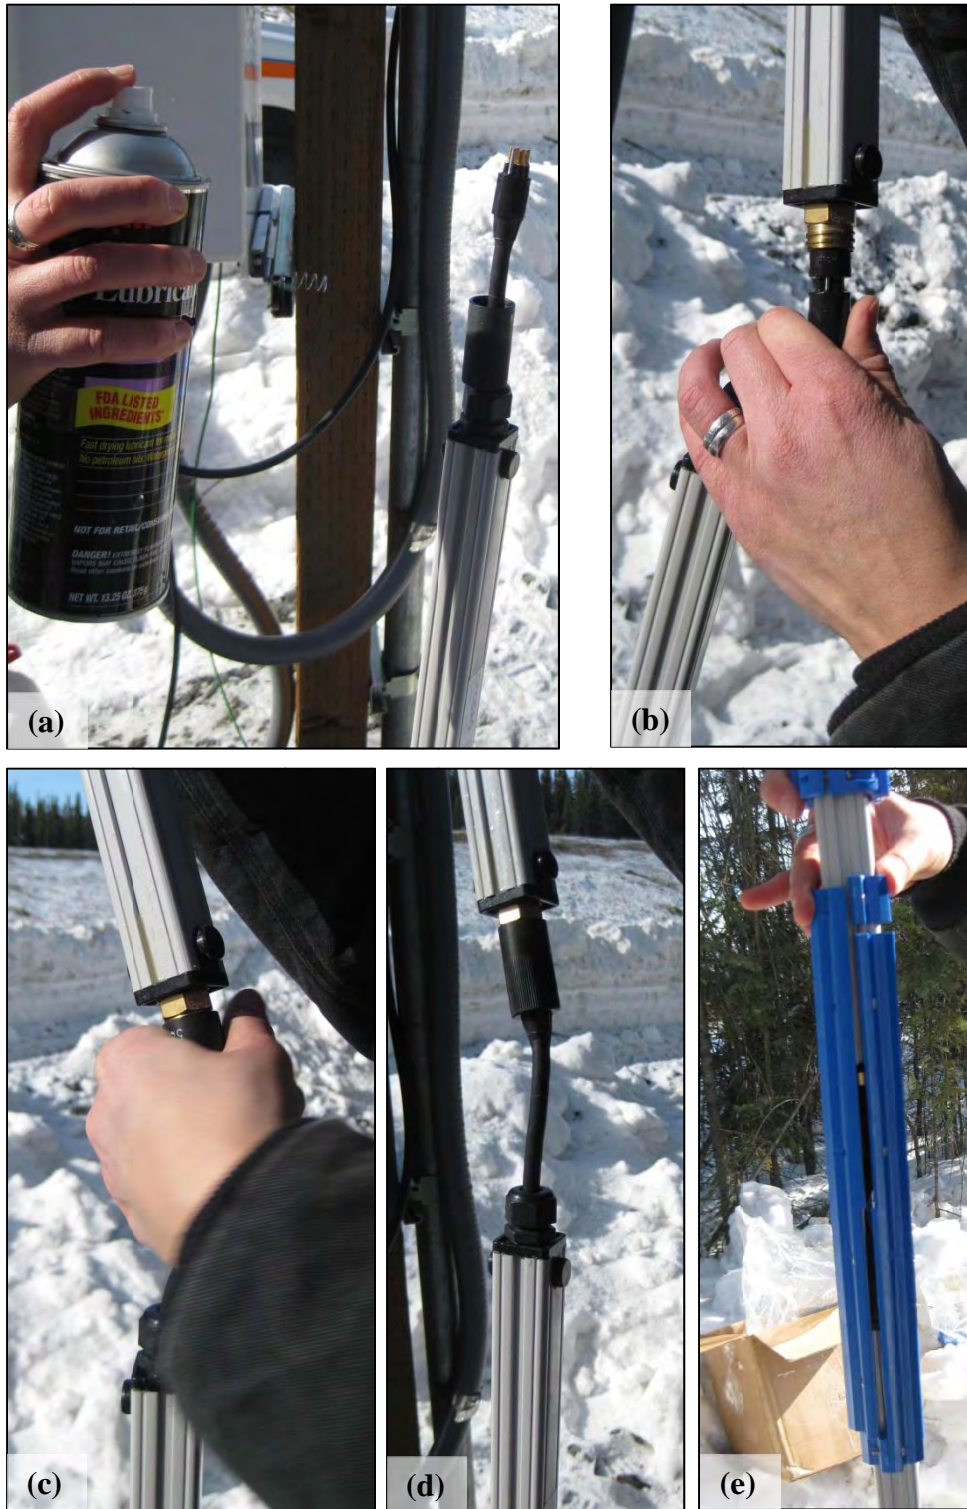
Figure A-11. Steps in the assembly of the INC500 modules. (a) Spraying the connections with silicon; (b) plugging the water-tight connectors together; (c) screwing the threaded connections together for the water-tight connection; (d) connected modules; (e) attaching the coupler assembly. (Photographs courtesy of A. Parsons, March 2010)

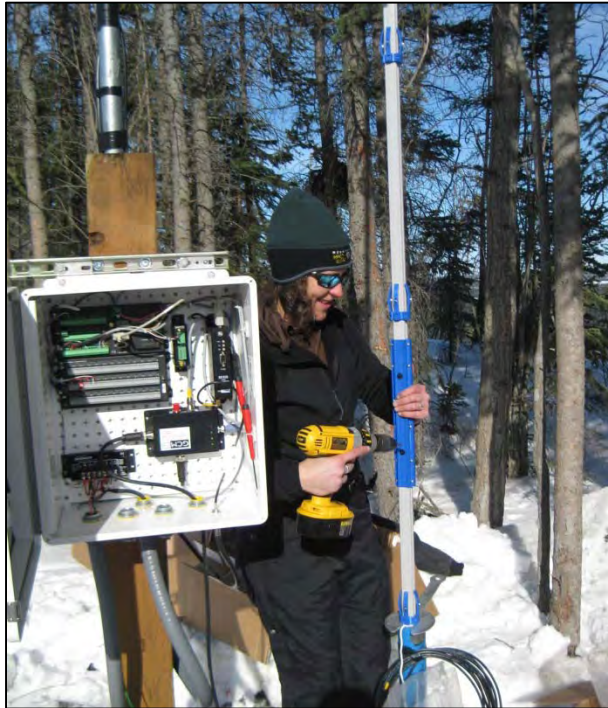
Figure A-12. Connecting the coupler assembly with machine screws. (Photograph courtesy of A. Parsons, March 2010)

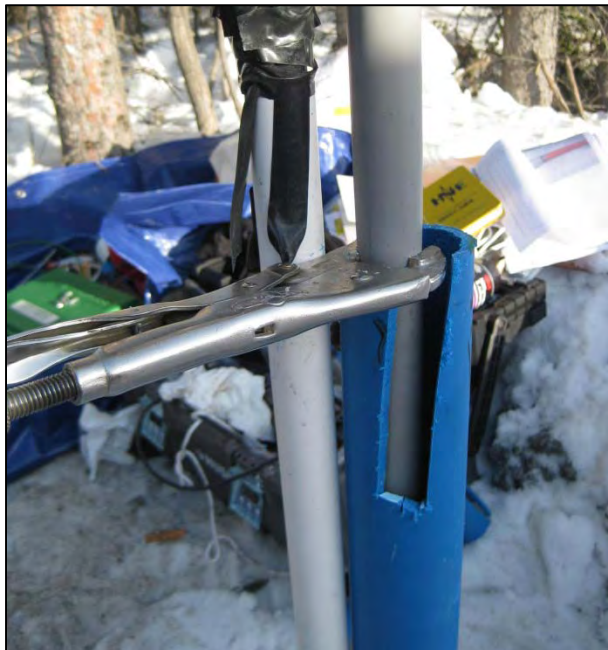
Figure A-13. Installing inner 1.05-in. PVC into guide casing for SAA device. Slot cut into the guide casing was to allow tightening of the hose clamp at the top of the PVC casing (see Figure A-14). White 1-in. PVC to the left was for a thermistor string. (Photograph by M. Darrow, March 2010)

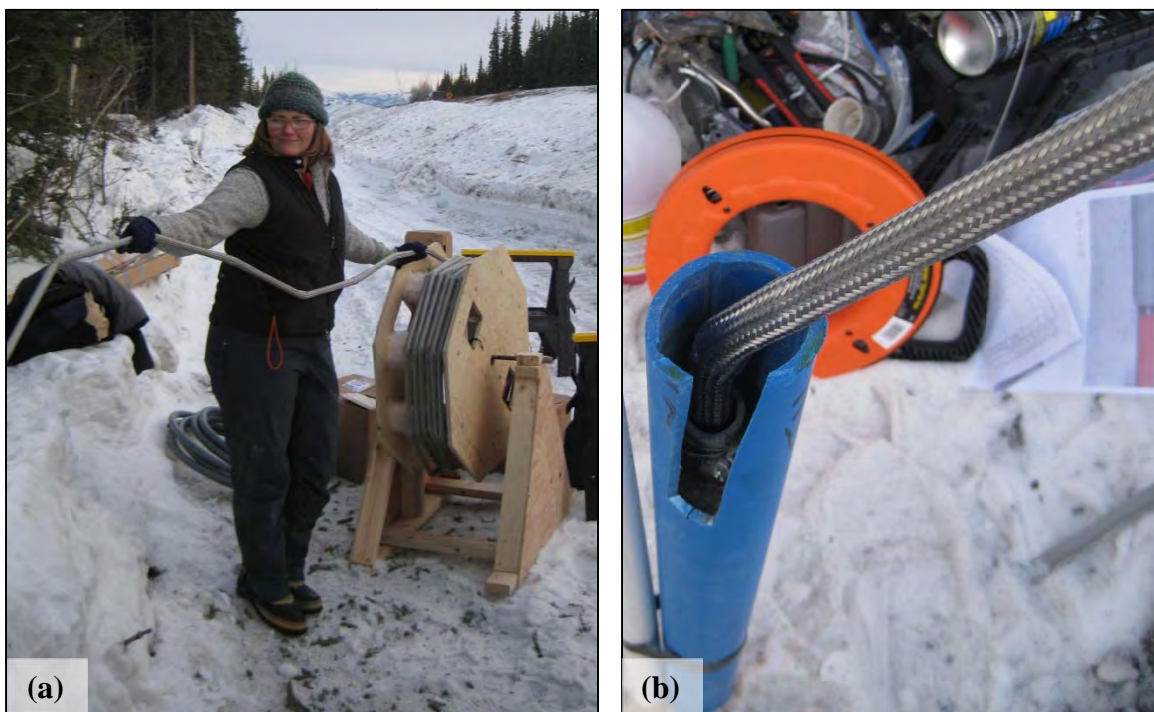
Figure A-15. Installing the SAA device. (a) Guiding the SAA off of the shipment reel, and (b) into the inner 1.05-in. PVC casing. (Photographs by M. Darrow, March 2010)

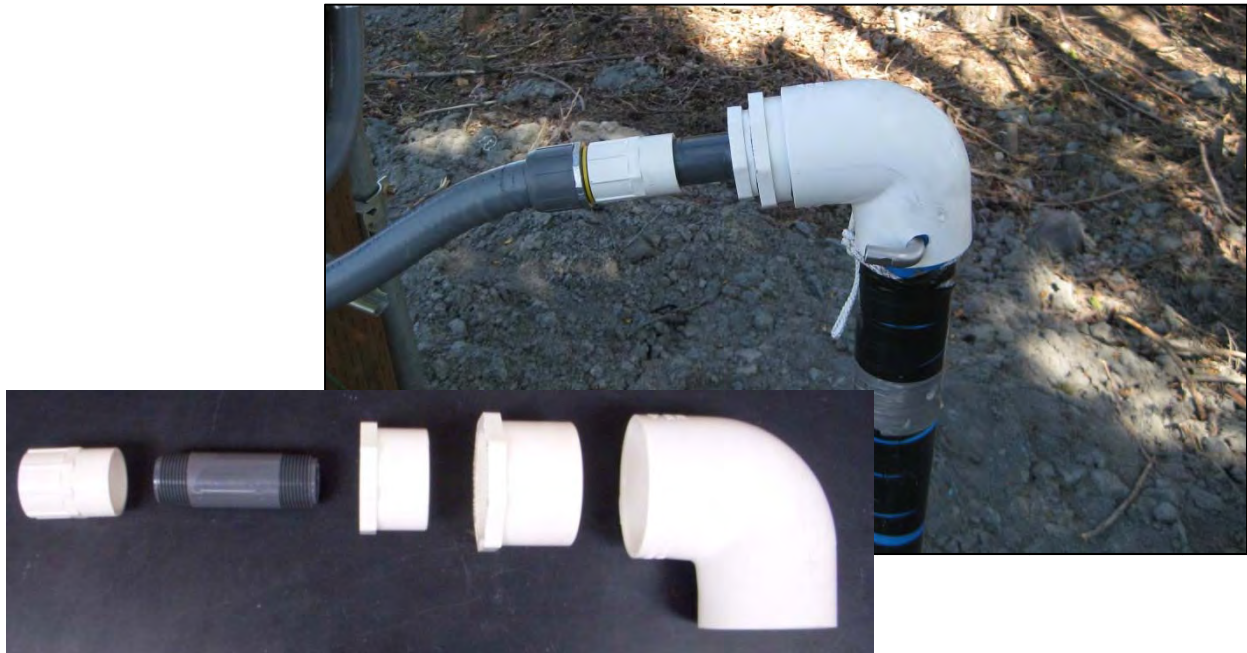
Figure A-18. Guide casing to flexible conduit adapter in place on TH09-1511 casing. Inset illustrates the various PVC fittings that comprise the adapter. (Photographs by M. Darrow, May 2010)

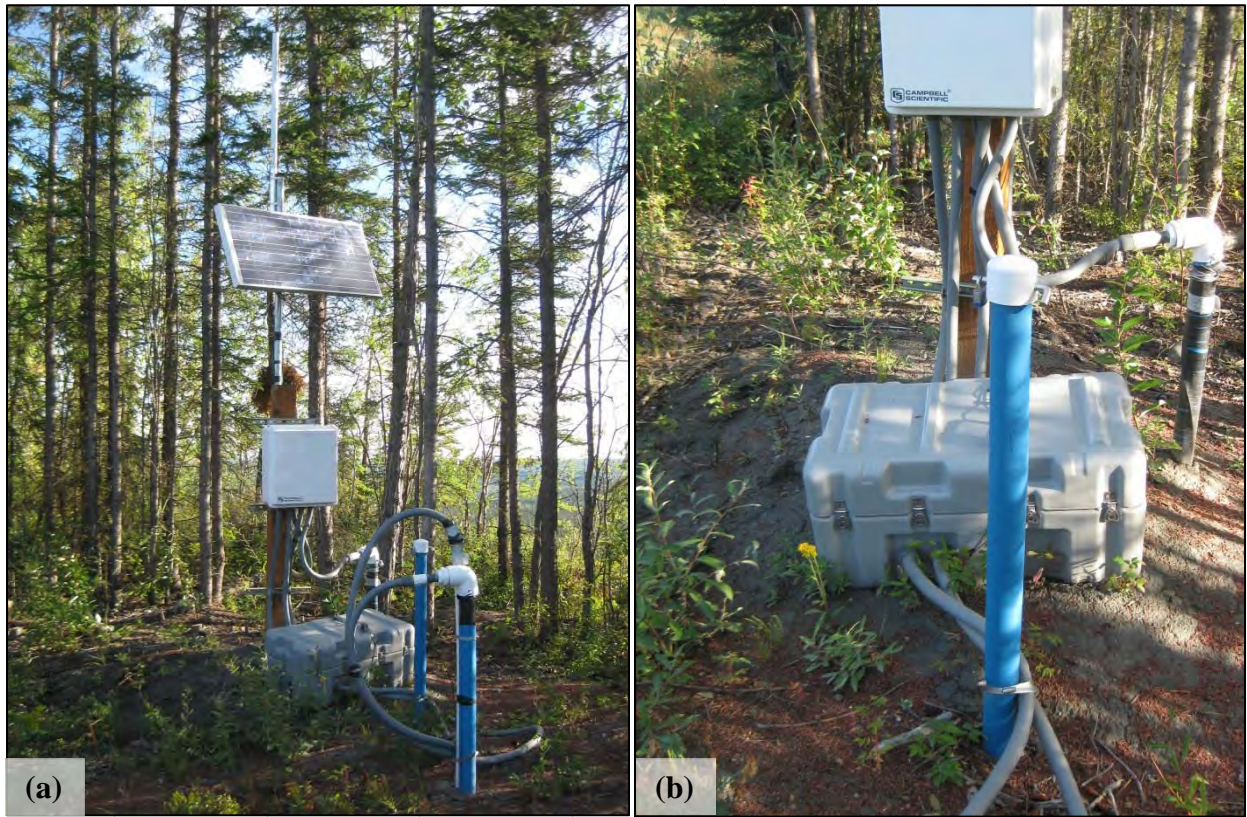
Figure A-19. Final configuration of the Rich113 site. (a) Complete ADAS overview; (b) TH07-1711 in foreground with battery box and ADAS; TH09-1511 is to the right. (Photographs by M. Darrow, Aug. 2011)

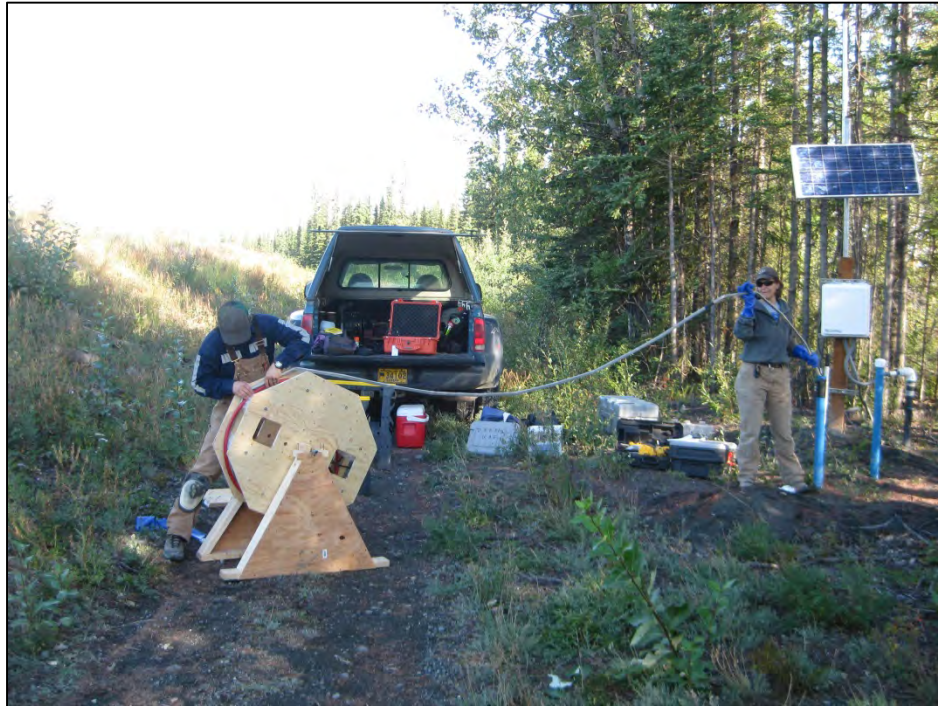
Figure A-22. Retrieving the SAA in August 2011, and replacing the device on the shipping reel. (Photograph courtesy of J. Yao)

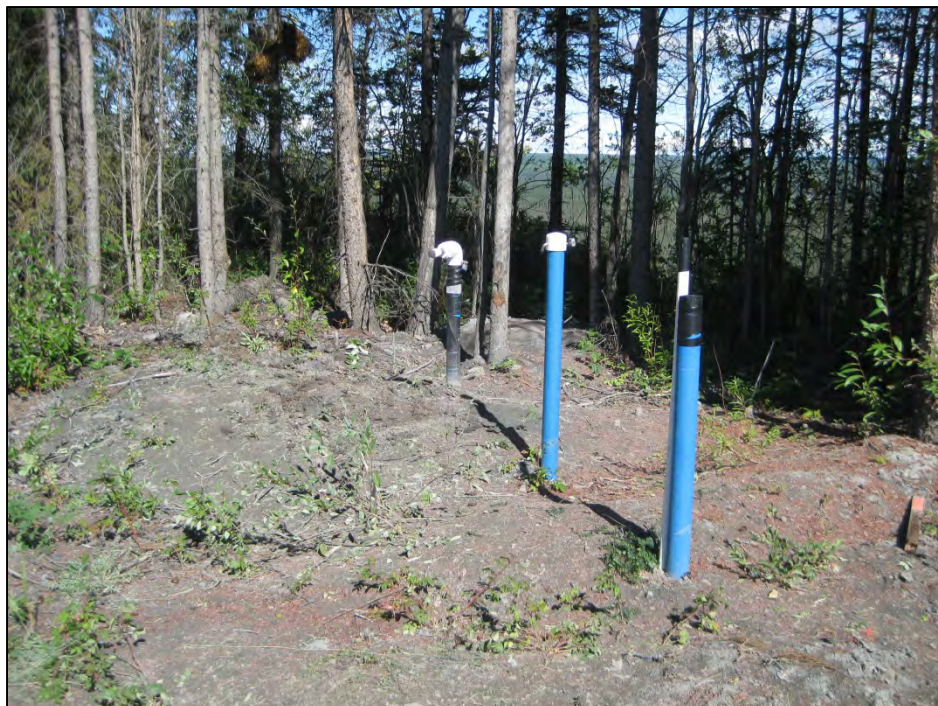
Figure A-23. Final configuration of the Rich113 site in August 2011. The post that supported the ADAS was cut off at the ground surface. Only the guide casings remain for manual inclinometer probe readings. (Photograph by M. Darrow)

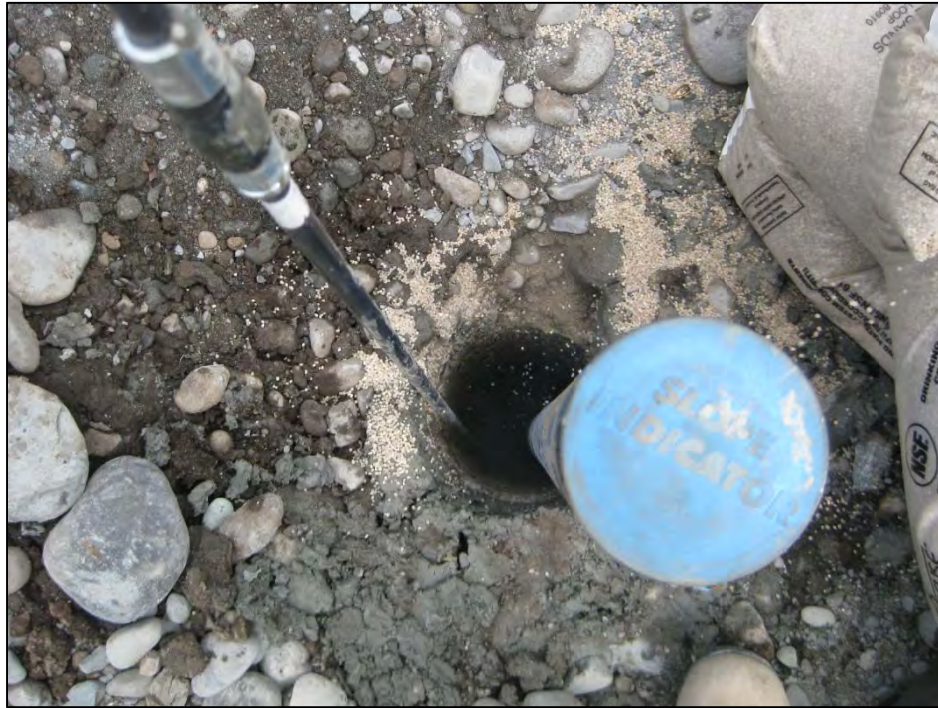
Figure B-1. Tamping dry sand backfill around the guide casing. (Photograph by M. Darrow, June 2010)

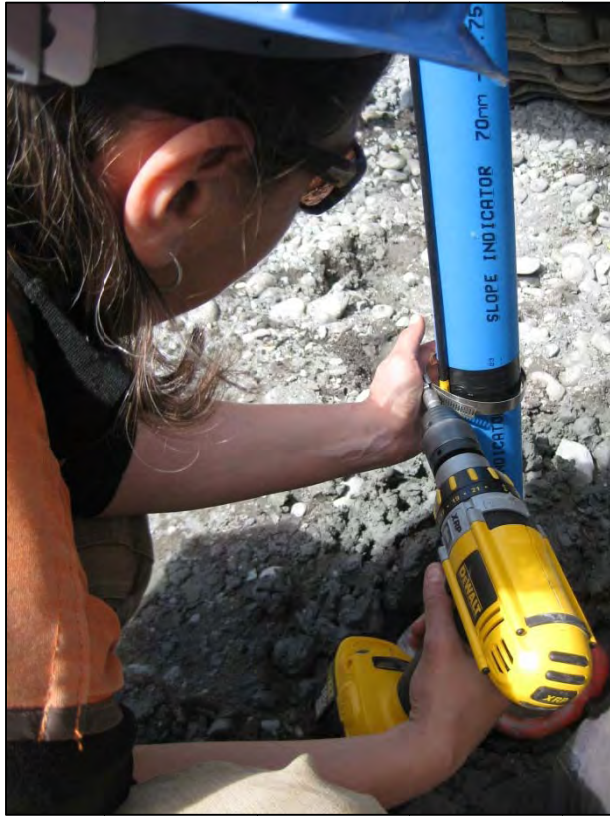
Figure B-3. Attaching the coaxial (TDR) cable with hose clamps at 10-ft intervals. (Photograph courtesy of T. Haller, June 2010)
