Evaluation of MEMS-based In-place Inclinometers in Cold Regions

Margaret M. Darrow, Ph.D.
David. D. Jensen, E.I.T.

December 2012

INE/AUTC 12.38

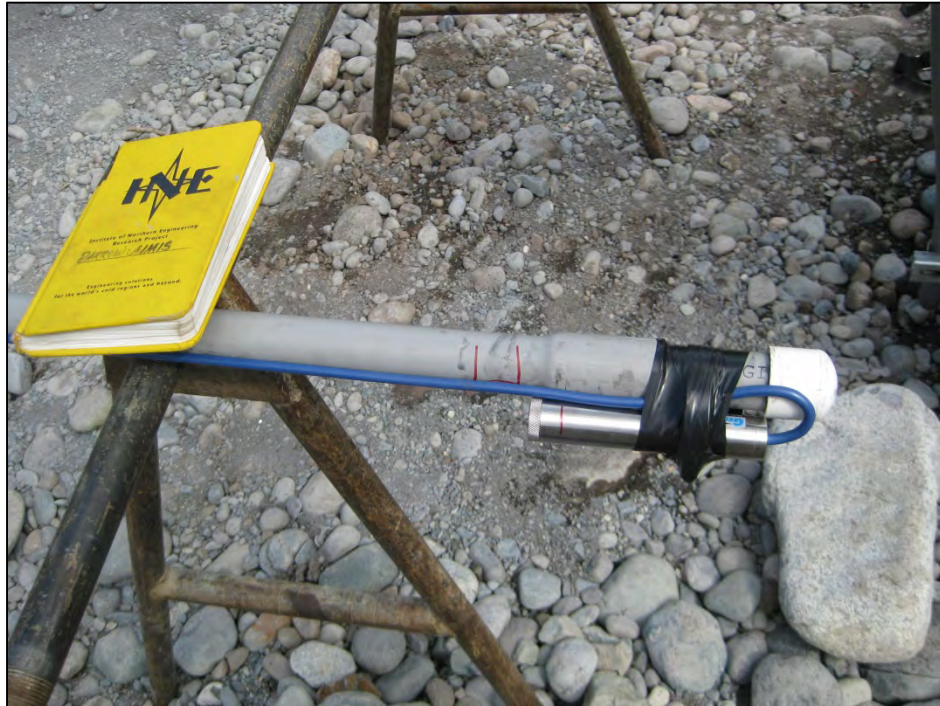
Figure B-5. Placement of vibrating wire piezometer on PVC casing for installation into TH10-1553. (Photograph by M. Darrow, June 2010)

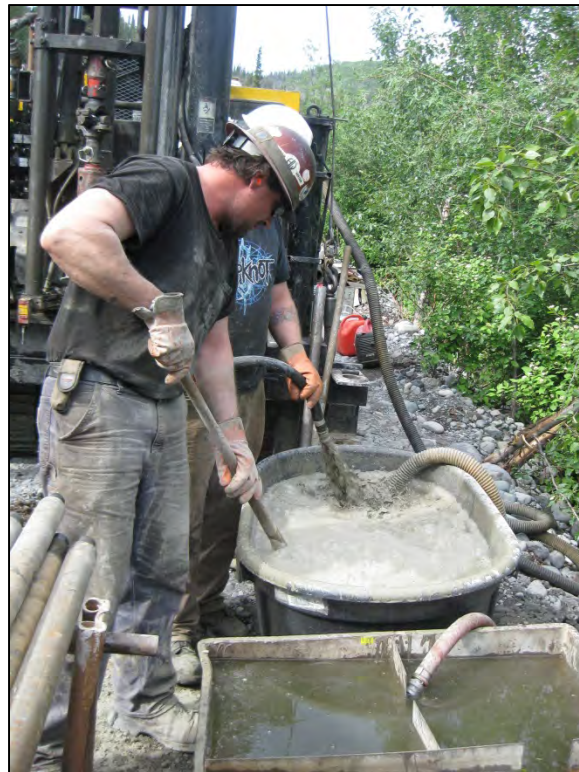
Figure B-6. Preparing the cement-bentonite grout for backfill into TH10-1553. (Photograph by M. Darrow, June 2010)

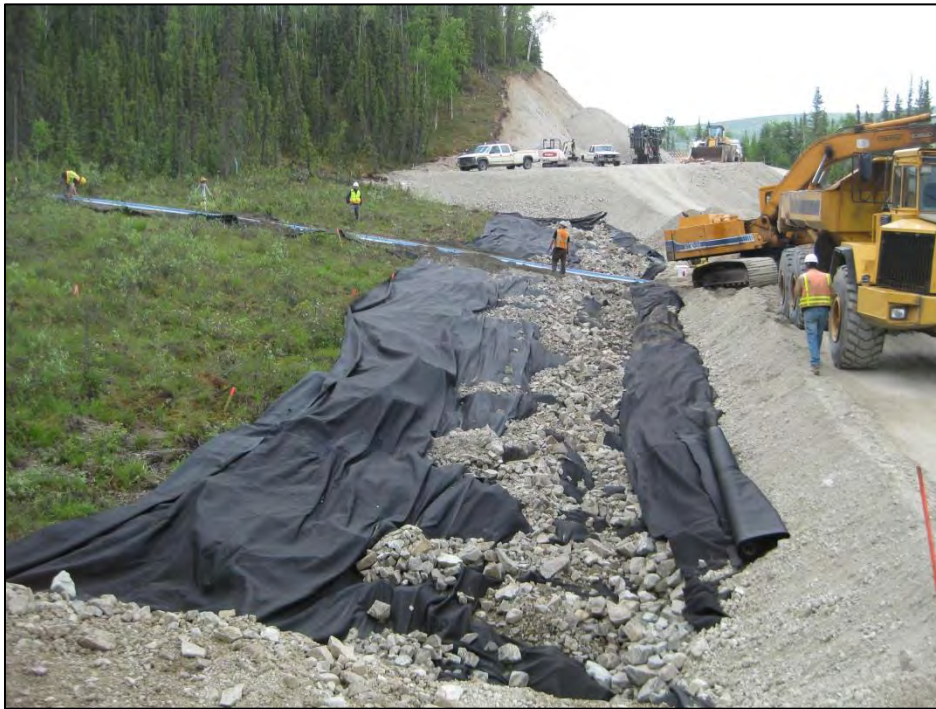
Figure C-1. Looking southeast towards the instrumented cross section. Geotextile with some ACE material is present in the foreground. (Photograph by M. Darrow, June 2012)

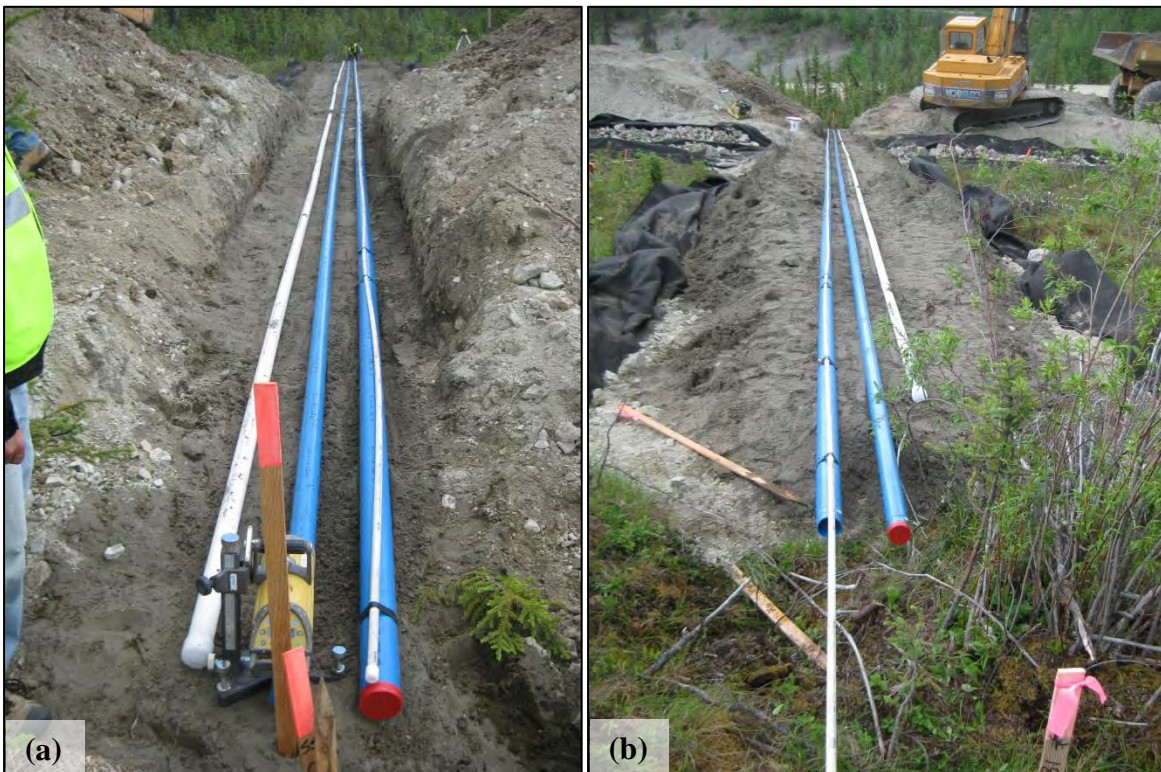
Figure C-2. Casings prior to backfill at the instrumented cross section, looking (a) upslope and (b) downslope. (Photographs by M. Darrow, June 2012)

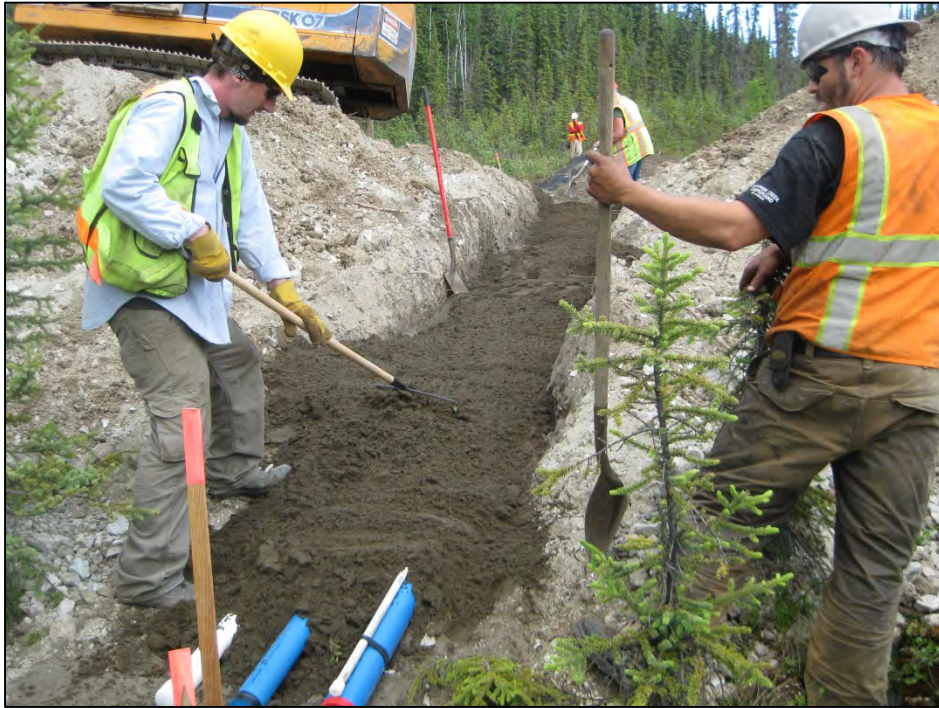
Figure C-3. Covering the casings with sand bedding. (Photograph by M. Darrow, June 2012)

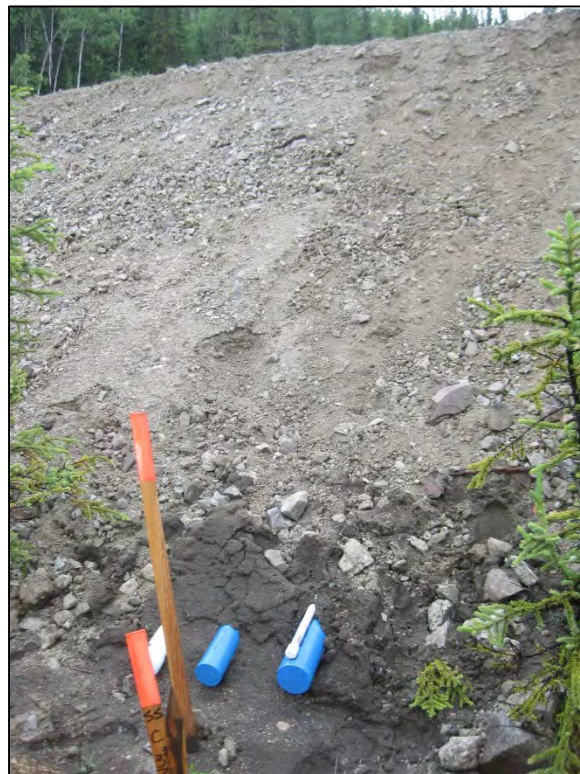
Figure C-4. Downhill toe of embankment with thermal berm and exposed casing ends. (Photograph by M. Darrow, July 2012)

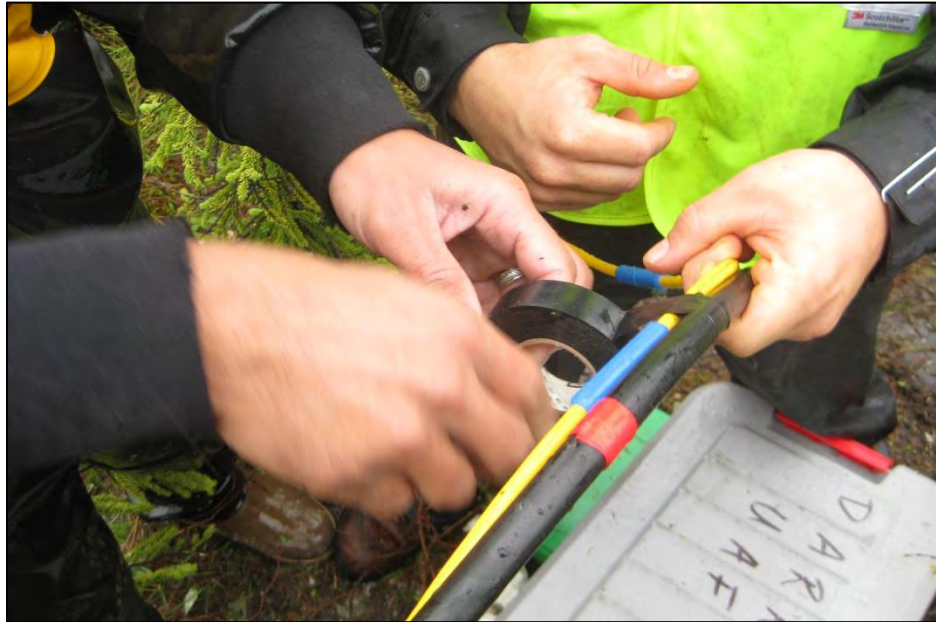
Figure C-5. Wrapping BeadedStream temperature acquisition cable (TAC) to thermistor cable for installation. (Photograph by M. Darrow, July 2012)

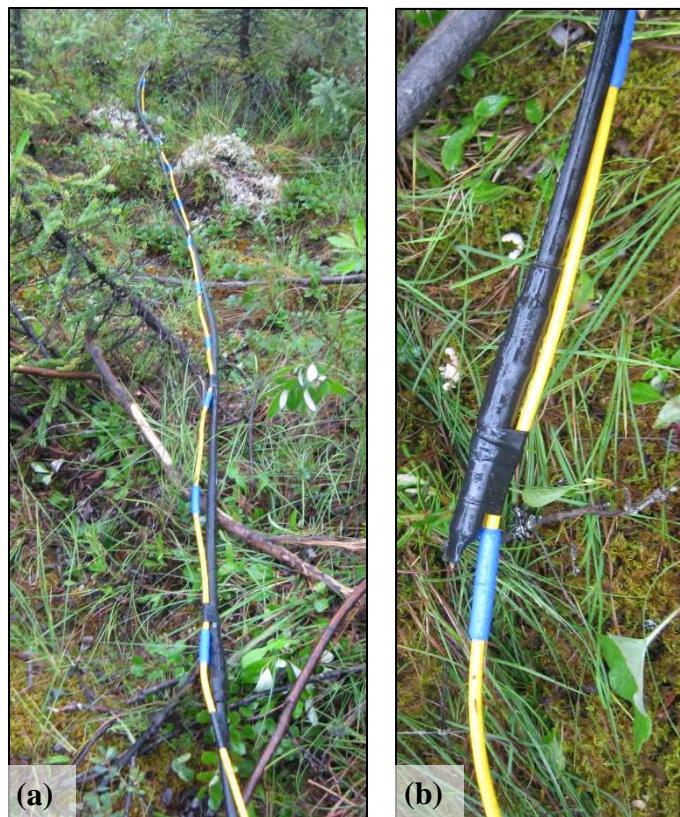
Figure C-6. Alignment of TAC and thermistor cable. (a) Location of thermistor beads relative to TAC sensors was recorded, (b) as well as the location of the final thermistor bead. (Photographs by M. Darrow, July 2012)

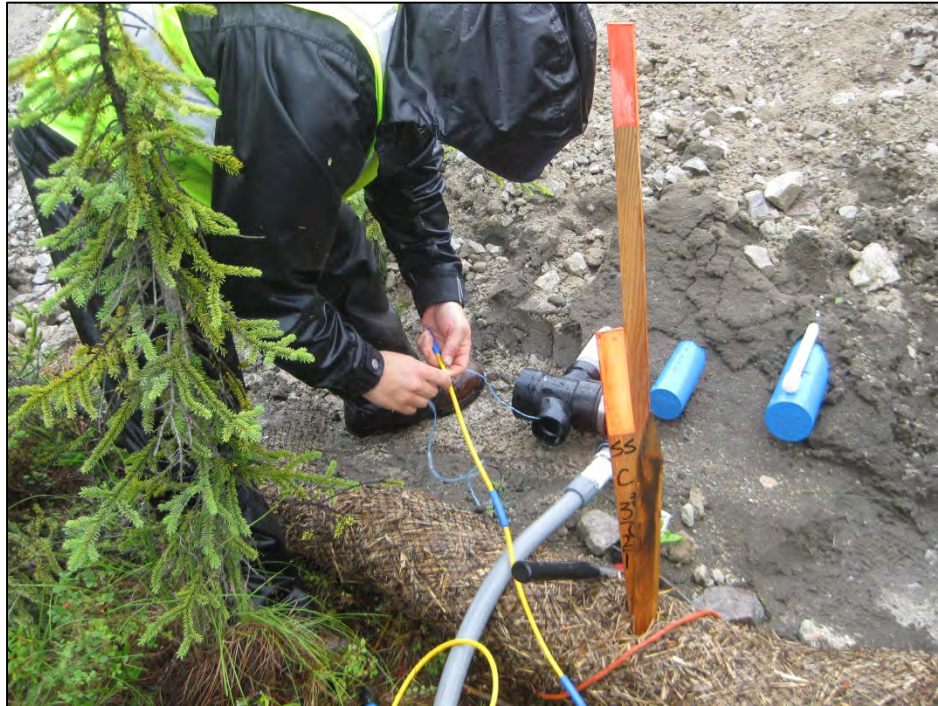
Figure C-7. Attaching the pull rope to the end of the TAC device. (Photograph by M. Darrow, July 2012)

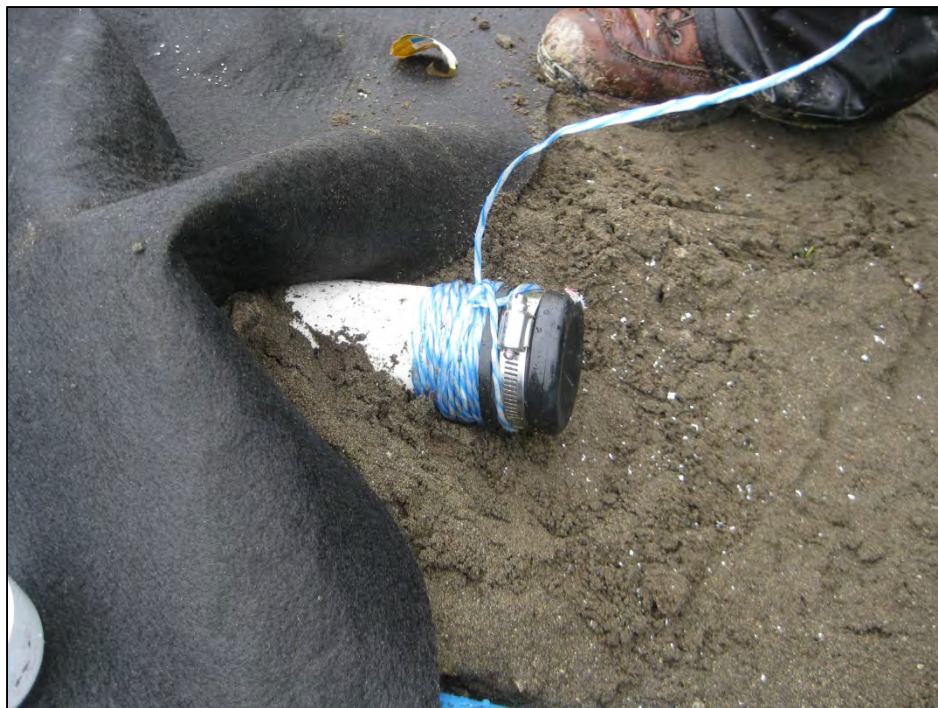
Figure C-8. Uphill termination of the casing containing the TAC and thermistor string. (Photograph by M. Darrow, July 2012)

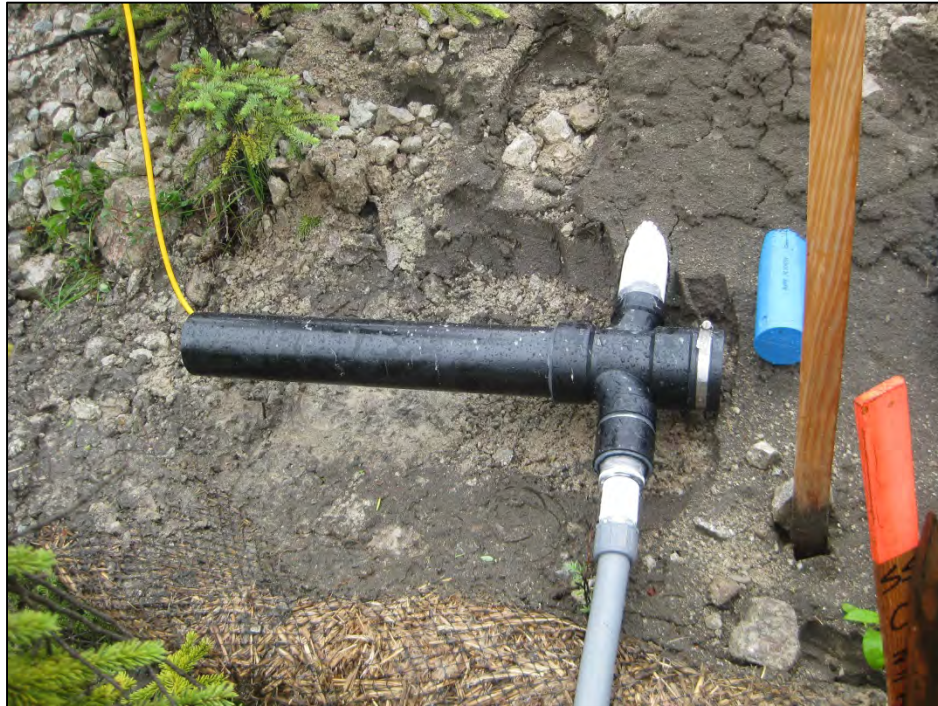
Figure C-9. PVC casing to flexible conduit adapter for the temperature measurement cables.
(Photograph by M. Darrow, July 2012)

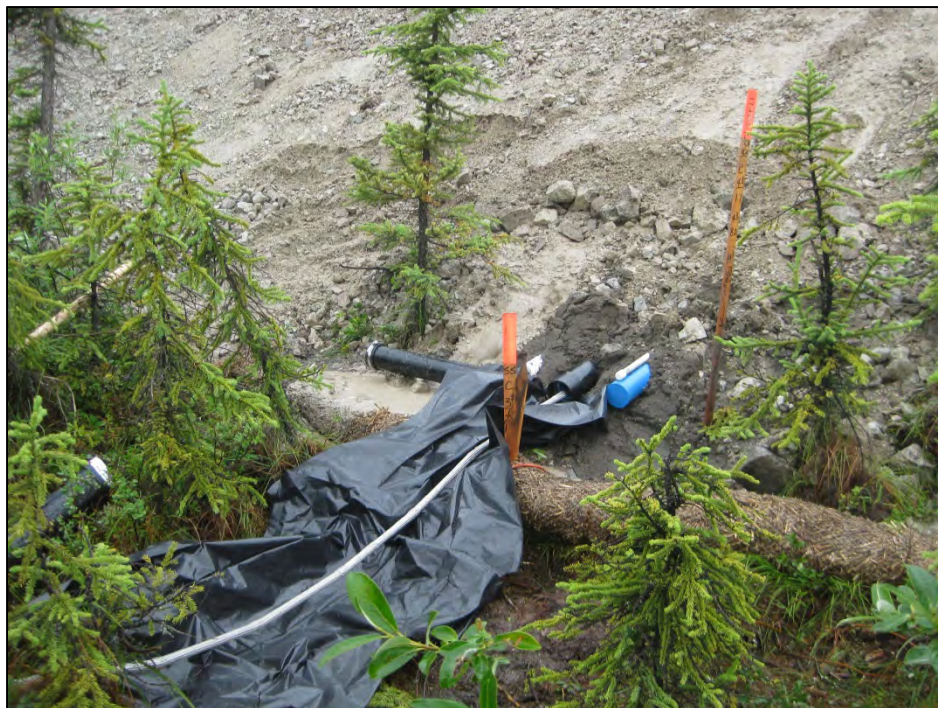
Figure C-10. Installing the SAA device from the downslope end, pulling from the upslope end.
(Photograph by M. Darrow, July 2012)

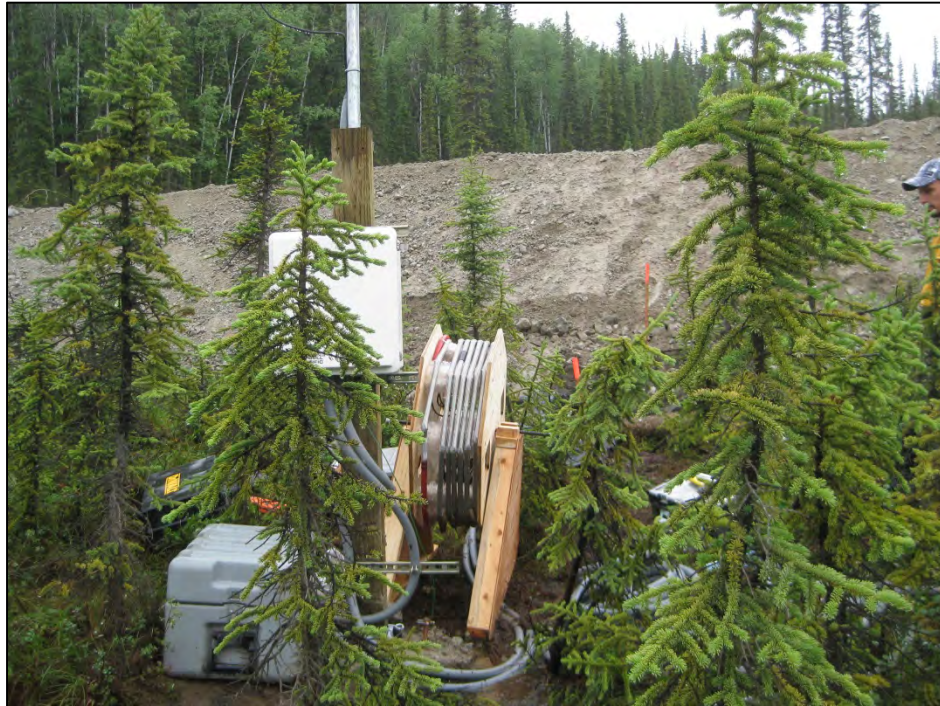
Figure C-11. Installation of SAA device, showing shipping reel position relative to embankment and ADAS. (Photograph by M. Darrow, July 2012)

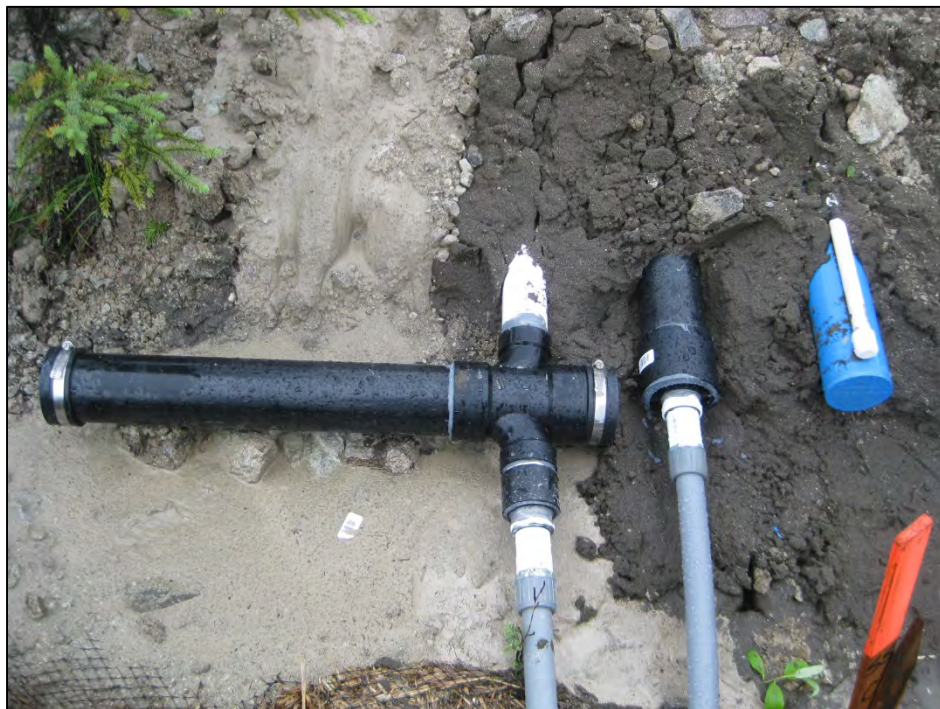
Figure C-12. PVC casing to flexible conduit adapter for SAA installation. (Photograph by M. Darrow, July 2012)

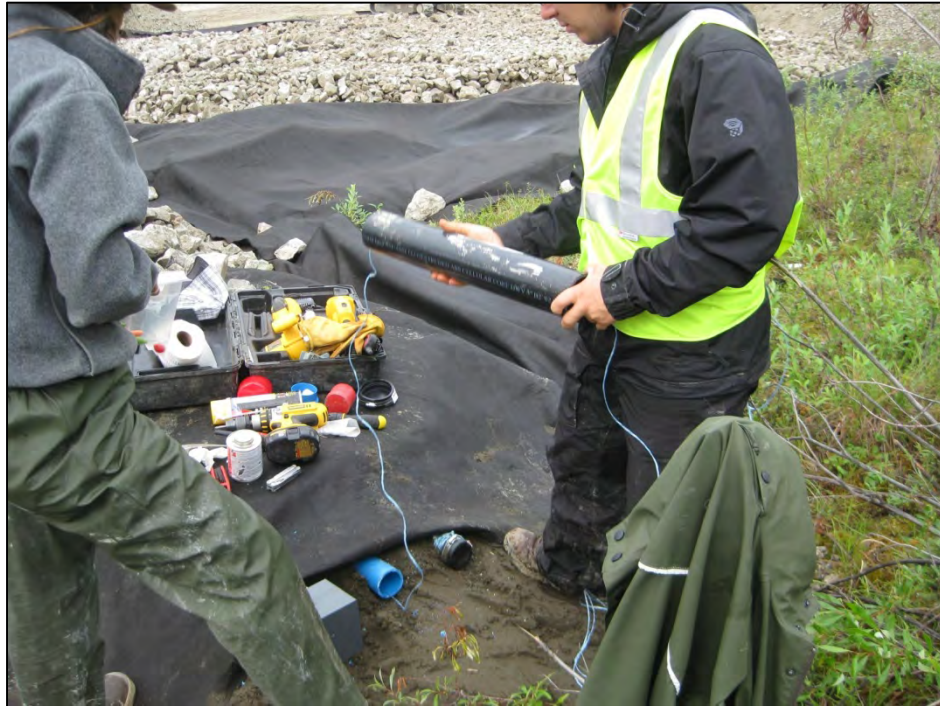
Figure C-14. Routing pull rope for SAA through ABS end cap adapter. (Photograph courtesy of J. Zottola, July 2012)

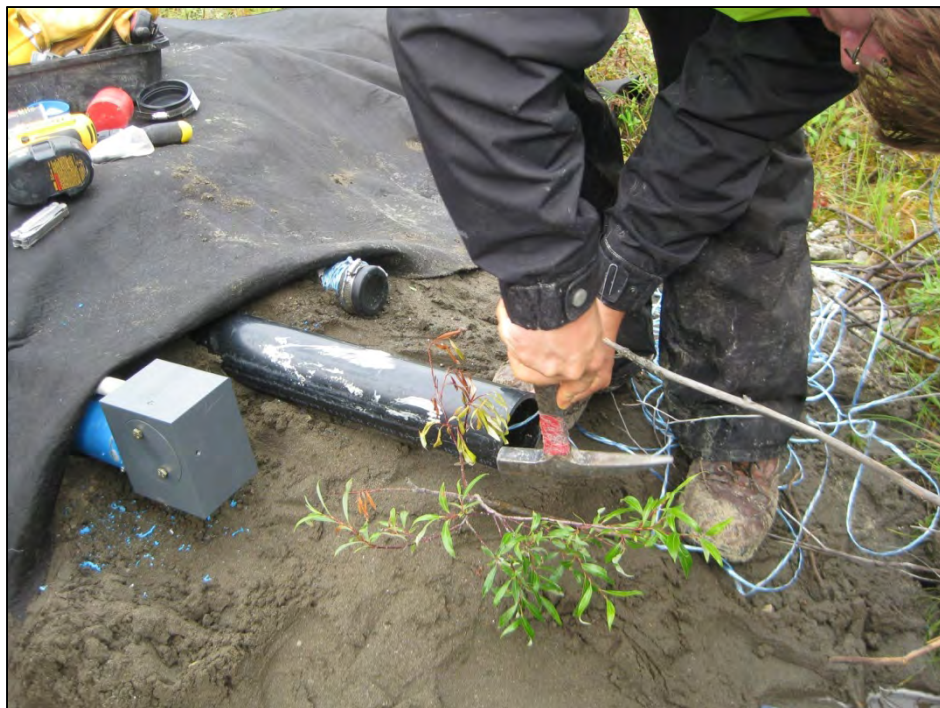
Figure C-15. Tapping ABS end cap adapter into the sand bedding to be flush with inner casing. (Photograph courtesy of J. Zottola, July 2012)

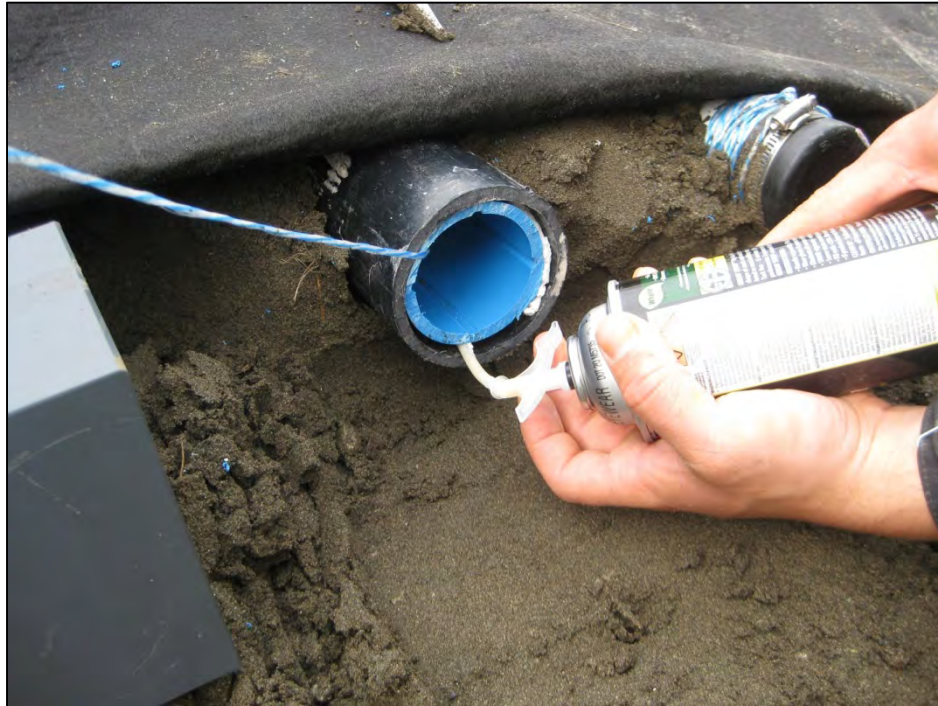
Figure C-16. Filling annulus space with expanding foam to seal outer ABS end cap adapter in place. (Photograph courtesy of J. Zottola, July 2012)

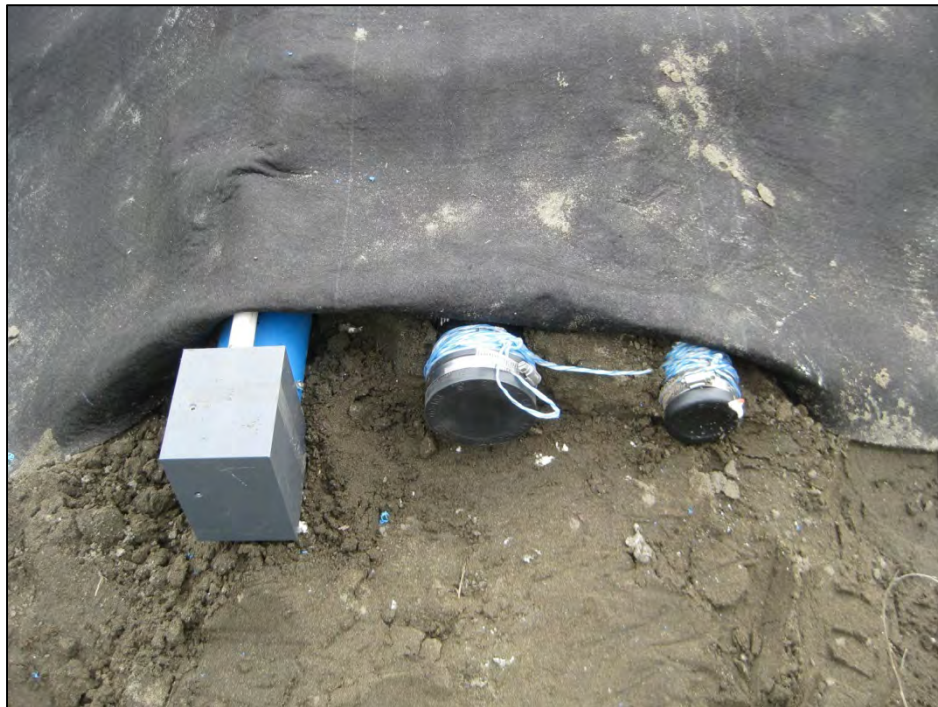
Figure C-17. Upslope casing ends secured. From left to right, dead-end pulley on guide casing for manual inclinometer probe measurements, sealed guide casing with tied-off SAA pull rope, sealed 2-in. PVC casing with tied-off TAC/thermistors string pull rope. (Photograph by M. Darrow, July 2012)

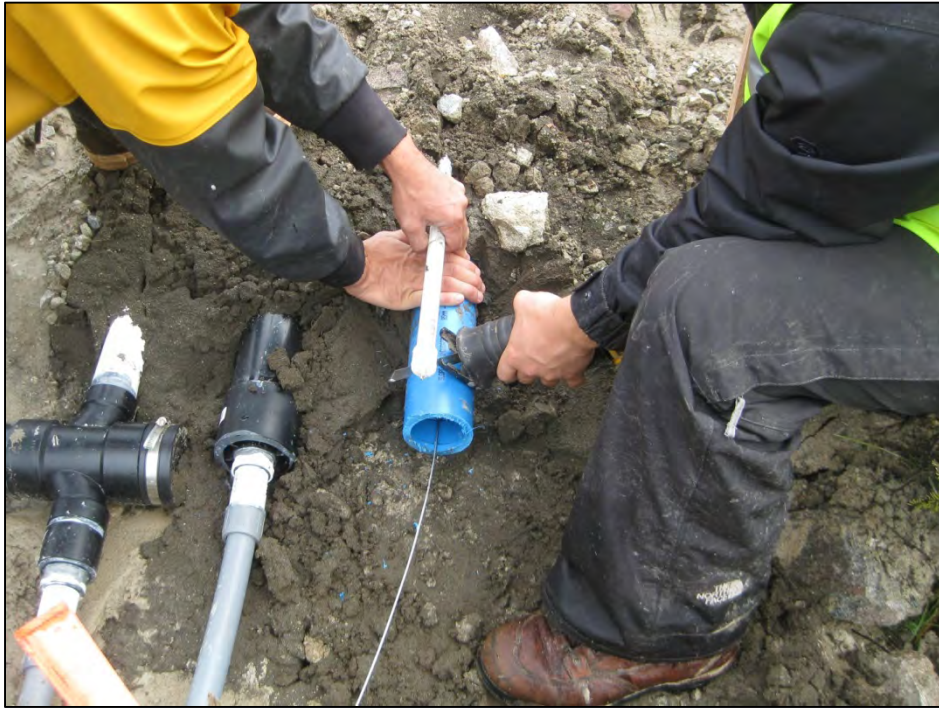
Figure C-18. Trimming the downslope guide casing for ABS end cap adapter. (Photograph by M. Darrow, July 2012)

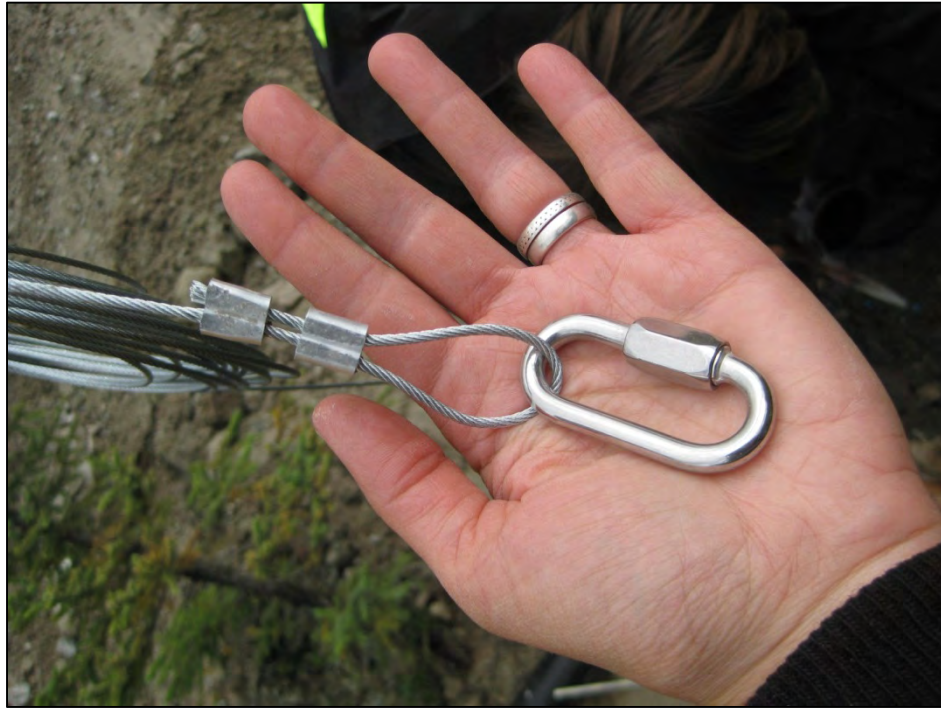
Figure C-20. Attaching 2 1/4-in. locking link to wire rope within guide casing. (Photograph by M. Darrow, July 2012)

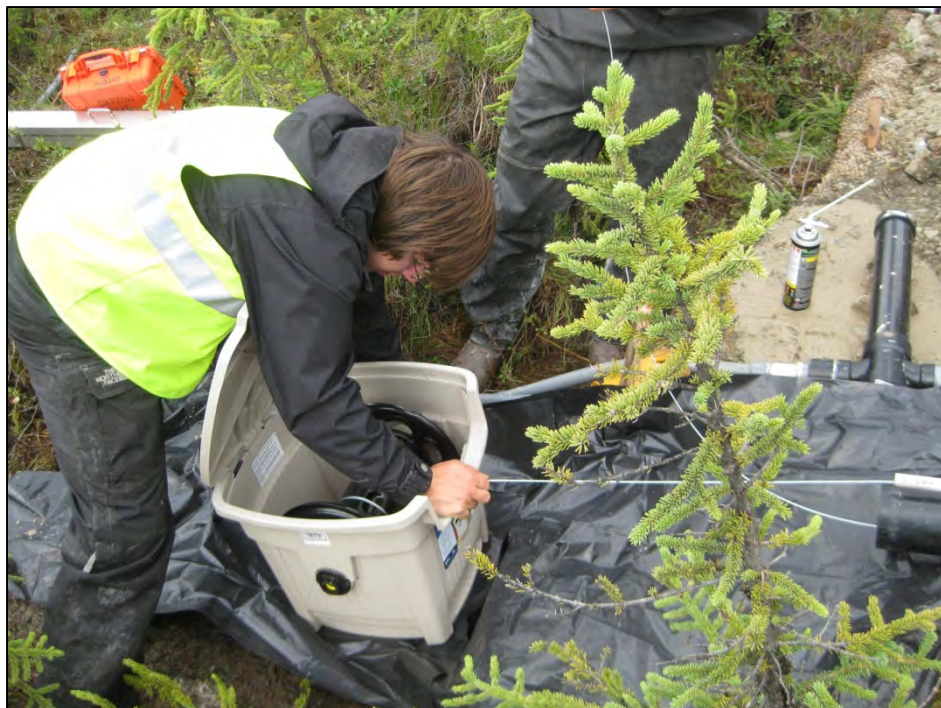
Figure C-21. Winding up excess wire rope from within casing assembly. (Photograph by M. Darrow, July 2012)

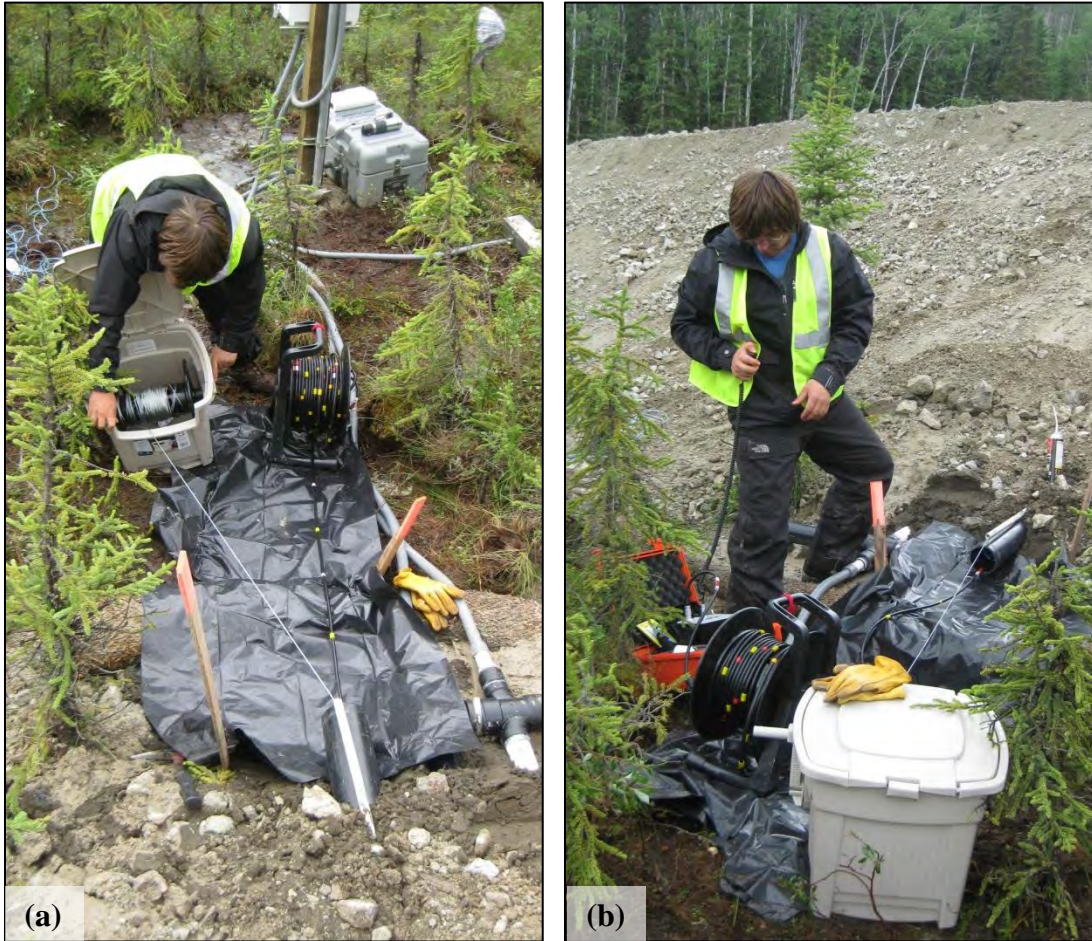
Figure C-22. Taking manual inclinometer probe measurements. (a) Feeding inclinometer probe cable into casing by reeling up the wire rope; (c) taking readings as the cable is retracted from the casing. (Photographs by M. Darrow, July 2012)

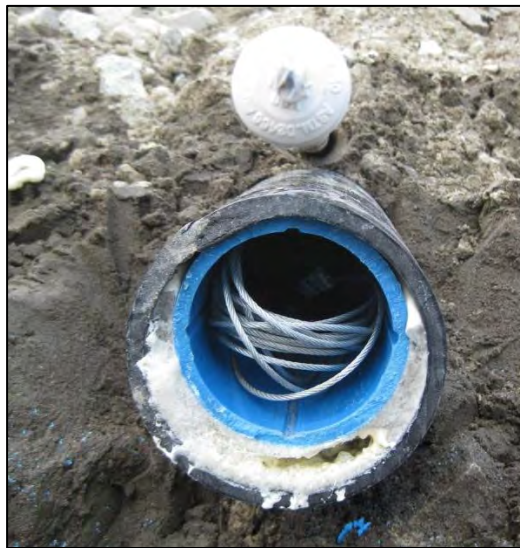
Figure C-23. Downslope guide casing termination. Wire rope is tucked into casing for easy retrieval for next reading. (Photographs by M. Darrow, July 2012)

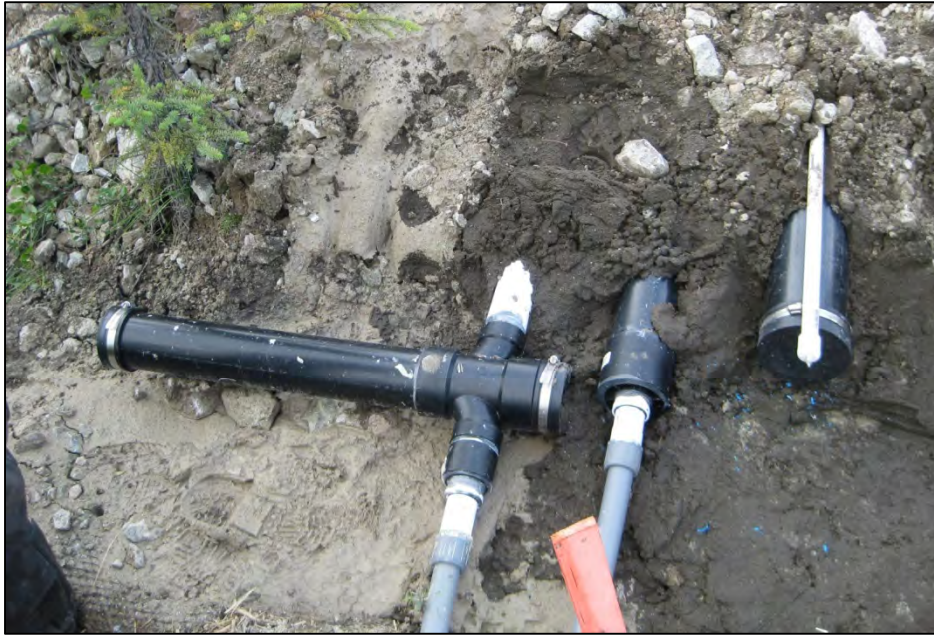
Figure C-24. Downslope casing ends secured. From left to right, ABS casing to flexible conduit adapters for TAC/thermistor cables and SAA device, and sealed guide casing for manual inclinometer probe measurements. (Photograph by M. Darrow, July 2012)

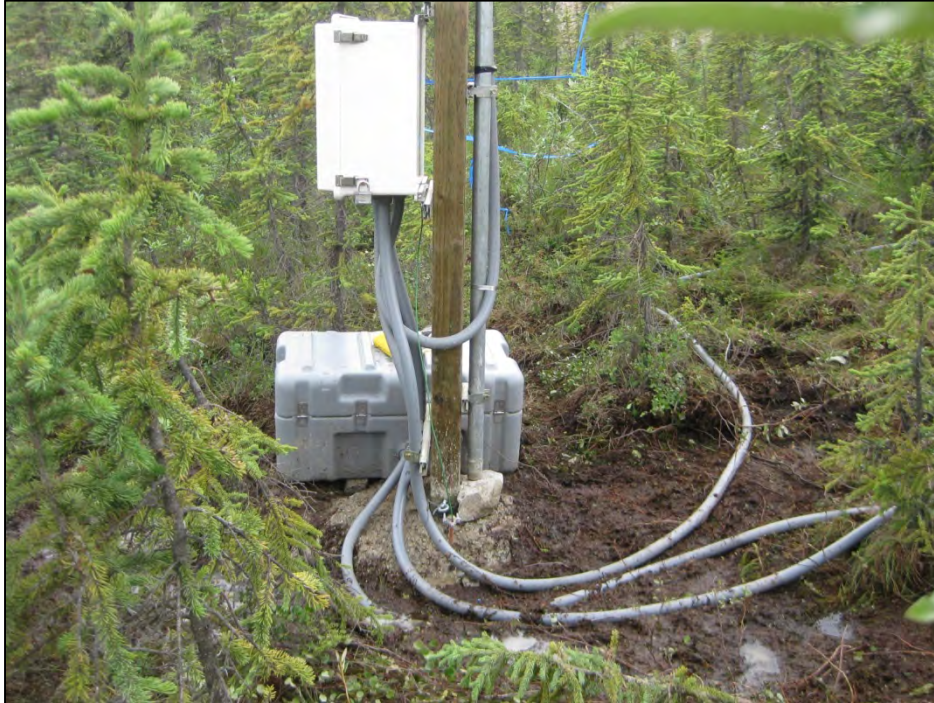
Figure C-25. Battery box and enclosure for ADAS. (Photograph by M. Darrow, July 2012)

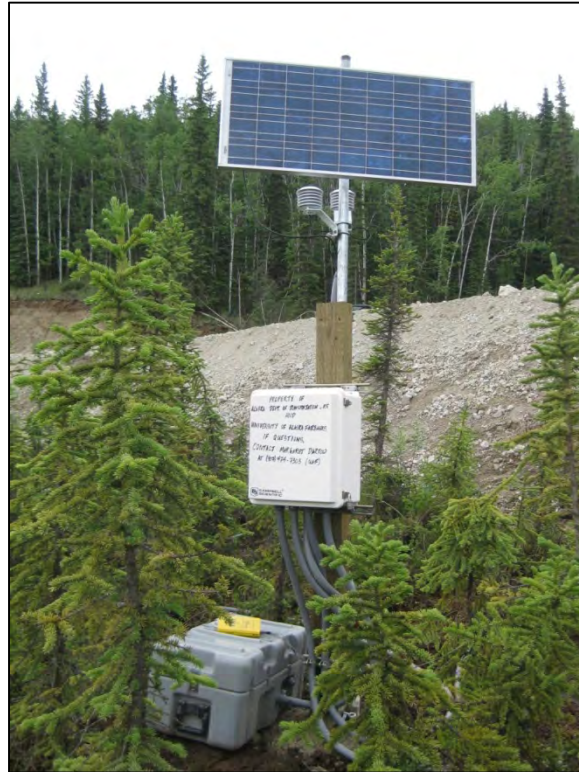
Figure C-26. Final ADAS configuration located near the downslope toe of the embankment. The thermal berm is visible behind the ADAS. (Photograph by M. Darrow, July 2012)

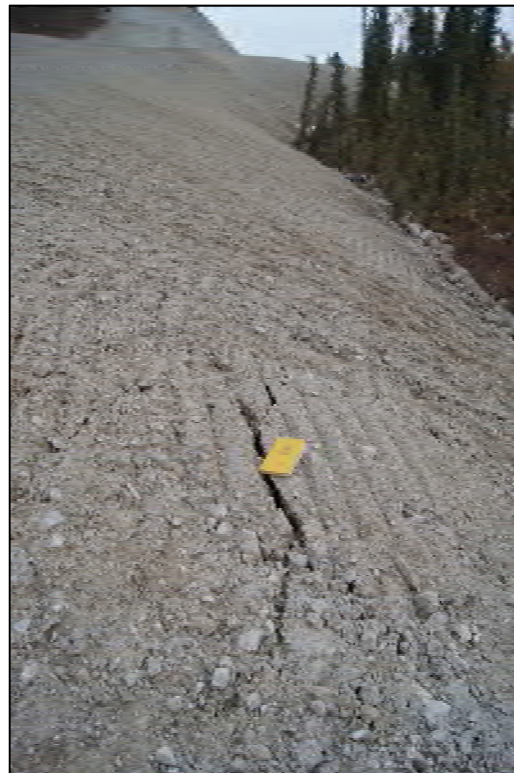
Figure C-27. Cracks in the thermal berm on September 14, 2012. (Photograph by D. Jensen)

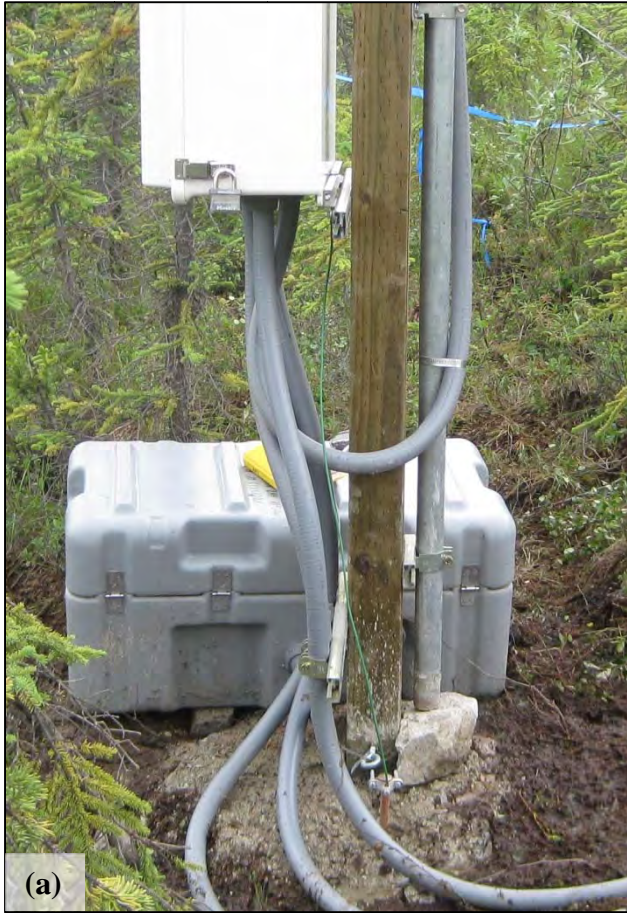
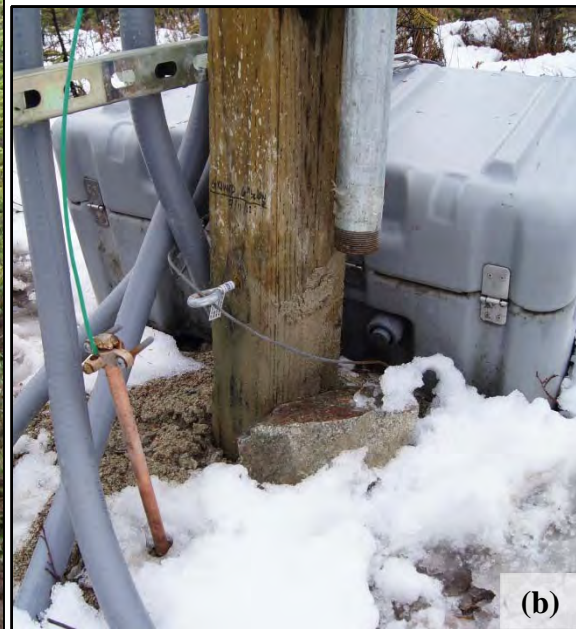
Figure C-28. Changes at the ADAS during the fall of 2012. (a) Post, solar panel support, and grounding rod on July 11, 2012; (b) Settlement of ground surface as of October 6, 2012. (Photographs by M. Darrow and D. Jensen)

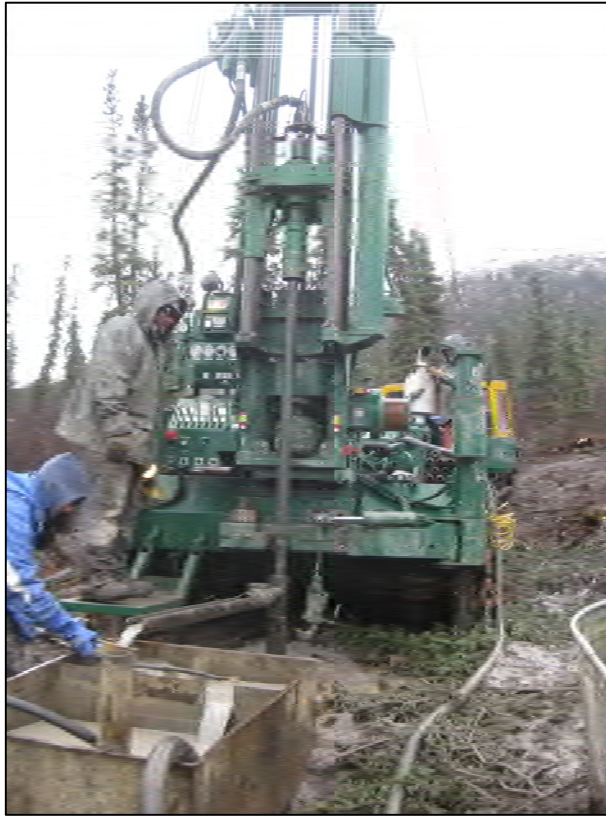
Figure D-1. Drilling TH12-9004 with tricone and casing. (Photograph by M. Darrow, Sept. 2012)

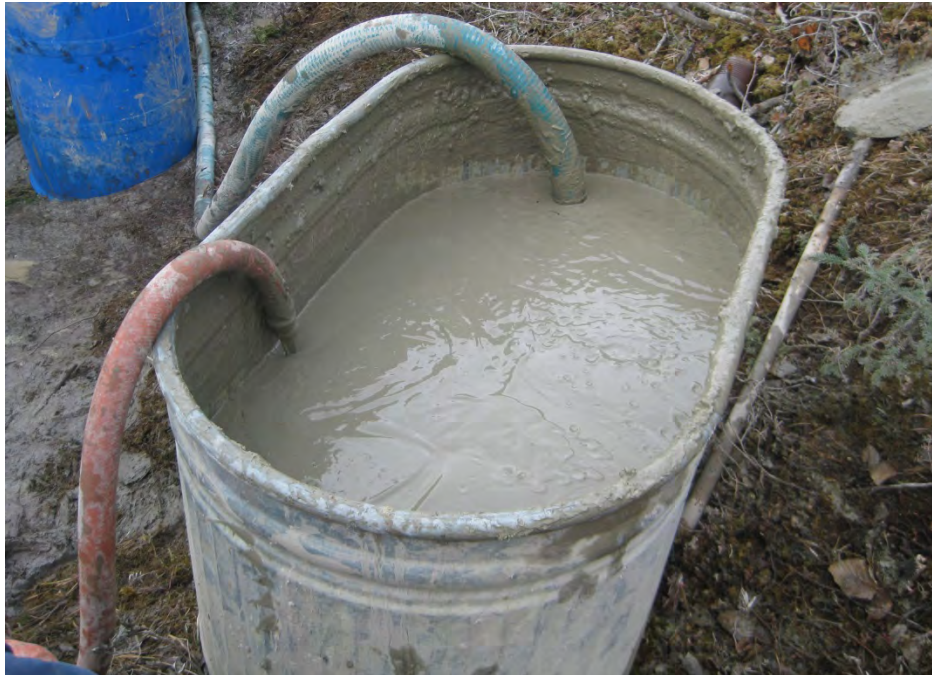
Figure D-2. Cement-bentonite grout during the back-filling process. (Photograph by M. Darrow, Sept 2012)

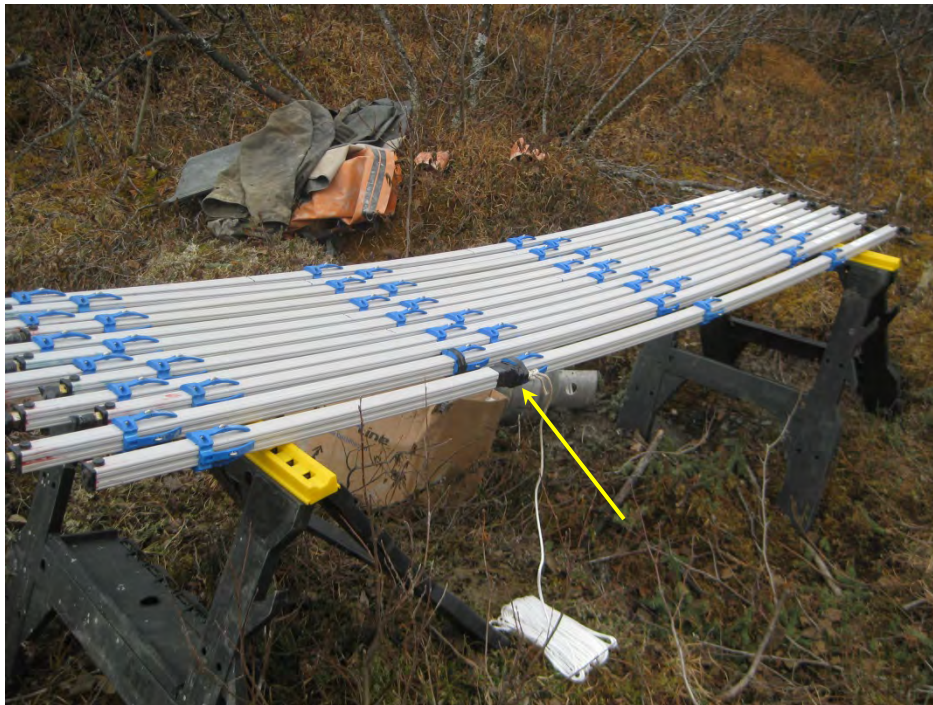
Figure D-3. INC500 modules, staged and ready for installation. A safety line was attached to the lowest module (indicated by the yellow arrow). (Photograph by M. Darrow, Sept. 2012)

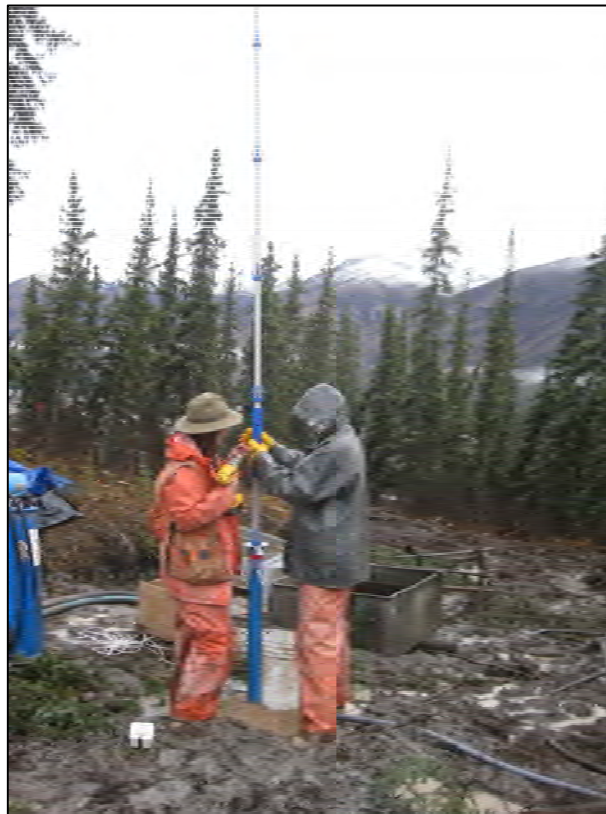
Figure D-4. Installing the INC500 within the guide casing in TH12-9004. (Photograph by J. Simpson, Sept. 2012)

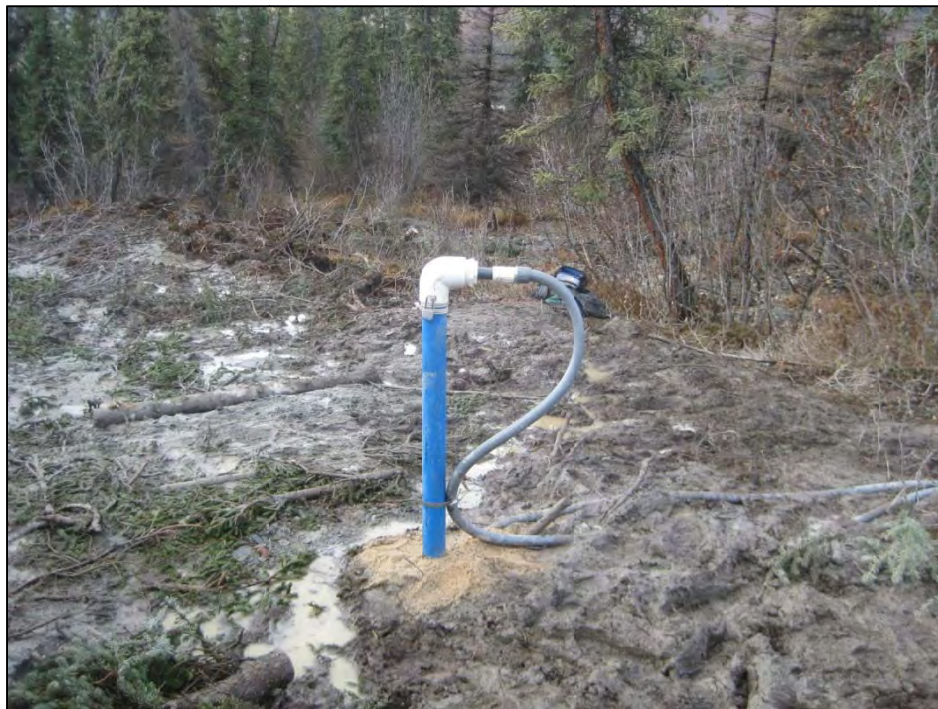
Figure D-6. Completed casing and instrument installation in TH12-9004. (Photograph by M. Darrow, Sept. 2012)

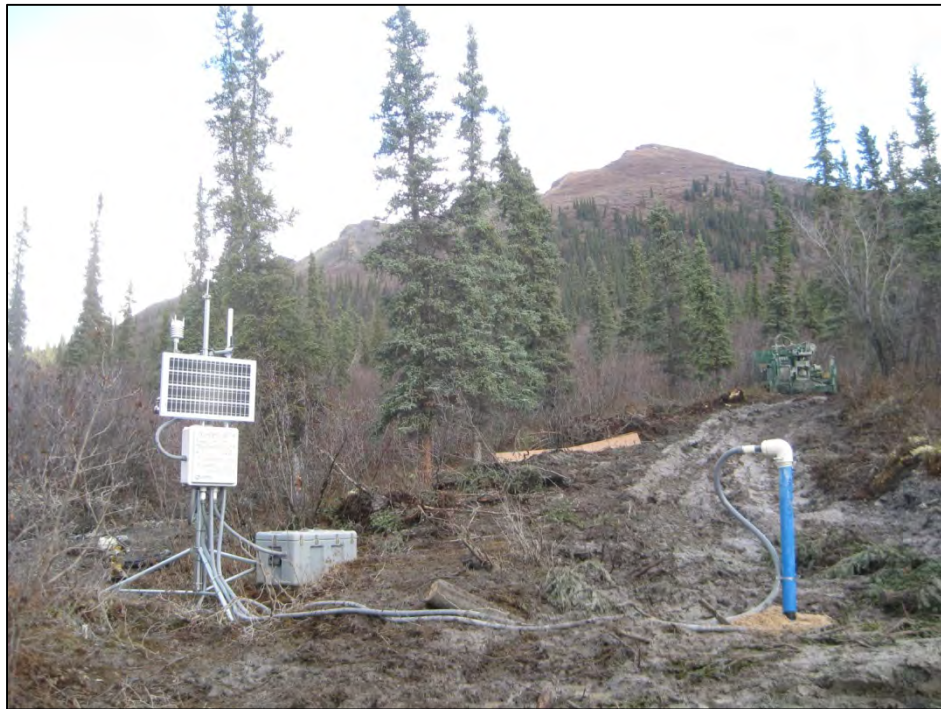
Figure D-7. Completed ADAS location and casing installation of TH12-9004. (Photograph by M. Darrow, Sept. 2012)
