**NCHRP REPORT 350 TEST 4-12 OF THE
ALASKA MULTI-STATE BRIDGE RAIL**

Research Project 404311-3
Contract No. T97232

February 1999

**TEXAS TRANSPORTATION INSTITUTE
THE TEXAS A & M UNIVERSITY SYSTEM
COLLEGE STATION, TEXAS**

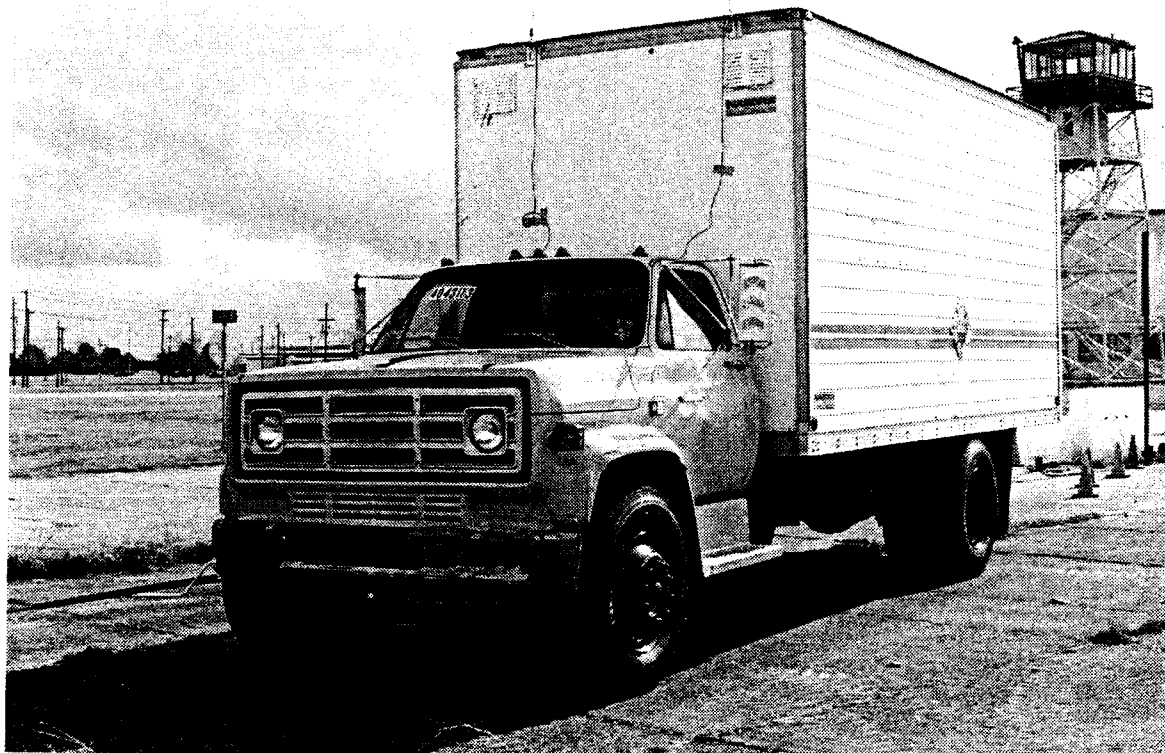
Figure 5. Vehicle before test 404311-3.

A 1987 GMC 7000 single-unit truck, shown in figures 4 and 5, was used for the crash test. Test inertia weight of the vehicle was 8000 kg, and its gross static weight was 8000 kg. The height to the lower edge of the vehicle front bumper was 520 mm and to the upper edge of the front bumper was 850 mm. Additional dimensions and information on the vehicle are given in appendix C, figure 11. The vehicle was directed into the installation using the cable reverse tow and guidance system, and was released to be free-wheeling and unrestrained just prior to impact.

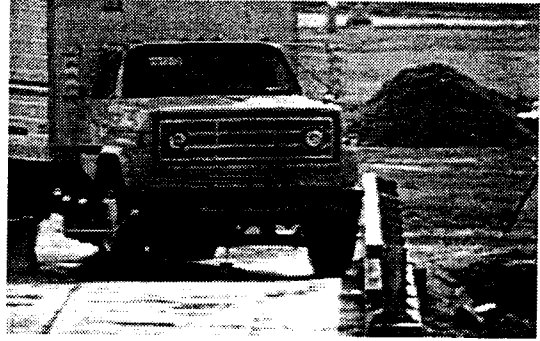
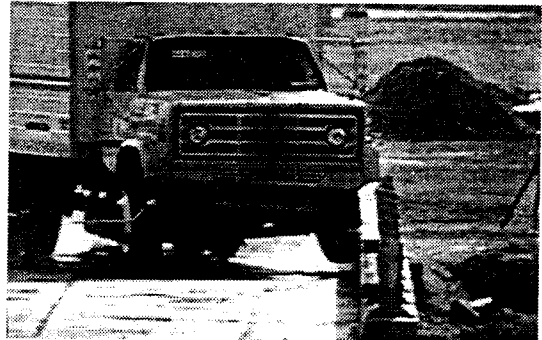
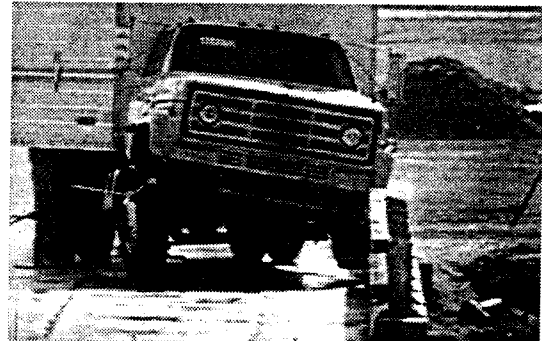
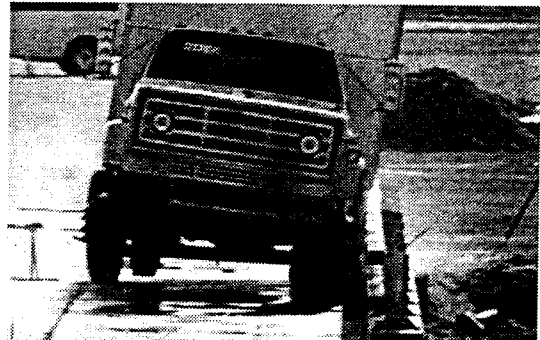
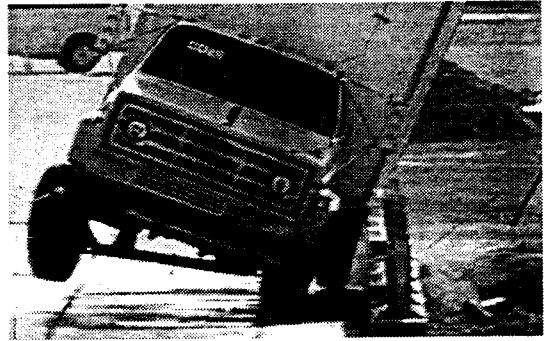
Figure 12. Sequential photographs for test 404311-3 (overhead and frontal views).

Figure 12. Sequential photographs for test 404311-3 (overhead and frontal views) (continued).

left side after exiting the installation at 2.609 s. The vehicle came to rest on its left side 64.7 m downstream and 13.7 m toward traffic. Sequential photographs of the test period are shown in appendix D, figures 12 and 13.
